April 7, 2015

SUBJECT: **DEMONSTRATION / DELIVERY HOLD - Safety Recall 15S02 Supplement #1**
Certain 2010-2013 Model Year Taurus and Police Interceptor Sedan, and 2011-2013 Model Year MKS Vehicles
Interior Door Handle Inspection and Repair

**CERTAIN 2010-2013 MODEL YEAR TAURUS AND POLICE INTERCEPTOR SEDAN
AND 2011-2013 MODEL YEAR MKS VEHICLES — INTERIOR DOOR HANDLE
INSPECTION AND REPAIR**

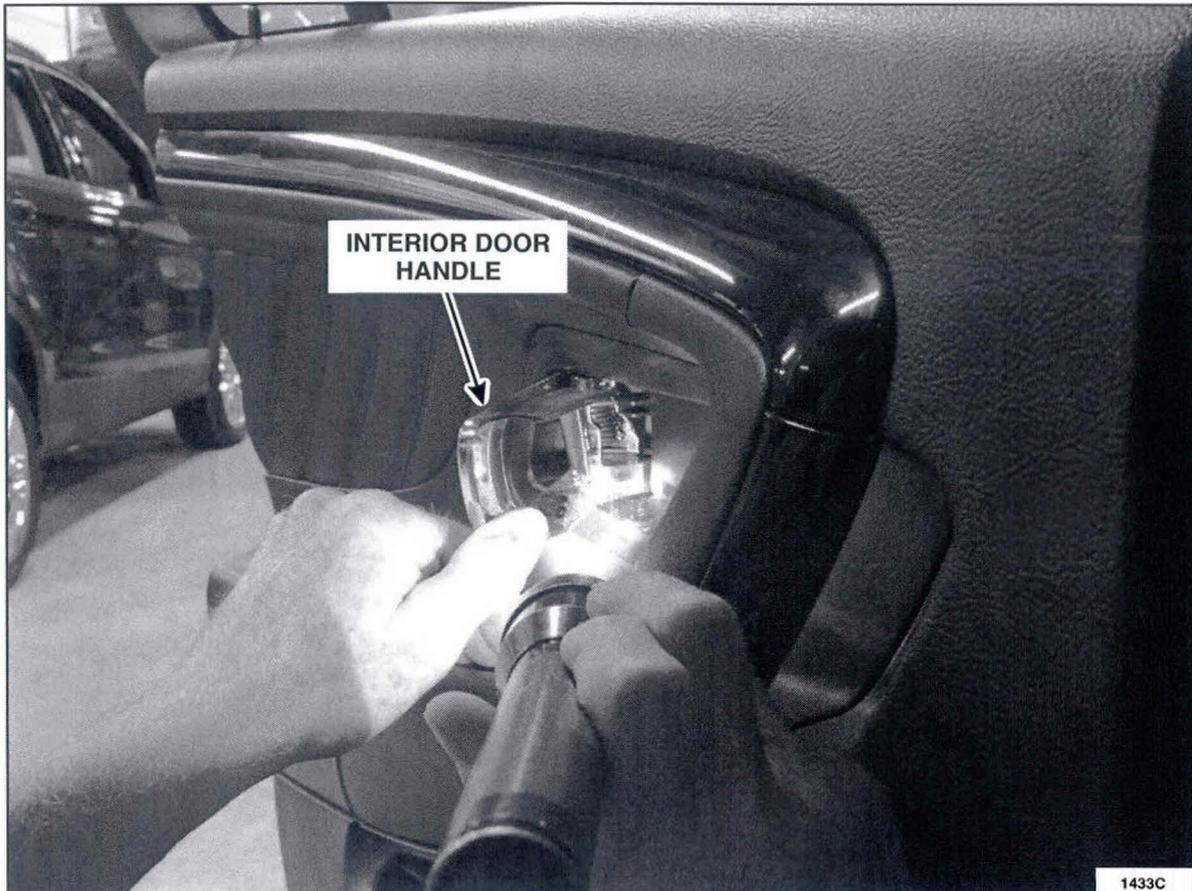
FIGURE 1

1. Hold the interior door handle in the open position. Using a flashlight, locate the return spring and return spring retainer wall. See Figure 1 below and Figure 2 on Page 2.

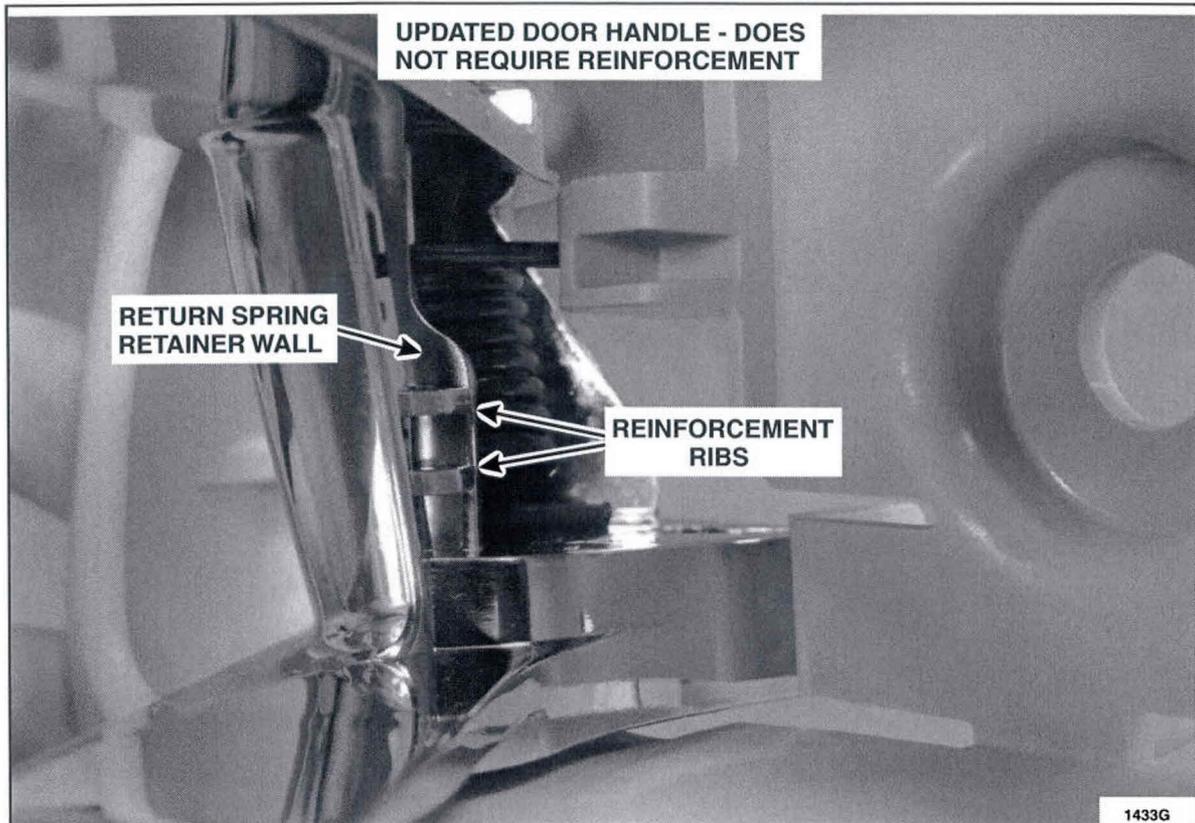
FIGURE 3

3. Interior door handle is equipped with two (2) reinforcement ribs on the return spring retainer wall. See Figure 3.

- No service is required on this interior door handle design.

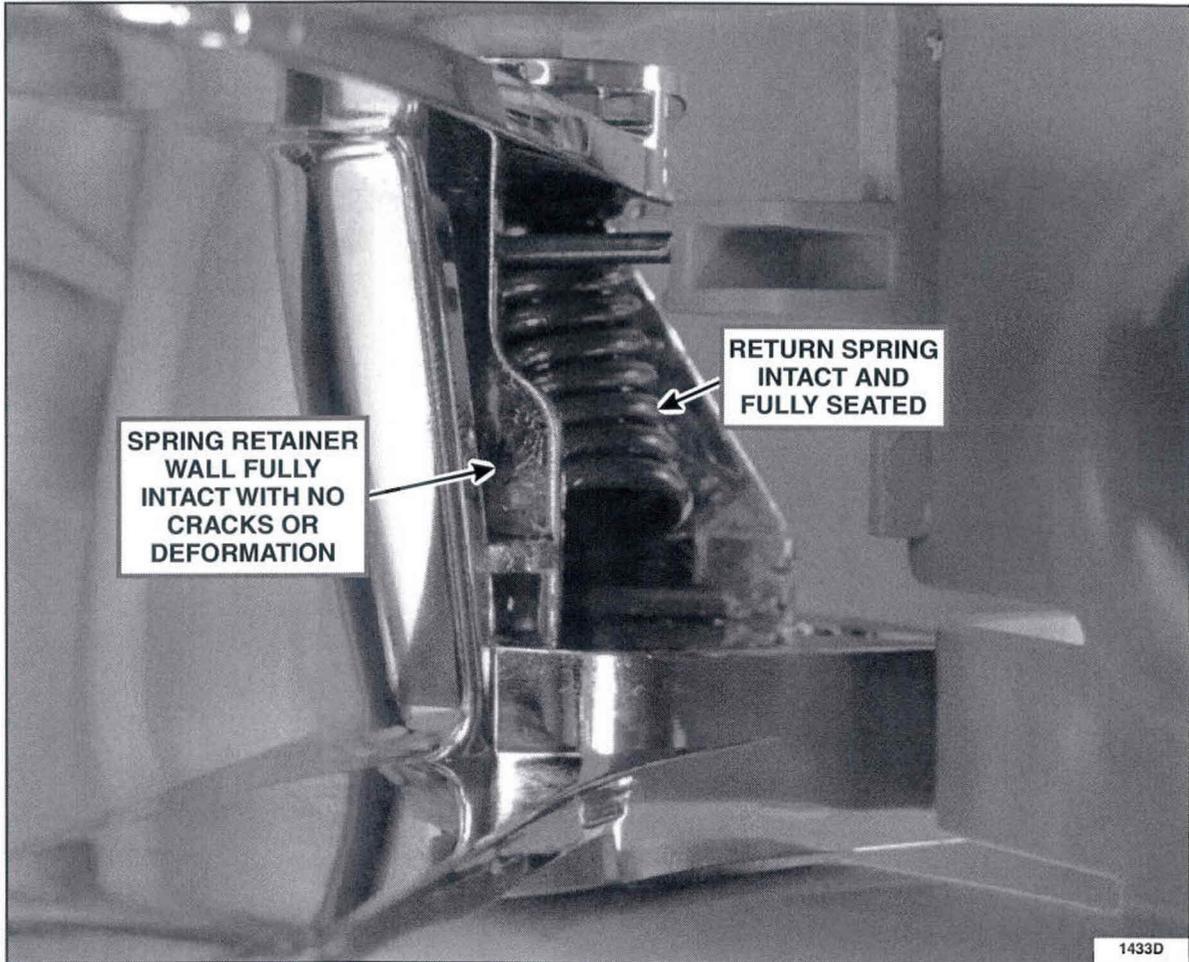
FIGURE 4

4. Return spring is intact and fully seated. The spring retainer wall is not deformed and is fully intact with no cracks. See Figure 4.

- Proceed to step 8.

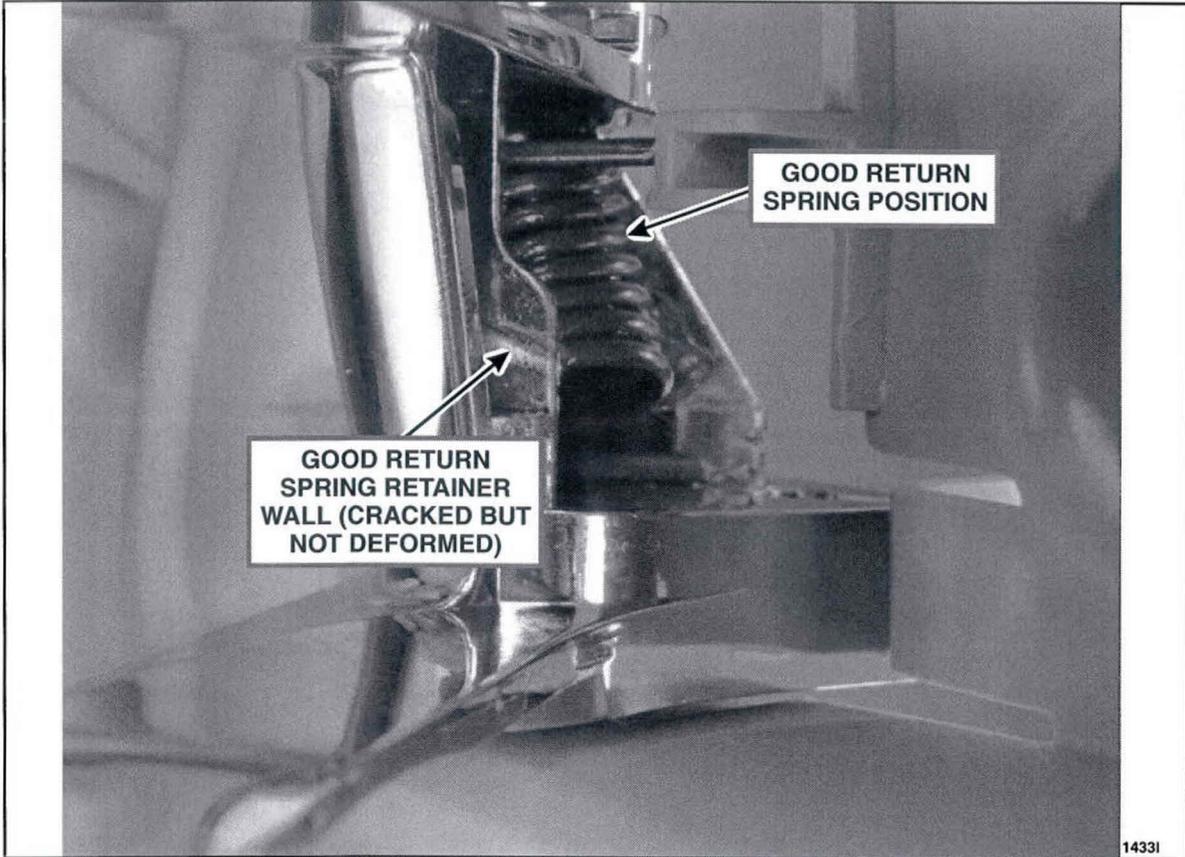
FIGURE 5

5. Return spring is intact and fully seated. The spring retainer wall has a single crack, but is not deformed and is fully intact. See Figure 5.

- Proceed to step 8.

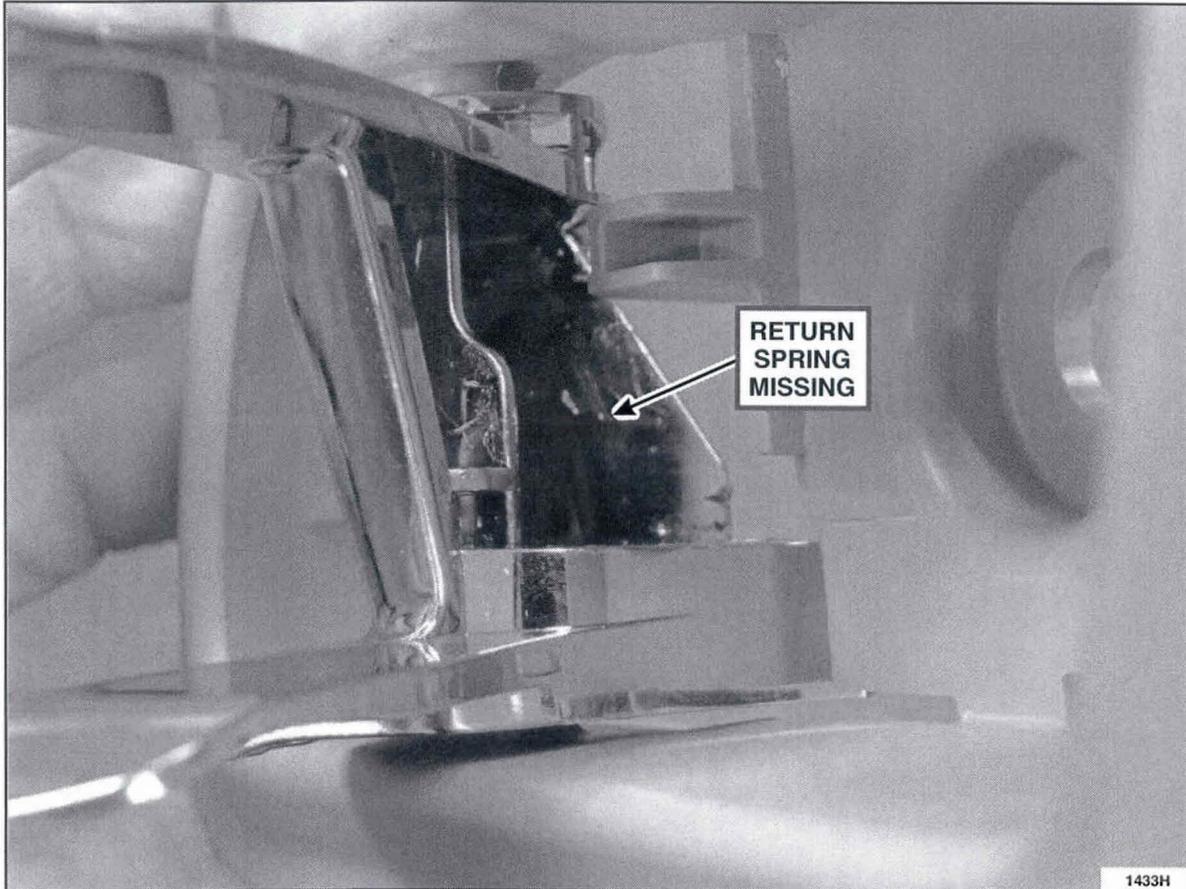
FIGURE 6

6. Return spring is loose, out of position, or missing. See Figure 6.

- Replace the interior door handle. Please follow the Workshop Manual (WSM) procedures in Section 501-14.

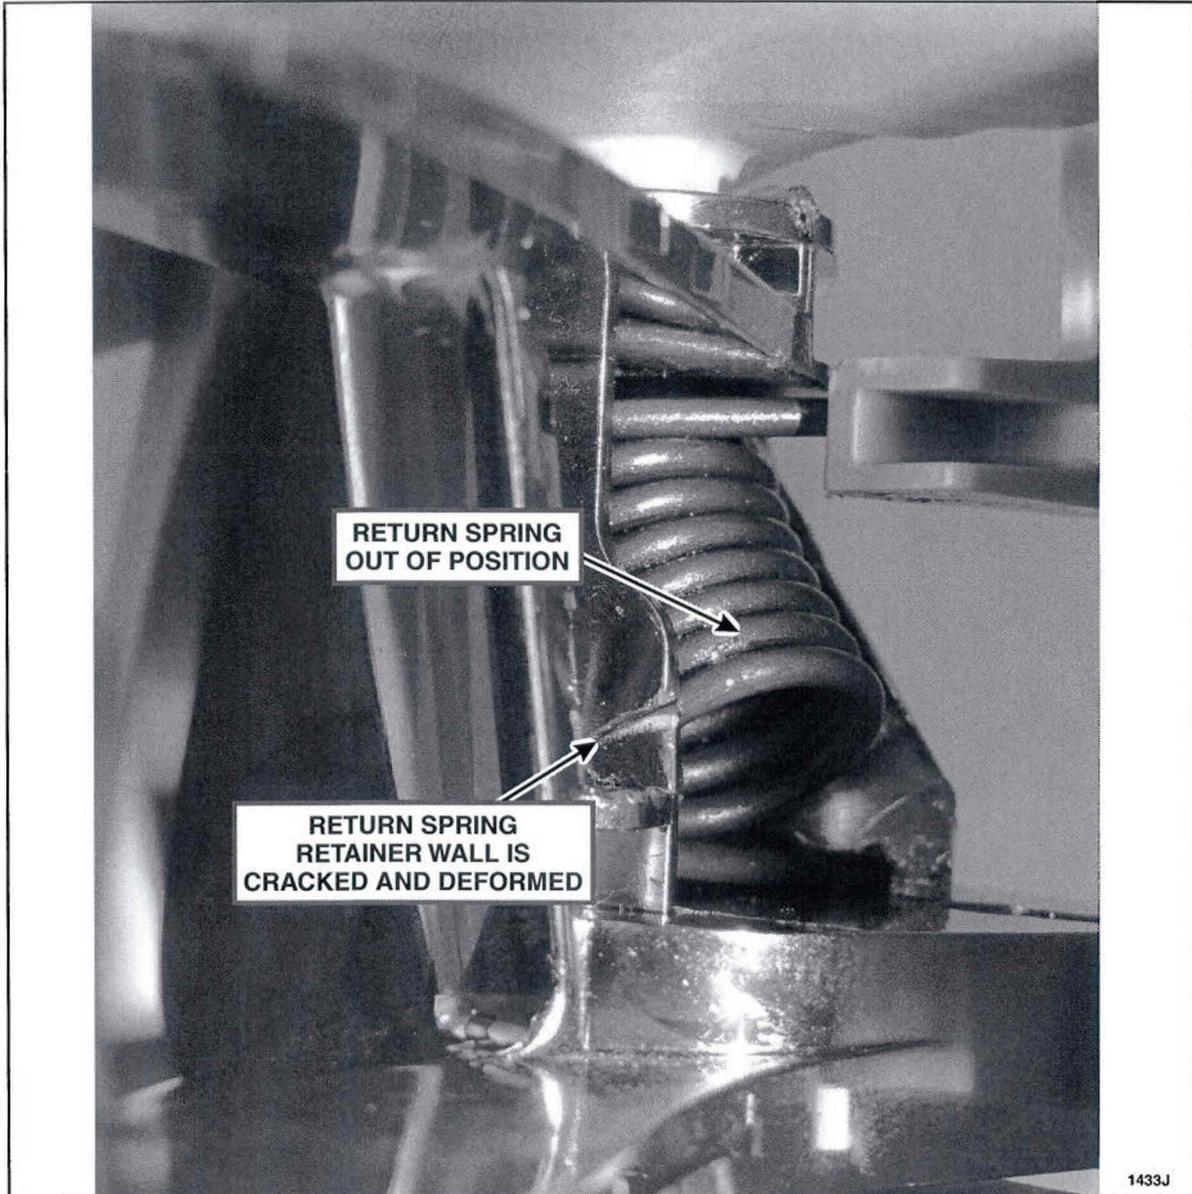
FIGURE 7

7. Spring retainer wall is missing, deformed, or broken. See Figure 7.

- Replace the interior door handle. Please follow the WSM procedures in Section 501-14.
