TO: ALL CHRYSLER, JEEP, DODGE, & RAM DEALERSHIPS & FIAT STUDIOS
ATTN: DEALER PRINCIPAL, SERVICE MANAGER & PARTS MANAGER
SUBJECT: SAFETY RECALL TECHNICAL ADVISORY (P36)

Chrysler Group LLC (Chrysler) released Safety Recall P36 – Sun Visor Wiring in August of 2014. This recall involves 2011 through 2014 model year (WD) Dodge Durango and (WK) Jeep Grand Cherokee vehicles.

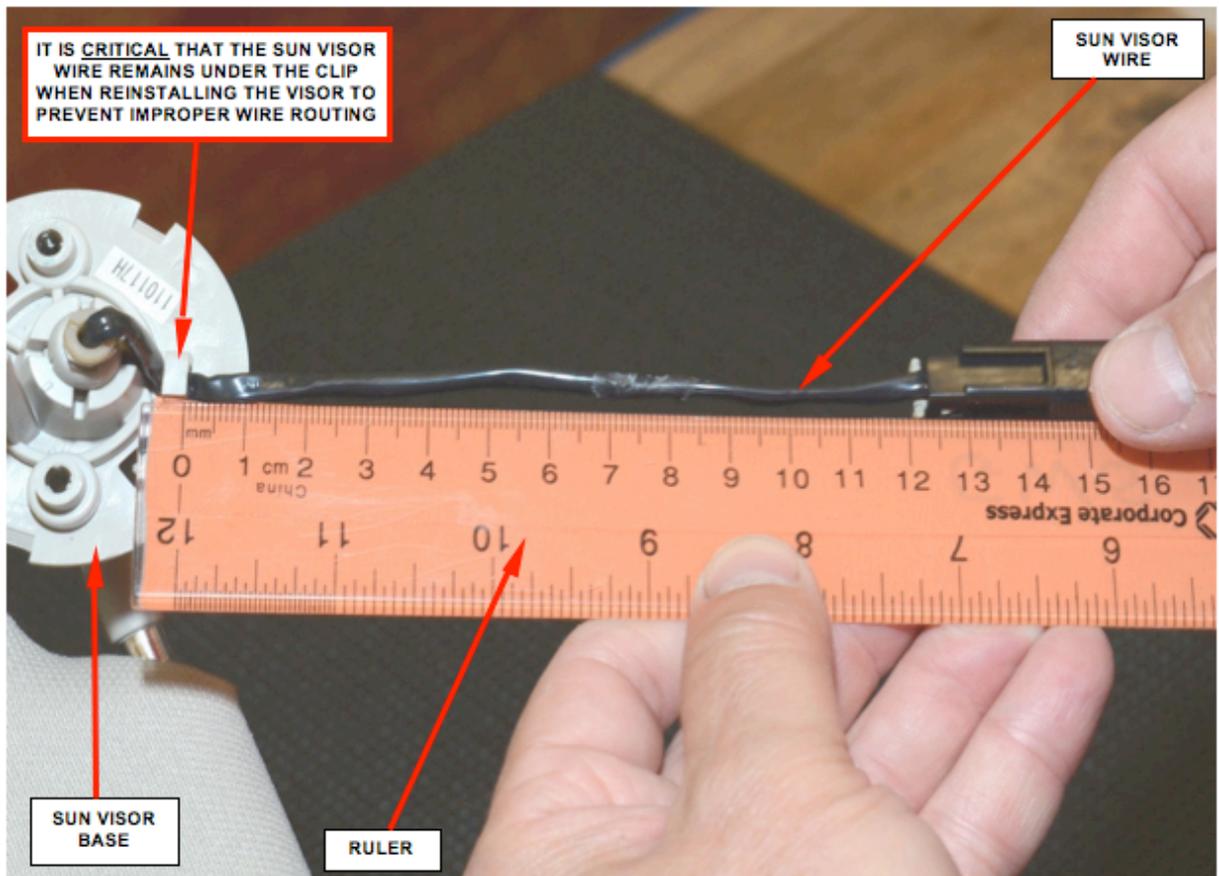
Figure 1 – Wire Must Be Clipped Before Installing the Sun Visor

It is critical that the sun visor wire remains under the clip when reinstalling the visor to prevent improper wire routing.

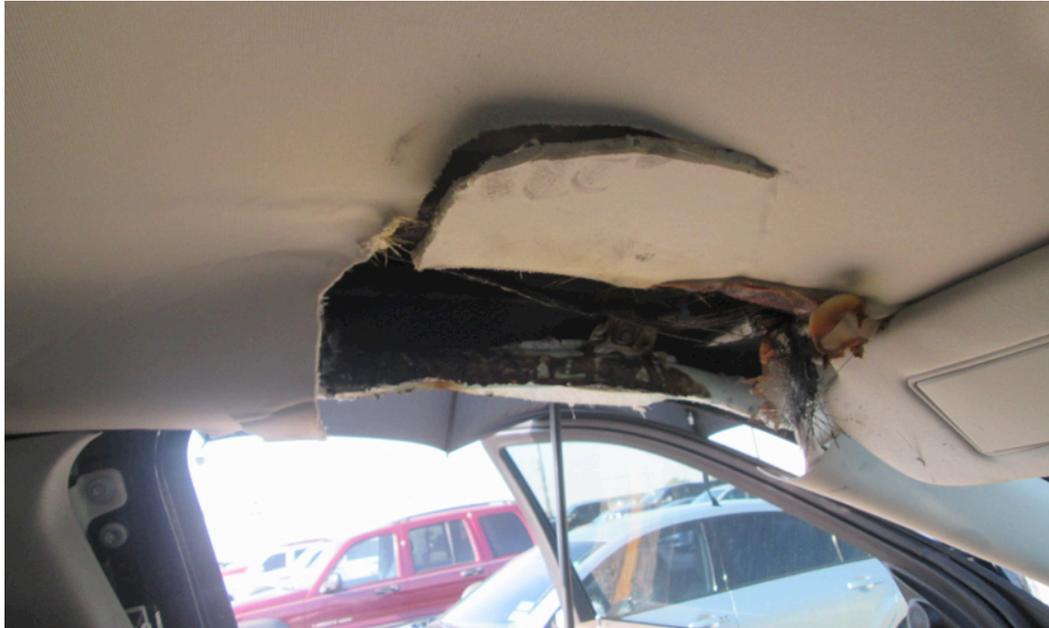
Figure 2 – Result of Improperly Performed Recall

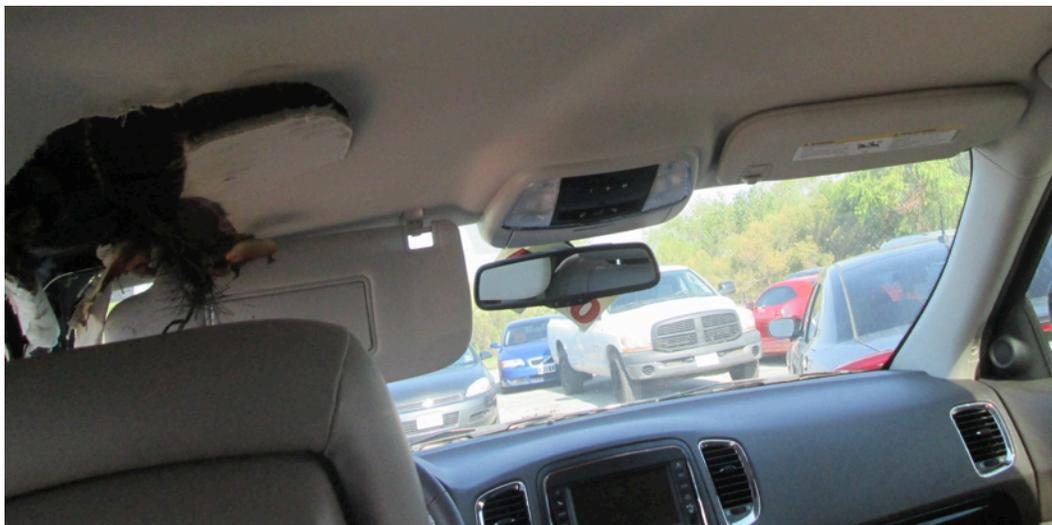
Figure 3 - Result of Improperly Performed Recall

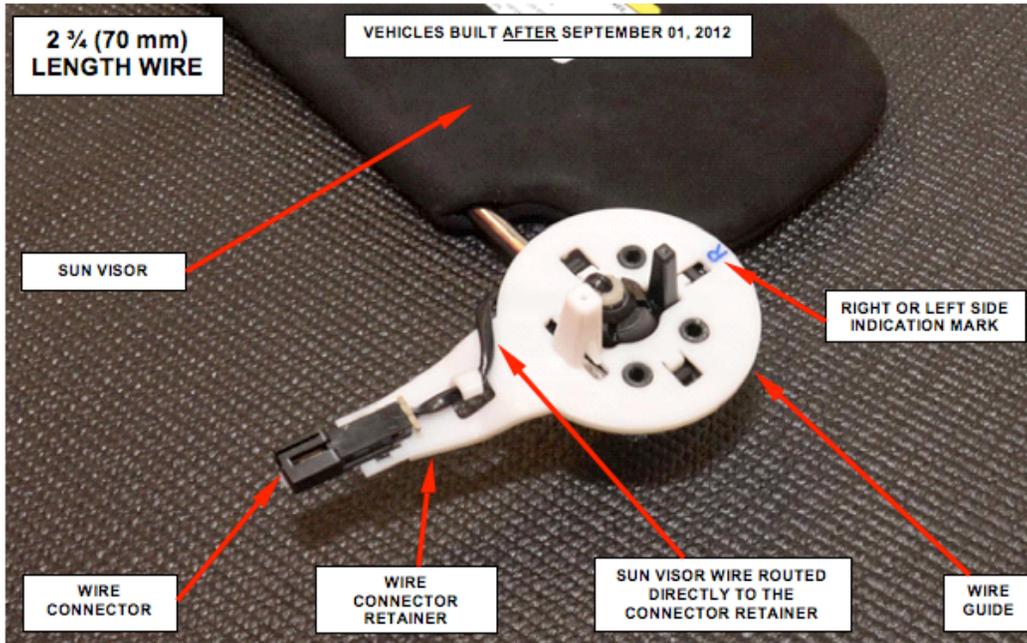
Figure 13 - Sun Visor Wire Routing (2 3/4 Inch / 70 mm Length Wire)
(Parts removed from vehicle for photographic purposes only)

It is very important to determine if the vehicle has the short sun visor wiring (2 ¾ in.) or the long sun visor wiring (4 ¾ in.) and to route the sun visor wiring as shown in the service instructions (see Figure 13 and 14 of the recall and/or included photos).

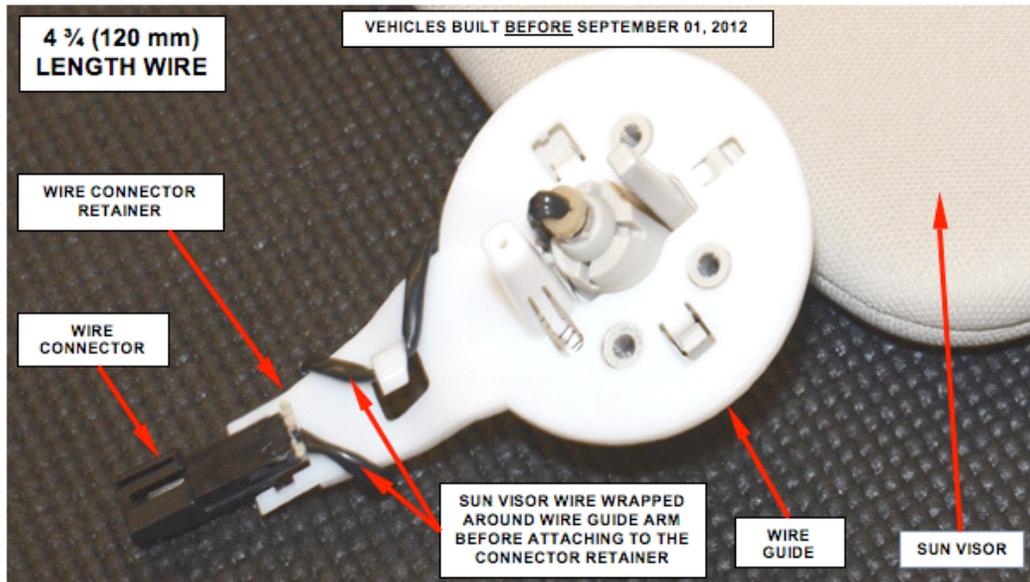
Figure 14 – Sun Visor Wire Routing (4 3/4 Inch / 120 mm Length Wire)
(Parts removed from vehicle for photographic purposes only)
