**TECHNICAL INSTRUCTIONS**  
**FOR**  
**VOLANTARY SAFETY RECALL CAMPAIGN SET15B**  
**FRONT PILLAR GARNISH LH TOP CLIP REPLACEMENT**  
**CERTAIN 2015 MODEL YEAR SIENNA**

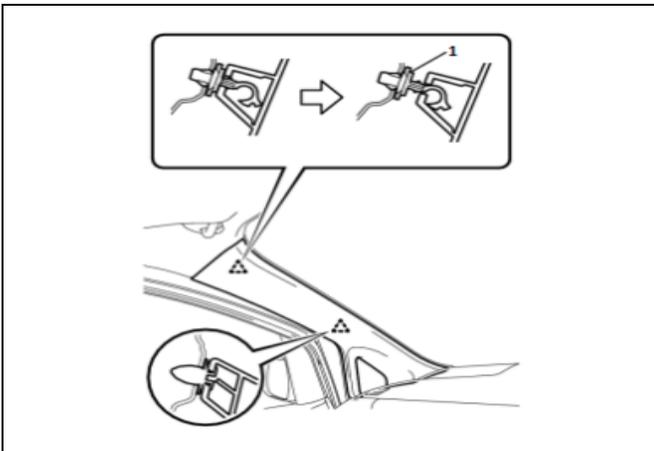
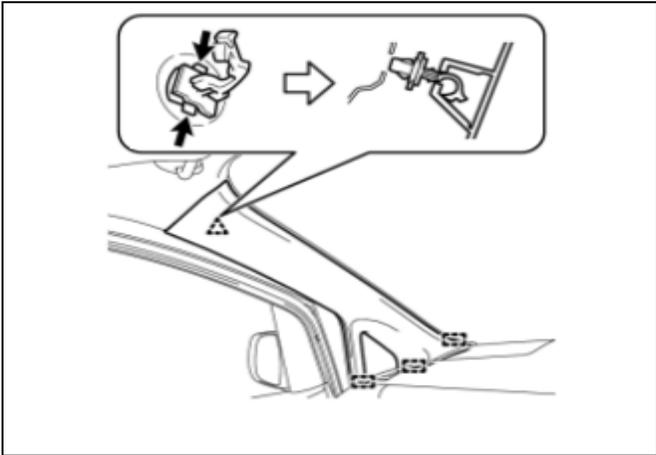
1	Front Pillar Garnish Top Clip
---	-------------------------------

SET either installed, or sold to dealers to install, accessory overhead entertainment systems for 2015 Toyota Sienna. The installation instructions associated with those systems stated that the A-pillar garnish clip could be reused as part of the installation. The installation instructions should have indicated that the A-pillar garnish clip should be replaced and not re-used. As a result, the A-pillar garnish clip may not have been replaced. The A-pillar garnish is in the deployment path of a side curtain airbag. If the A-pillar garnish clip has been damaged during the installation of the overhead entertainment system and is reused, there is the potential for the A-pillar garnish to become detached during a curtain airbag deployment and cause injury to an occupant.

#### 3. REMOVE FRONT PILLAR GARNISH LH AND TOP CLIP

- Separate the front pillar garnish clip from the front pillar garnish LH.

- b) Disengage the clip.
- c) Press the 2 areas indicated by the arrows in the illustration.
- d) Disengage the front pillar garnish clip and 3 guides to remove the front pillar garnish LH.
- e) Remove the front pillar garnish clip from the front pillar garnish LH.
