Re: 49 CFR Part 573 Defect Report

**Generic Name of the item:** Frame Rail Mounting System

**Make:** IFS **Model:** Electric APU BA600

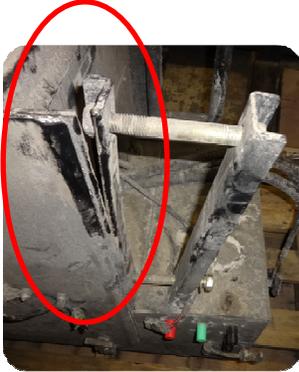
**A. Crack:** In certain APU units, the C-channels of the metal housing of the frame rail system have shown evidence of cracking and tearing. The following is a picture of a unit that shows signs of cracking:

Improper radius design of C-channel corners and a lack of gusseted corners with end cap.

If left unchecked, the C-channel radius could crack, which could cause parts of the unit to dislodge from the vehicle frame rail. If an APU unit completely separated from a truck frame, it could create a safety hazard.

As indicated, an upgrade kit (as reviewed and approved by NHTSA) will be sent to all affected IFS dealers. The APU frame rail upgrade kit consists of two gusset plates, two backer brackets, mounting hardware and instructions. The gusset plates are to be welded to the top of the APU frame C-channel to prevent cracks from propagating along the channel radius. The backer brackets are installed on the back side of the vehicle frame rail by means of four bolts which attach directly to the APU frame. The upgrade will provide additional structural support alleviating the stresses on the APU that may be associated with backer bracket deformity and/or broken bolts. A decision tree such as found in attached Appendix One will help to guide the field inspection and corrections as required.

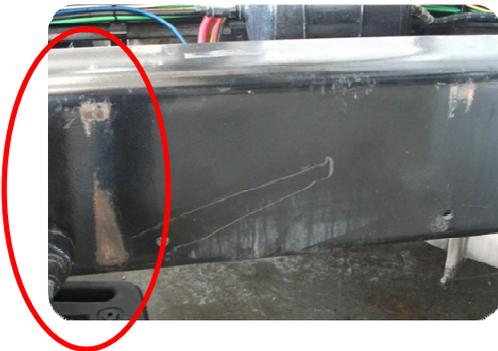
**B. Mounting:** In certain APU units, mounting bolts have become loose or in some cases failed. The following is a picture of a vehicle frame rail that showed signs of wear (rub marks) from incorrectly torqued bolts:

Incorrectly torqued bolts may result from inadequate strength of the backer C-channel. Deformity along with a loss of torque tightness has been witnessed in some installations. It is believed that a bending moment is created which fatigues the channel. The defect condition is the result of the existing backer C-channel design and the variable tightening torque used during APU vehicle installation.

Improperly torqued bolts could loosen over time. Once loosened, they can detach, wear or fracture. If an APU unit completely separated from a truck frame, it could create a safety hazard.

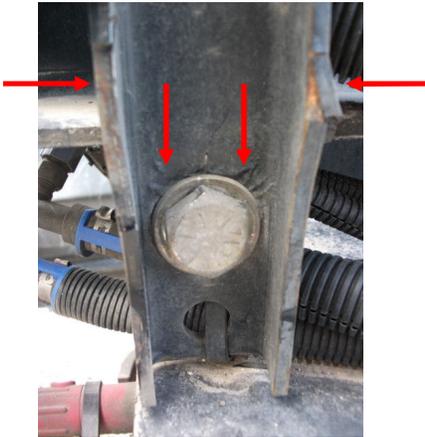
The following is a picture of a Venture frame backer C-channel that showed deformity at the lower bolted area and subsequent bolt loosening.

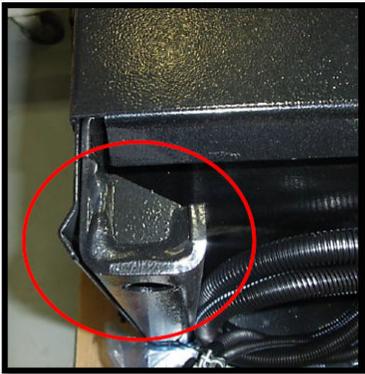
Figure 2 - Frame gusset in place
