**TECHNICAL INSTRUCTIONS**  
**FOR**  
**SAFETY RECALL F0J**  
**POWER STEERING ECU INSPECTION**  
**CERTAIN 2015 MODEL YEAR HIGHLANDER & HIGHLANDER HV**

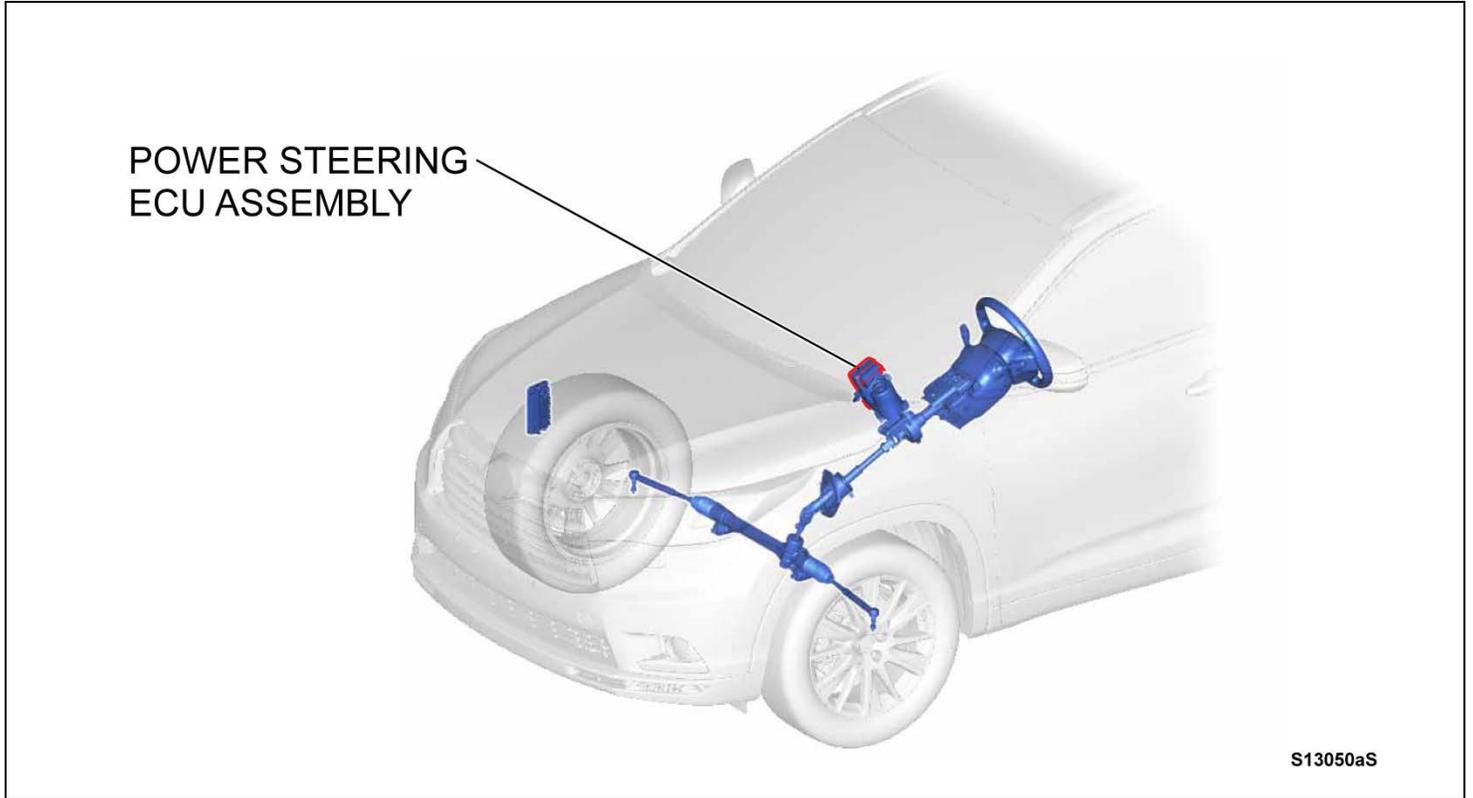
A circuit board for the electric power steering (EPS) in the subject vehicles may have been damaged during its manufacturing process. This can result in the loss of power steering assist. Manual steering is maintained, but the loss of power steering assist results in increase steering effort at low vehicle speeds and increases the risk of a crash.

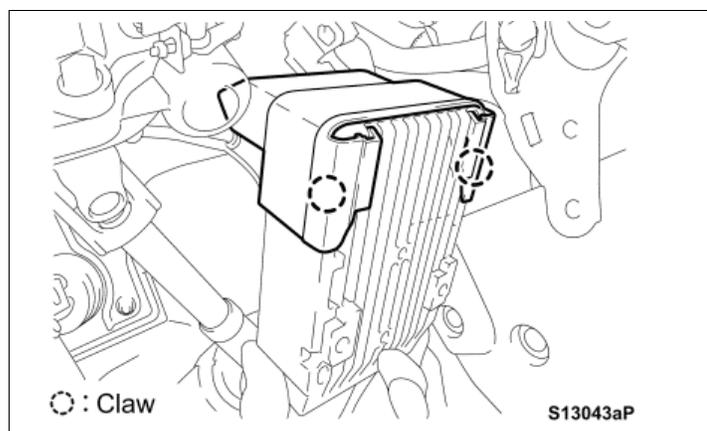
VIN: 5TDJKRFH4F000000000  
Model: Highlander LHD  
EPS ECU Serial Number: EATCEC0173037089889C12014120200626  
Result: **THE EPS ECU is AFFECTED, repair the vehicle as described in the TI.**

Install new EPS ECU

Perform Steps 11 - 17
