Dealer Service Instructions for:

Safety Recall R16 / NHTSA 13V-527 Steering Linkage

2008 – 2010 (DM) RAM Truck (4500/5500 Cab Chassis)

2011 – 2012 (DP) RAM Truck (4500/5500 Cab Chassis)

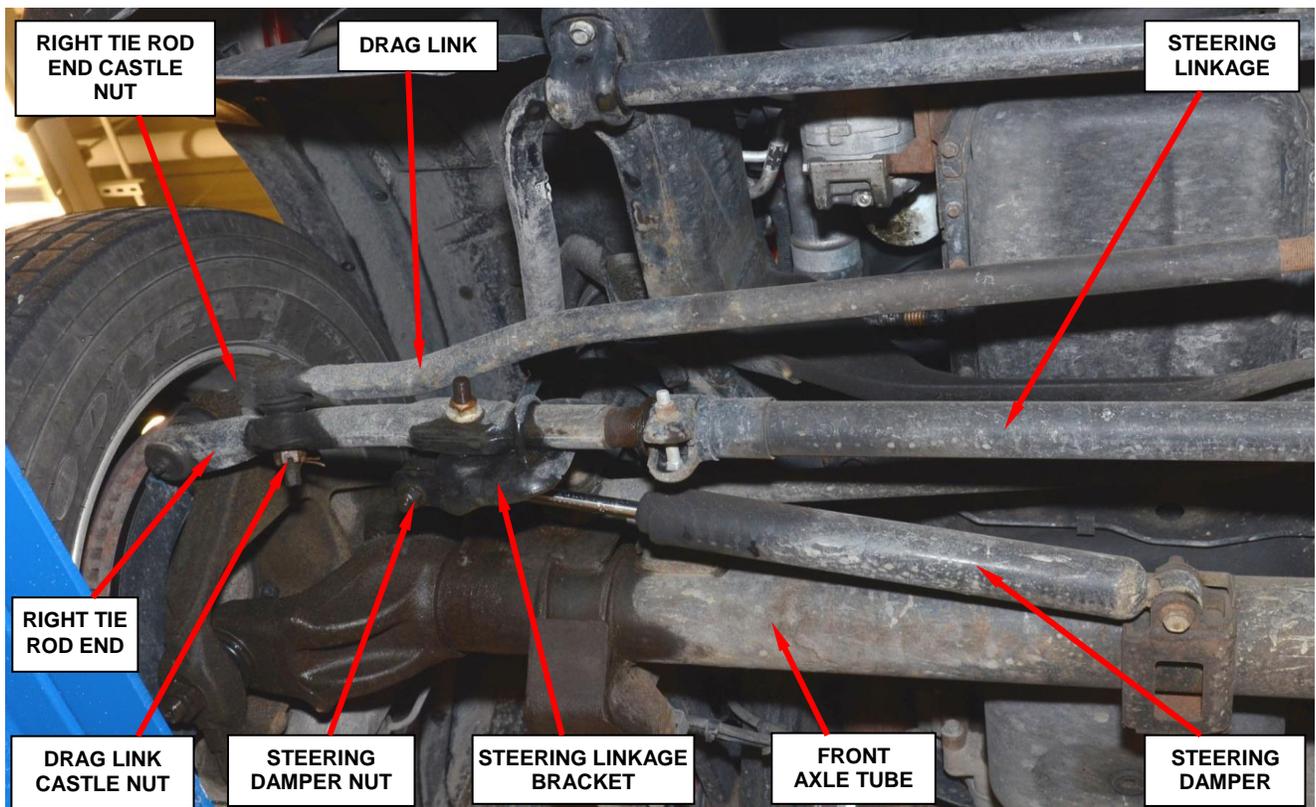
Figure 1 – Original Steering Linkage

The left tie rod ball stud on about 35,900 of the above vehicles may fracture under certain driving conditions. This could cause a loss of directional control and/or a crash without warning.

1. Lift the vehicle on an appropriate hoist.
2. Remove and save the steering damper nut and bolt at the steering linkage bracket (Figure 1).
3. Remove and save the drag link castle nut at the right tie rod end (Figure 1).
4. Using special tool 8677 or equivalent, separate the drag link from the right tie rod end.

5. Remove and save the right side tie rod-to-knuckle arm castle nut (Figure 1).
6. Using special tool 8677 or equivalent, separate the right tie rod end from the right knuckle arm.
