LIPPERT
COMPONENTS

**AMENDED
SAFETY RECALL 15E-029
STOP SALE NOTICE**

NHTSA ID: 15E029 Transaction ID: 15-001523-16441-11 (Amendment 1)

Trailer Axle Hub Stud Breakage Identification - Recall Number 15E-029

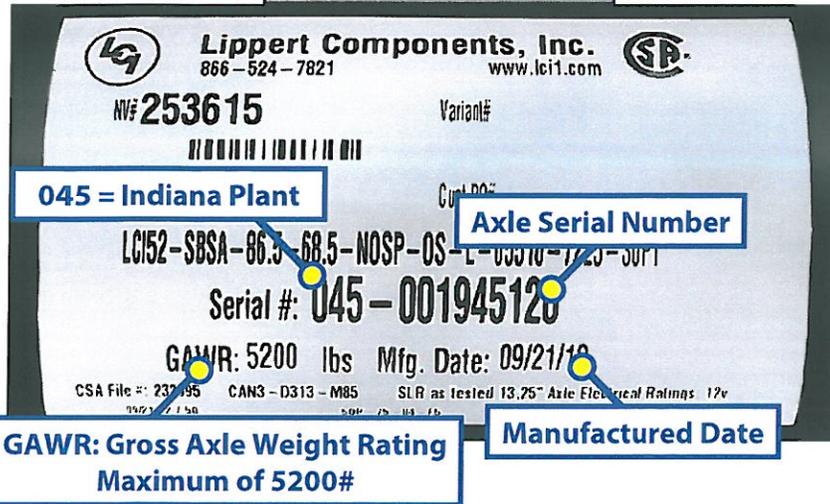
Fig. 5 - Indiana Axle Tag

NOTE: The Axle Tags demonstrate the plants from which the original axles in question were shipped, see Figs 5 & 6. Please take note of the first three numbers of the Serial Numbers on the Axle Tags to determine the plant of origin.
