Utilimaster Corporation

RECALL SERVICE BULLETIN

DOCUMENT P/N 03102510-X001EN Rev. A

SUBJECT: Utilimaster Corporation has determined a defect relating to driveline bolts that may cause it to detach.

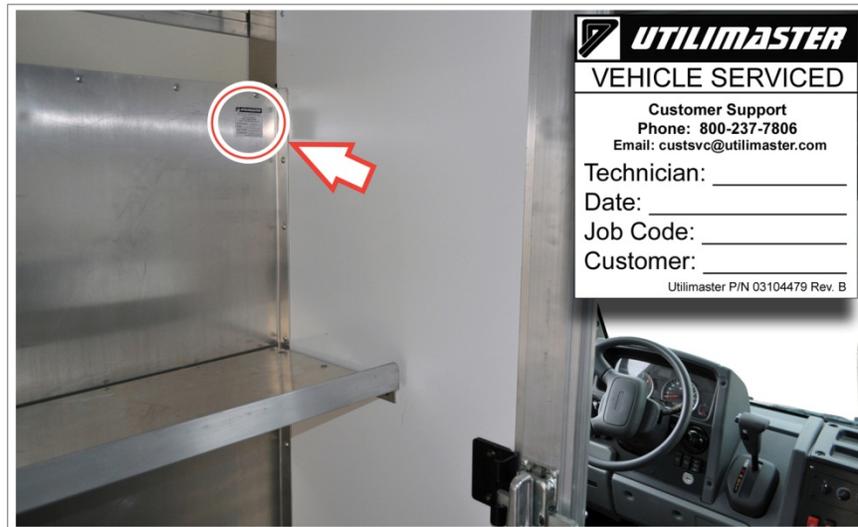
Service decal on driver's door pocket (cargo side)

1. Read and understand all the instructions before starting the repair.
2. Torque the (4) hanger (carrier) bearing bolts to 80-106 ft•lbs per Lippert instructions SF-043.
3. Torque the (4) strap (kit) tech bolts to 25-36 ft•lbs per Lippert instructions SF-043.
4. Use Job Code 13-K7-89-37 from this document to complete the SERVICED decal.
5. Adhere the decal to the upper right-hand corner of the driver's door pocket panel next to the bulkhead wall. Do NOT cover any previously applied decals.
