TECHNICAL BULLETIN
P046 NAS5
18 JUN 2015

Safety Recall: Supplementary Restraint System (SRS) Warning Lamp Illuminated

Range Rover Evoque (LV)

LR2 (LF)

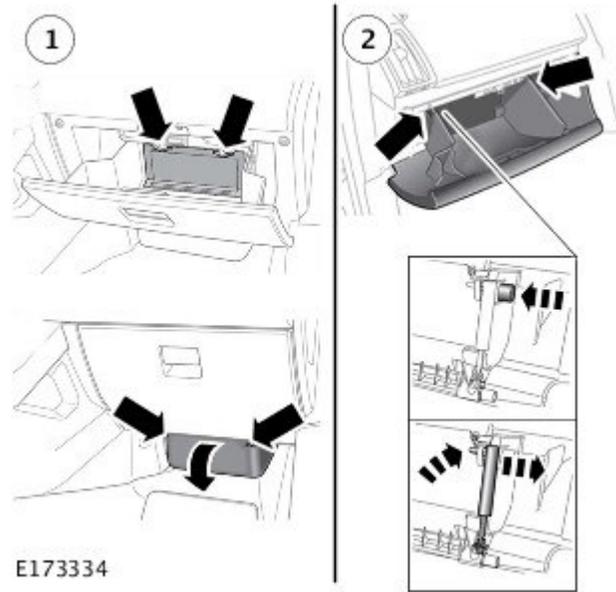
- The fuse box is located in the passenger compartment:
 - '1' - Range Rover Evoque: fuse 56P [fuse rating 10A]
 - '2' - LR2: fuse FS2 [fuse rating 10A] - 2010-2012MY; fuse FP60 [fuse rating 10A] - 2013-2015MY
- Press the on-screen green ✓ (tick) to continue.
- Install the previously removed OCSCM fuse when SDD displays a blue scroll bar in the center of the screen.
 - This should be within 10 seconds of pressing the green ✓ (tick) on the software download confirmation screen.
 - If the download is completed successfully, continue to the next step.
 - If the download fails again, please contact your local Technical HelpLine for assistance.

Once the software download parts confirmation screen is presented, remove the OCSCM fuse.
