Recall Bulletin

PRODUCT SAFETY RECALL

SUBJECT: Fuel Odor or Spotting on Ground – Inspect Fuel Pump Module

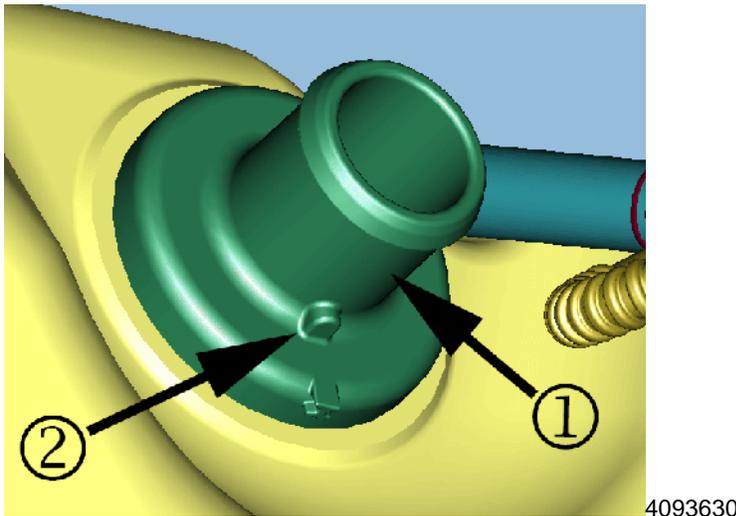
Identifying the 20870462 or 25947828 fuel tank.

The fuel tank hose connection (1) will have an index feature (2) at the bottom 6 O'clock position where the hose joins the tank. Older style tanks have this feature on top at the 12 O'clock location. The fuel tank may also have an identifying tag displaying the part number.

- If the part number **is** 20870462 or 25947828, and has the bottom index, **do not** replace the fuel tank or fill pipe.
3. If the part number **is not** 20870462 or 25947828, and has the top index, **replace the fuel tank and fill pipe**. Remove the fuel tank filler pipe. Refer to *Fuel Tank Filler Pipe Replacement* in SI.
 4. Remove the fuel pump module. Refer to *Fuel Pump Module Replacement* in SI.
 5. Install a new fuel pump module. Refer to *Fuel Pump Module Replacement* in SI.
