Petition

RE: Petition for a Defect Investigation under 49 U.S.C. § 30162 Petitions by interested persons for standards and enforcement

This is a petition for an investigation into low-speed surging in different models of Toyota automobiles in which the car starts accelerating and the engine RPM increases even when the accelerator pedal is not depressed. Recently the NHTSA rejected a petition from [REDACTED] asking for a similar investigation. I am petitioning NHTSA a second time based on my wife and my case and additional data analysis which shows a troubling similarity amongst EDRs of Toyota cars showing sudden acceleration.

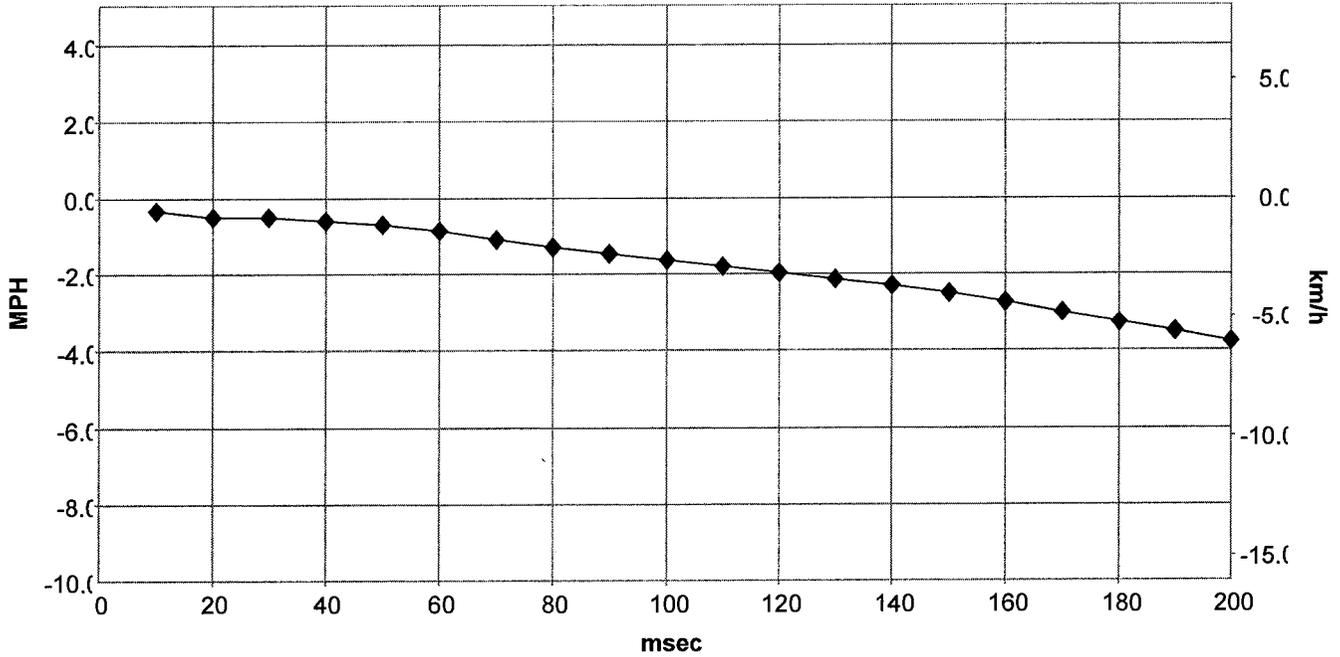
Recording Status, Time Series Data	Complete
Max Longitudinal Delta-V (MPH [km/h])	-3.8 [-6.1]
