GROUP Safety Recall Campaign	MODEL 2011MY Sportage (SL)
	NUMBER SC 121	DATE July 2015
VOLUNTARY SAFETY RECALL CAMPAIGN		
STOP LAMP SWITCH REPLACEMENT (SC121)

STOP LAMP SWITCH REPLACEMENT (SC 121)

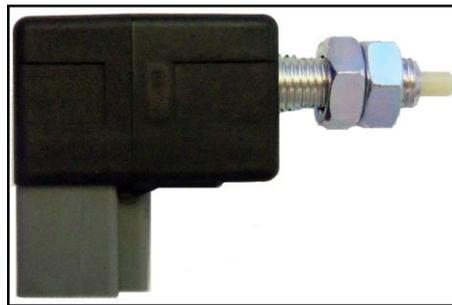
This bulletin provides information relating to the replacement of the stop lamp switch of some 2011MY Sportage (SL) vehicles, produced from March 7, 2011 through June 8, 2011. The stop lamp switch may experience interruption in the electrical current flow in the switch contacts. This condition could potentially result in intermittent operation of the cruise control feature, the intermittent illumination of the ESC indicator lamp or interfere with brake light illumination. To correct this condition, and improve customer satisfaction, Kia is requesting the completion of this Safety Recall Campaign on all affected vehicles.

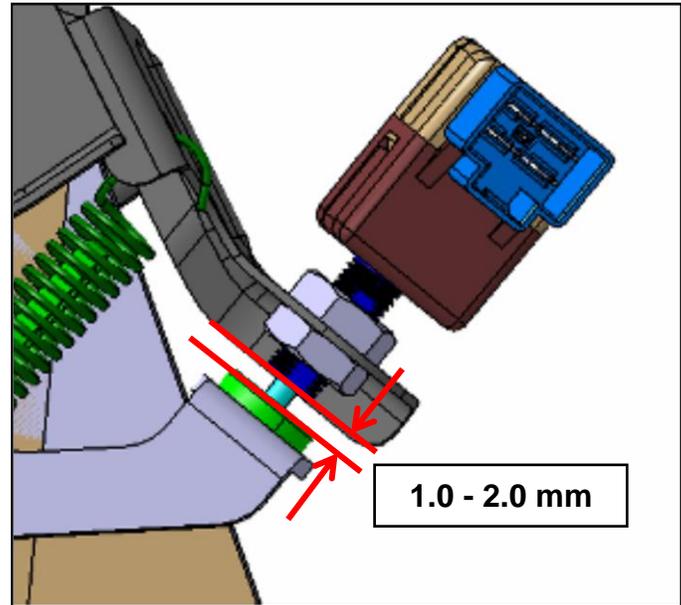
*** NOTICE**
Failure to properly adjust the switch may result in check engine and/or ESC malfunction indicator lamp illumination.

- 8. Adjust the gap to 1.0 ~ 2.0 mm (0.04" ~ 0.08") between the stop lamp switch lower mounting end and the brake pedal switch stopper, without applying the brake pedal.
