U.S. Department
of Transportation
**National Highway
Traffic Safety
Administration**

DEPARTMENT OF TRANSPORTATION
National Highway Traffic Safety Administration
Denial of Motor Vehicle Defect Petition

ACTION: Denial of a petition for a defect investigation.

Appendix - Petition Analysis - DP15-005

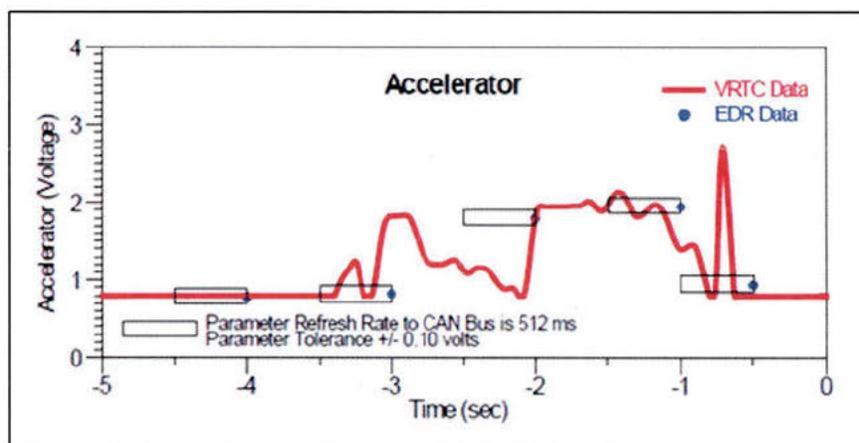
In 2010, NHTSA's Vehicle Research and Test Center (VRTC) conducted testing to validate the EDR pre-crash data used in NHTSA field investigations.⁴ Figure 1 shows accelerator pedal sensor voltage data from one test performed by VRTC in the validation testing.⁵ As the figure shows, the EDR does not necessarily capture all accelerator pedal applications during an event and the accelerator pedal voltage recorded at each EDR time interval may not be the actual accelerator pedal voltage at that interval.

Figure 1. VRTC validation testing of EDR accelerator pedal sensor voltage from simulated collisions in a 2007 Toyota Camry.

Subsequent studies have confirmed the limitations of stored EDR pre-crash data in capturing the entire crash event due to the data refresh rates, data resolutions and EDR sampling rates.^{6,7,8}
