TECHNICAL BULLETIN  
P065NAS1  
08 SEP 2015

**SECTION: 501-17**

Safety Recall: Panoramic Roof Panel Bonding

**LR4 (LA)**

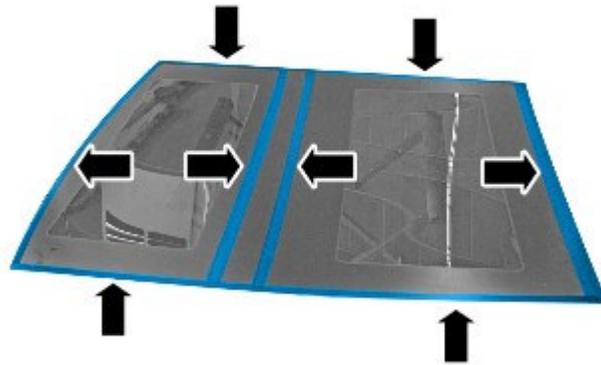
2 The Illustration identifies the areas where the adhesive and primer will be present.
