## **IMPORTANT SAFETY RECALL – 14V-371**

**SN-611-14**

**SUBJECT:** *Muncie PTO switch leakage on Ford 6.8L Gas engines*

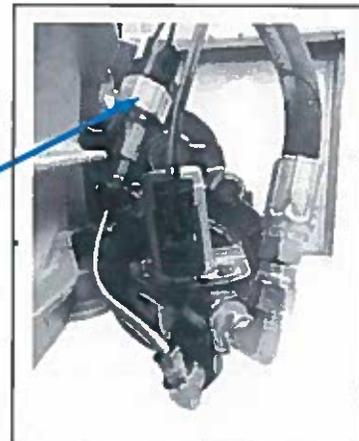
Muncie Power Products has issued a recall on FR67 series Power Take Off (PTO), when installed on Ford F350 to F550 with 6.8L Gas engine from June 1, 2009 through 2013. The Terex part number for the PTO is 94467 and the Muncie number is FR67-F1506-G4NX. A pressure switch attached to the PTO can develop a leak onto the exhaust if the thermal blanket is damaged. **Oil leaking onto the hot exhaust can result in a fire.**

Note: The PTO is located on the side of the transmission. The switch is located on the front of the PTO.

Switch to inspect for leakage

Immediately inspect affected vehicles for any oil leakage from the PTO switch and the condition of the thermal blanket around the exhaust pipe in front of and below the PTO. If the switch is leaking immediately remove the vehicle from service and replace the switch. Also inspect the thermal blanket around the exhaust pipe in front of and below the PTO for damage. Replace the thermal blanket if damaged.
