BMW Motorrad USA

Service Information Bulletin

****Notice of Recall 15V-537****

Subject: Engine idle unstable

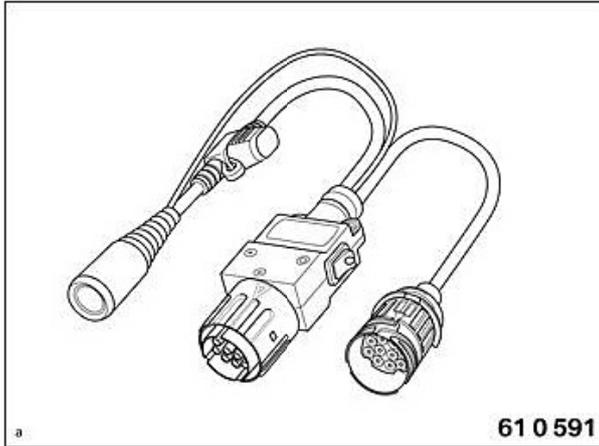
Figure 1

Special Tools: Adapter cable (61 0 591) see figure 1. This adapter cable needs to be connected in line with the ICOM D cable, see Figure 2. When connected in line, you then turn the ignition switch to ON and turn the switch located on the side of the adapter cable to ON. (A green LED will light up)

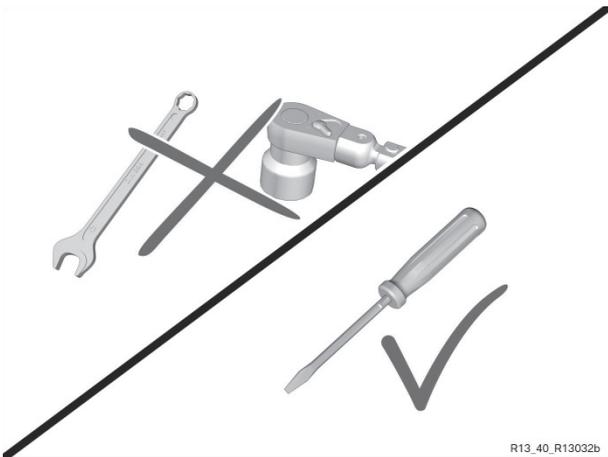
6

Tightening the screw clamp of the throttle body with excessive force or unsuitable tools.

Impaired engine running due to deformed intake stub.

► Tightening clamp at throttle body

- Use only a plain slotted screwdriver to tighten the screw clamp, without using additional tools.
- Do not use torque-amplifying tools such as an open-end spanner or a reversible ratchet for extra leverage.
