SUBJECT: DEMONSTRATION / DELIVERY HOLD - Safety Recall 15S25
Certain 2016 Model Year F-53 and F-59 Vehicles
Transmission Shift Cable Bracket Replacement

CERTAIN 2016 MODEL YEAR FORD F-53 MOTORHOME AND F-59 STRIPPED CHASSIS VEHICLES — TRANSMISSION SHIFT CABLE BRACKET REPLACEMENT

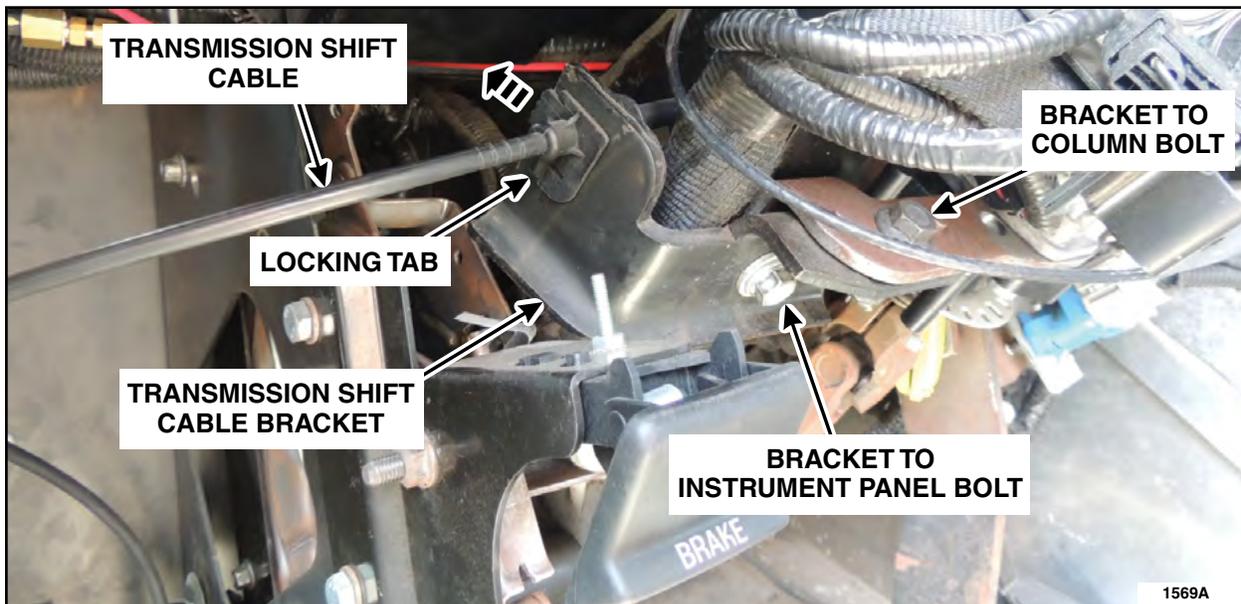
FIGURE 1

In the affected vehicles, the transmission shift cable bracket may have been manufactured out of specification, causing the transmission shift cable to be installed incorrectly. This condition may result in unintended vehicle movement if force is applied to the gear shift lever when in the park "P" position. Unintended vehicle movement may increase the risk of an injury or crash. Dealers are to replace the transmission shift cable bracket and adjust the shift cable (selector lever cable) using the following procedure.

1. Remove the lower steering column trim/knee bolster panel as necessary to gain access to the lower steering column area. Refer to the Coach Builders Repair Manual for additional information if necessary.
2. Remove the transmission shift cable bracket. See Figure 1.
 - a. Carefully lift the locking tab and disconnect the transmission shift cable from the bracket.
 - b. Remove the two bolts and the transmission shift cable bracket.
 - When installing the bolts, torque to the following specifications:
 - Bracket to Column bolt to 36 lb.ft (48 Nm).
 - Bracket to Instrument Panel bolt to 21 lb.ft (28 Nm).

3. To install the *new* transmission shift cable bracket, reverse the removal procedure.
4. Perform the Selector Lever Cable Adjustment procedure. Please follow Workshop Manual (WSM) procedures in Section 307-05.
