ZOOM-ZOOM

DATE: November 2015

SUBJECT: **Driver Air Bag Inflator Final Repair - Safety Recall 8215F**

Driver Air Bag Inflator Final Repair - Safety Recall 8215F NHTSA Campaign No. 15V-382

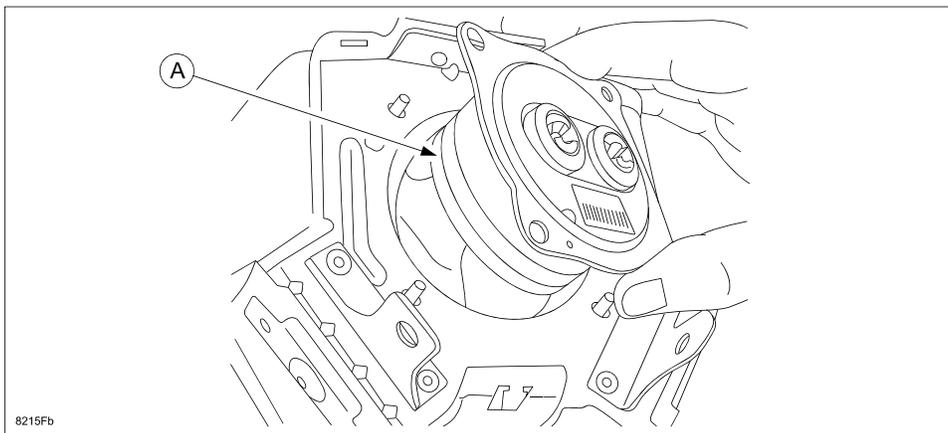
1. Remove the inflator (A) from the air bag module.

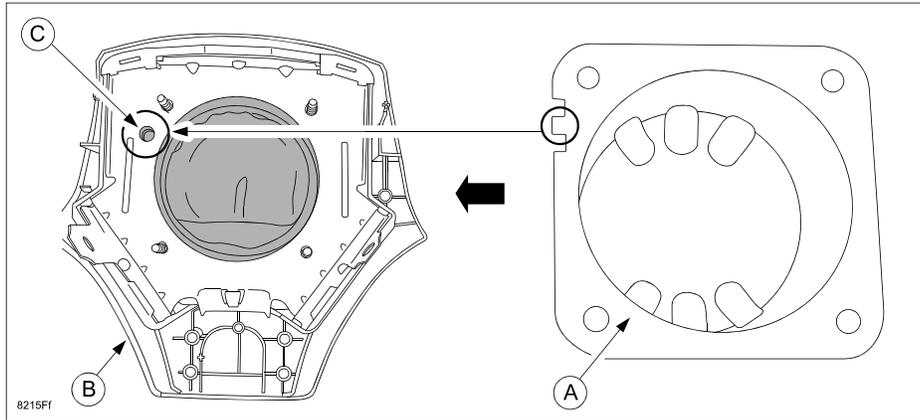
CAUTION: Verify that the notch of the diffuser is engaged in the hole of the module for sure. If the diffuser is not installed in the correct position, the air bag will not develop sufficient deployment performance.

3. Install the diffuser (A) to the module (B) aligning the notch of the diffuser with the hole of the module (C).

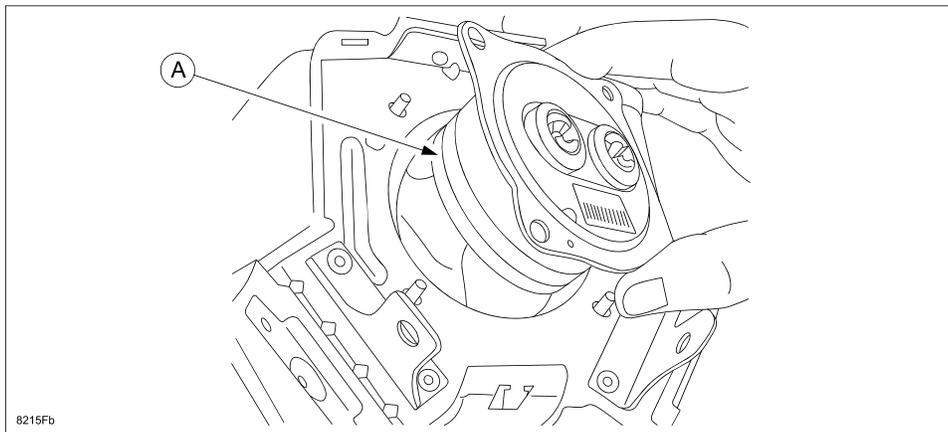
1. Remove the inflator (A) from the air bag module.
