Subject: Eaton FR Transmission

Models Affected: Specific Freightliner Cascadia, Business Class M2, 108SD, and 114SD vehicles and Western Star 4700 vehicles manufactured January 4, 2015, through April 24, 2015, with certain Eaton FR 10-speed manual transmissions.

Recall Campaign

November 2015
FL693A
NHTSA #15V-617

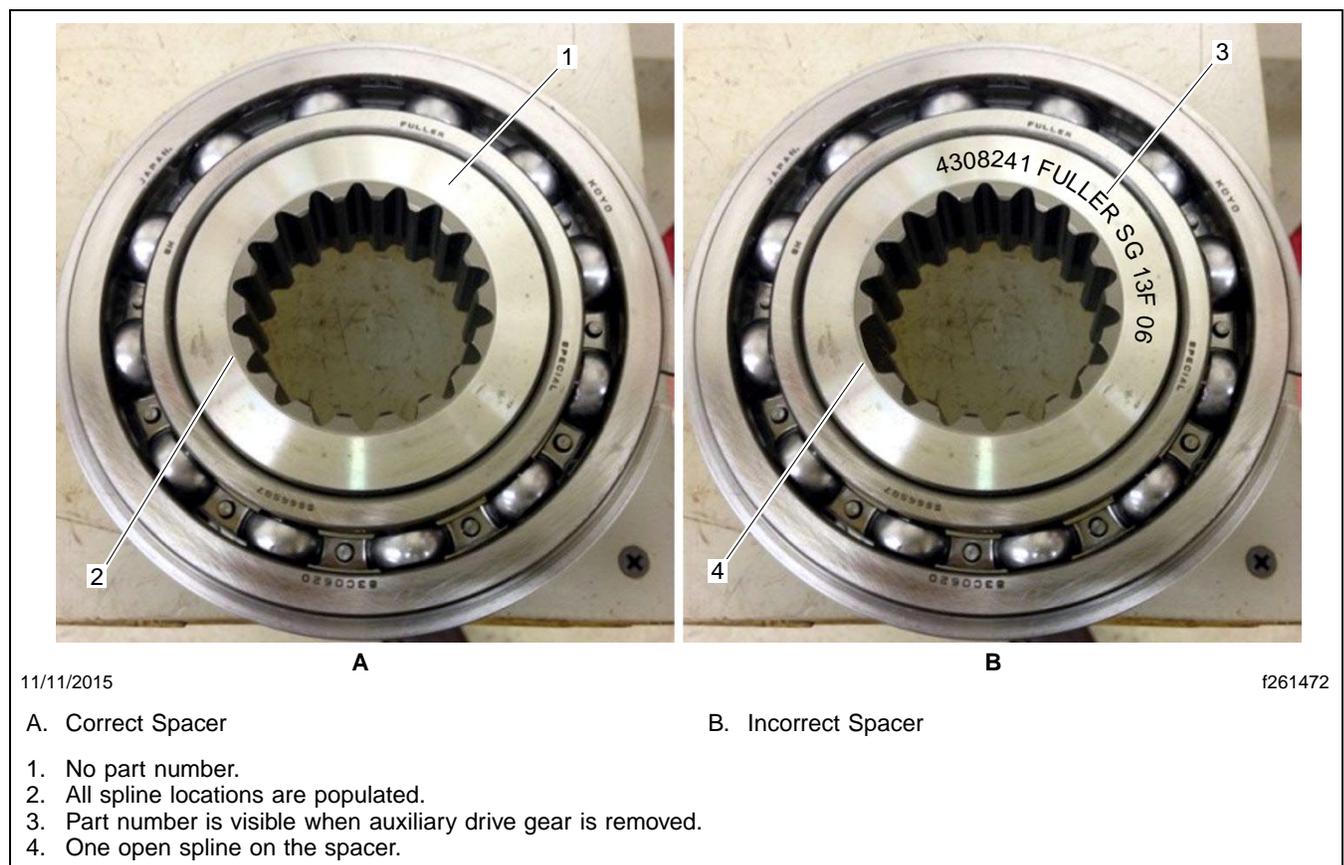
Fig. 1, Spacer Identification

The correct spacer does not have an open spline or a visible part number printed on it. **Fig. 1**, Ref A shows the correct spacer, and Ref B shows the incorrect spacer. Submit photographs to RTW for verification regardless of the spacer installed.

If the spacer has all the possible splines engaged with the mainshaft and no visible part number, go to step 20.

If the spacer has an open spline and the part number 4308241 is visible, go to step 19.

19. Work with RTW to perform a detailed inspection of the main transmission components for damage. If damage is found, remove the transmission; see "Transmission Removal and Installation" in these work instructions.
20. Move the shift bar housing from the top of the transmission.
21. Install the auxiliary drive gear and snap ring.
22. Clean the sealing surfaces of the main case, shift bar housing, auxiliary section, and shift tower.
23. Set a new shift bar housing gasket in place.
24. Position the shift bar housing, using a spacer block to allow the auxiliary section to be installed.
25. Install the auxiliary section. Tighten the capscrews 40 to 45 lbf-ft (54 to 61 N·m).
