SUBJECT: **DEMONSTRATION / DELIVERY HOLD - Safety Recall 14S17 – Supplement #2**
Certain 2013 and 2014 Model Year Focus ST and Escape Vehicles Equipped with a
2.0L Engine
Engine Wiring Splice Repair

DEMONSTRATION / DELIVERY HOLD Safety Recall 14S17 – Supplement #2
Certain 2013 and 2014 Model Year Focus ST and Escape Vehicles Equipped with a 2.0L Engine
Engine Wiring Splice Repair

CERTAIN 2013 AND 2014 MODEL YEAR ESCAPE VEHICLES EQUIPPED WITH A 2.0L ENGINE — ENGINE WIRING SPLICE REPAIR

CERTAIN 2013 AND 2014 MODEL YEAR FOCUS ST VEHICLES — ENGINE WIRING SPLICE REPAIR

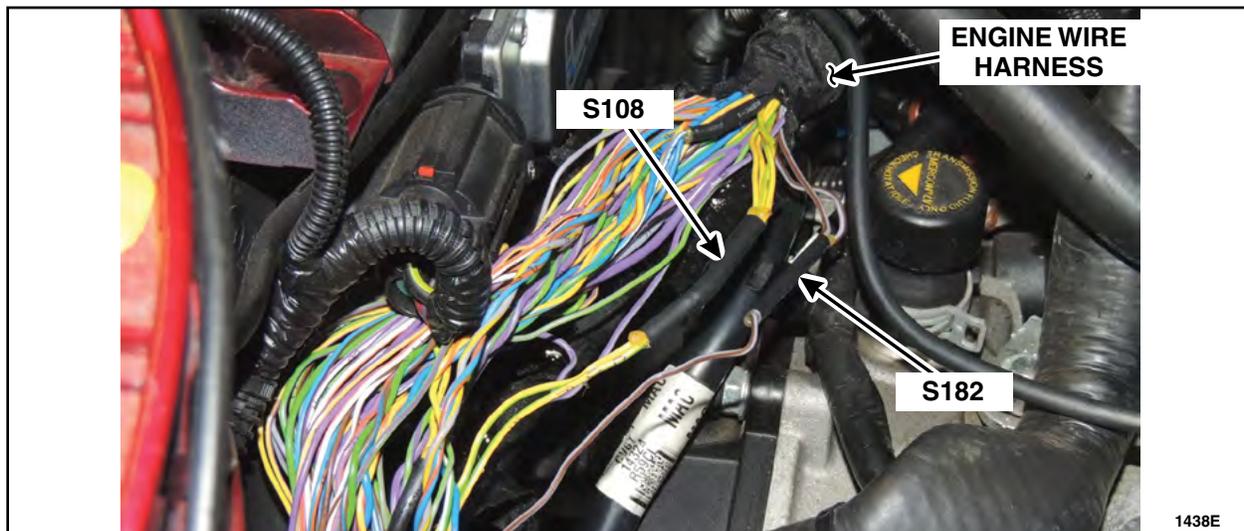
FIGURE 6

- S182 is a one (1) wire into two (2) wire splice with Gray/Brown wires.
- S108 is a two (2) wire into four (4) wire splice with Yellow/Green wires.

10. Locate splice S182 and S108. See Figure 6.

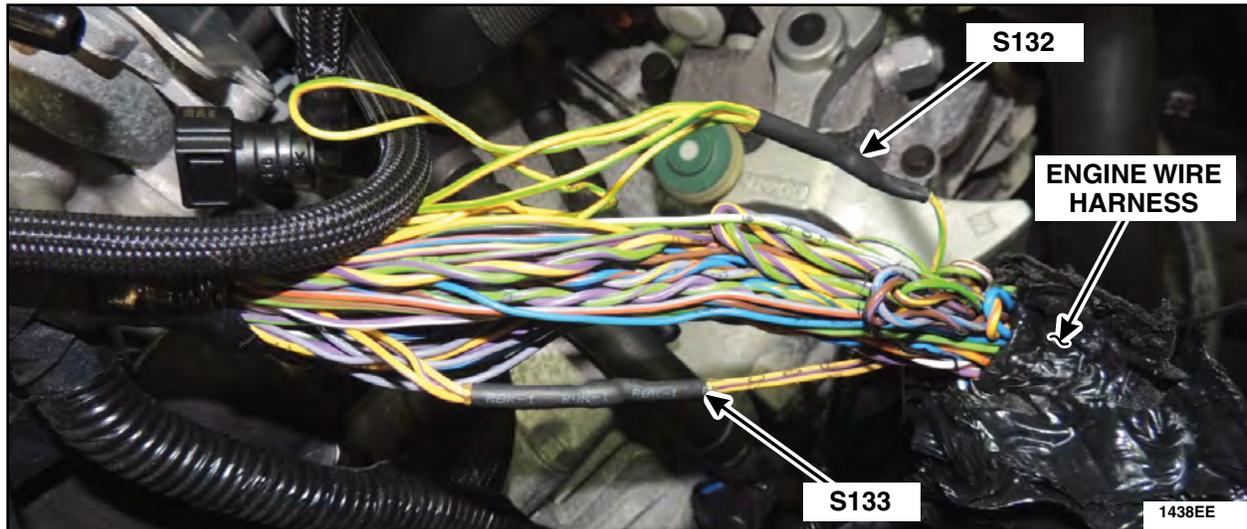
FIGURE 6

- S132 is a one (1) wire into four (4) wire splice with Yellow/Green wires.
- S133 is a two (2) wire into three (3) wire splice with Yellow/Violet wires.

10. Locate splice S132 and S133. See Figure 6.
