Ferrari North America, Inc.

U.S.A. RECALL CAMPAIGN NO. 59

488 GTB

Replacing Low Pressure Fuel Line

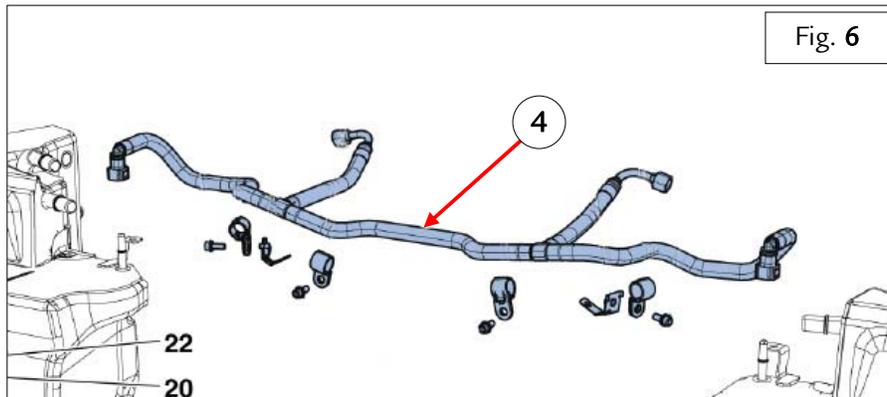
1.12 Remove the low pressure fuel pipe (4) from the engine compartment and replace – Fig. 6.

1.13 Lay out the new low pressure fuel pipe Part No. 70003864 (4) on the engine in the same position as the original pipe – Fig. 6.
