RECALL CAMPAIGN BULLETIN

NTB14-085a

VOLUNTARY SAFETY RECALL CAMPAIGN 2014 FRONTIER CREW CAB REAR SEATBELT ANCHOR WELD NUT

CAMPAIGN ID #: PC309
NHTSA #: 14V-418
APPLIED VEHICLES: 2014 Frontier Crew Cab (D40)

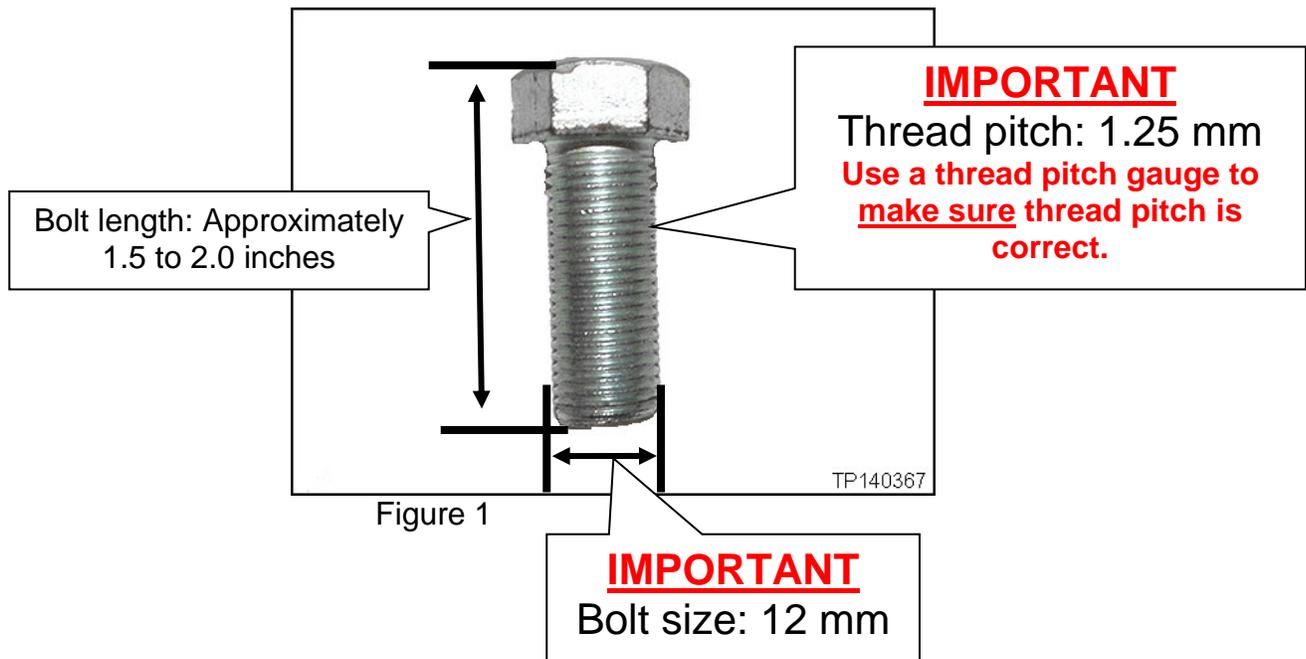
Obtain an inspection bolt, from a local source, as shown in Figure 1.

- The Service Procedure in this bulletin will determine if an over-sized weld nut was incorrectly installed for the 2nd row seat (rear seat) seatbelt lower anchor located in the left and right side rear pillars (C-pillars).
- **An over-sized bolt of the exact size and thread pitch, as shown above, is required to perform the inspection.**

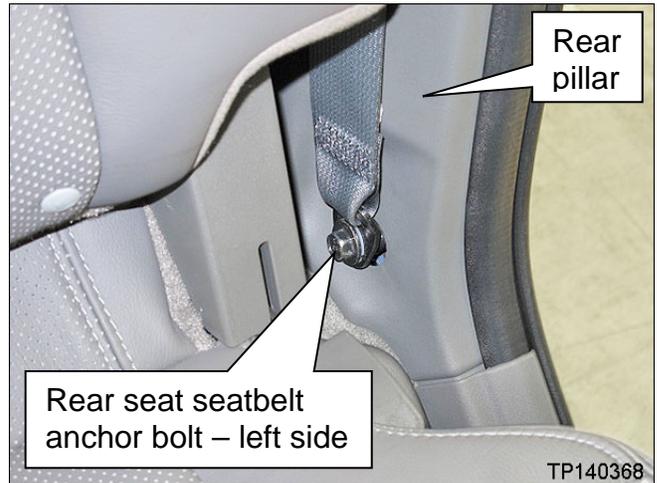
Figure 3

1. Locate and remove the two rear seat seatbelt anchor bolts located in the rear pillars (see Figure 3).
 - The left side (driver side) is shown.
 - Both sides will need to be removed for this inspection.
 - The right side (passenger side) is a mirror image.

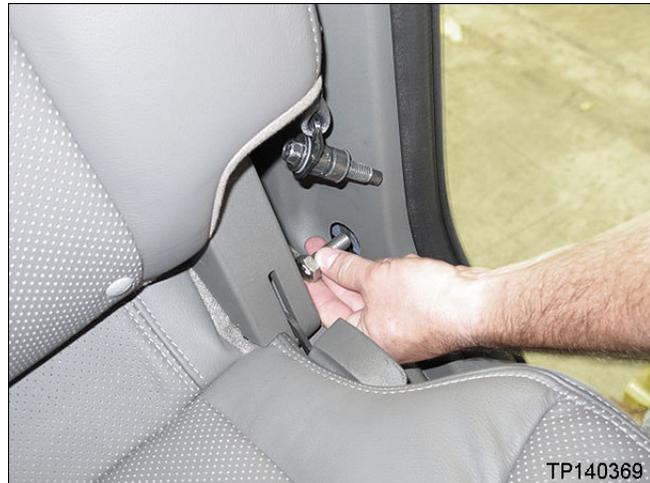
Figure 5

3. Insert the inspection bolt into the seatbelt lower anchor bolt hole.
4. **By hand only** – attempt to thread the inspection bolt into the weld nut.
 - Make at least three attempts to thread the bolt into the nut.
 - The left side (driver side) is shown.
 - **Make sure to perform this inspection on both sides (the passenger side and the driver side).**

Inspection bolt does not thread into either weld nut – inspection is OK:

Inspection bolt does thread into either weld nut – inspection is NG:

- If the inspection bolt **DOES NOT** thread into either side seatbelt lower anchor weld nut after three attempts:
 - a. Re-install the original anchor bolts.
 - b. Torque the anchor bolts to 49 N-m (5.0 kg-m, **36 ft-lb**)* using the 14 mm torque adaptor (J-49752).

- If the inspection bolt **DOES** thread into either side seatbelt lower anchor weld nut:
 - a. Repair only the weld nut(s) that fail the inspection.
 - Obtain a weld nut Repair Kit (refer to the Parts Information).
 - b. Use the Weld Nut Repair procedure starting on the next page.
 - c. Refer to the Claims Information for the correct op-code.
