# Recall Bulletin

## PRODUCT SAFETY RECALL

**SUBJECT:** Brake Pedal Pivot Nut/Bolt Loose

**MODELS:** 2015 - 2016 Chevrolet Silverado LD, HD  
2015 - 2016 Chevrolet Tahoe PPV (RPO 9C1)  
2015 - 2016 Chevrolet Tahoe Special Services (RPO 5W4)  
2015 - 2016 GMC Sierra HD

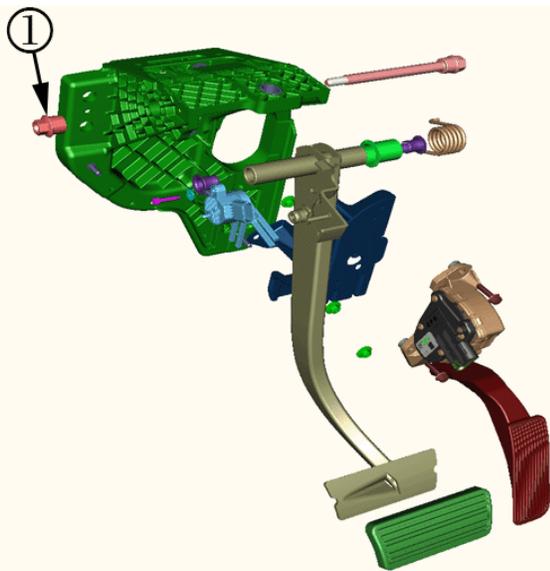
4404307

- Using an inspection mirror, determine if the brake pedal pivot nut is on the outboard side of the vehicle.

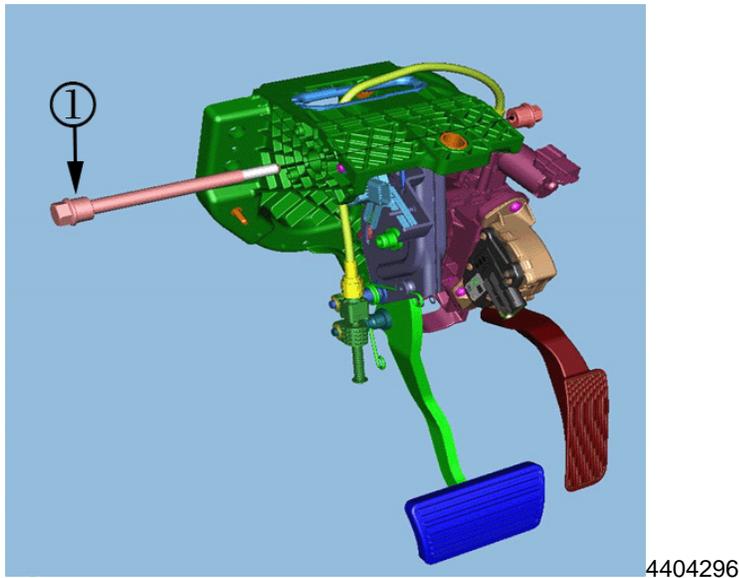
- If the brake pedal pivot nut (1) is on the outboard side of the vehicle, proceed to step 2.

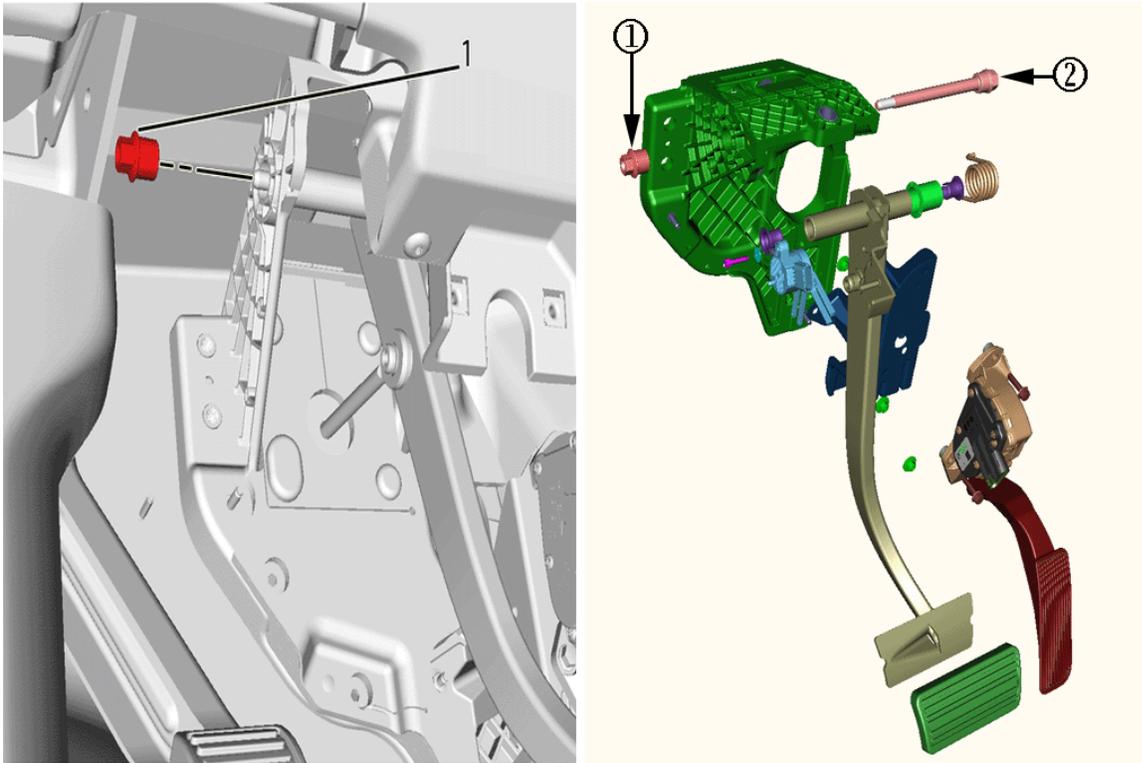
- If the brake pedal pivot bolt (1) is on the outboard side of the vehicle (nut on the inboard side), no further action is required.
2. Determine if the vehicle is equipped with a manual or automatic transmission.
    - If the vehicle is equipped with a manual transmission remove the clutch pedal. Refer to *Clutch Pedal Replacement* in SI. After the clutch pedal has been removed, proceed to step 5.
    - If the vehicle is equipped with an automatic transmission, proceed to step 3.
  3. Remove the Instrument Panel Knee Bolster. Refer to *Instrument Panel Knee Bolster Replacement* in SI.
  4. Remove the Floor Front Air Outlet Duct - Left Side. Refer to *Floor Front Air Outlet Duct Replacement - Left Side* in SI.
