Technical Service Bulletin

16-01-011

Elantra (MD/UD)

**YAW RATE/"G" SENSOR INSPECTION AND HECU UPDATE
(RECALL CAMPAIGN 137)**

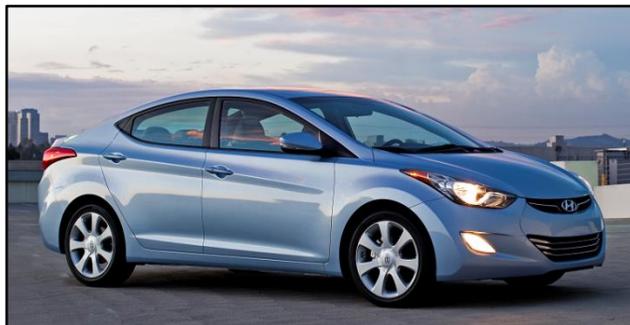
On certain 2011 to 2012 model year Elantras (MD/UD), the Yaw Rate/"G" sensor may send a signal that may result in one or more of the following:

1. Inadvertent ESC system intervention,
2. Illumination of the "ESC" indicator lamp in the instrument cluster.
3. Diagnostic codes C1282 and/or C1283 (for the yaw sensor) stored in the ESC Control Module.

ESC system intervention may include inadvertent brake application to one or more wheels and/or reduced engine torque, both of which can increase the risk of a crash. This bulletin describes the procedure to check for diagnostic codes, replace the Yaw/"G" sensor if necessary, and update the hydraulic unit ECU (HECU) software.

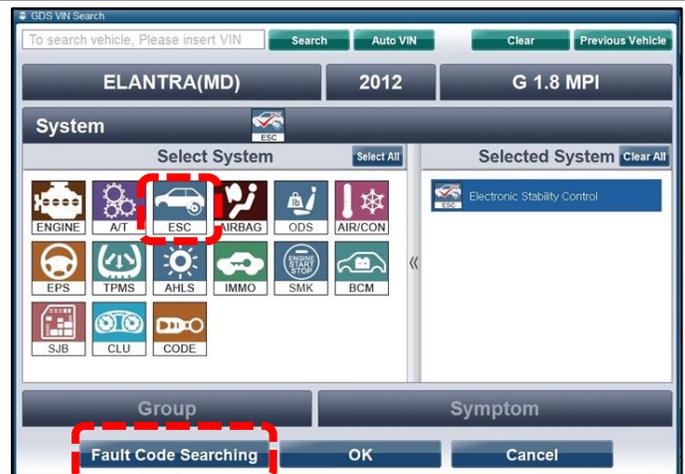
1. Connect the GDS or GDS Mobile and search for DTCs in the ESC System.

- 2a. If codes **C1282** or **C1283** are found either as active or history;
1. Attach a GDS screen capture of the Fault Code Search screen, clearly showing the VIN and the C1282 and/or C1283 DTCs found.
