NUMBER: 14-001-12 REV. A

GROUP: Fuel System

DATE: March 01, 2012

Fuel Spit Back During Refueling Due To Inlet Check Valve X39 (Unlimited Time And Mileage Warranty Extension)

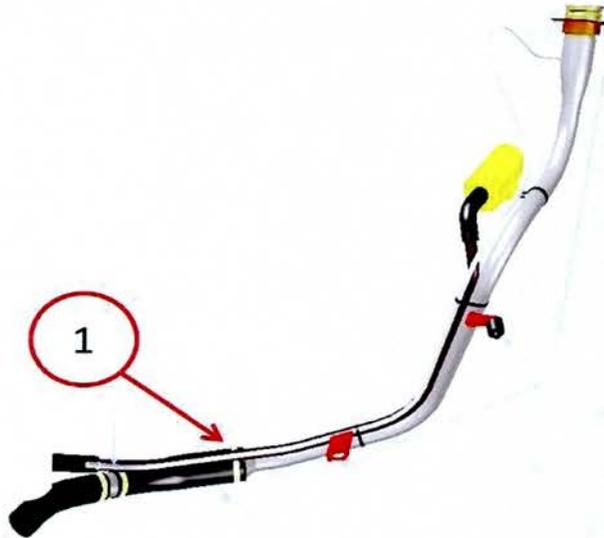
Fig. 1 Fuel Filler Tube

1 - worn gear hose clamp

1. Hoist vehicle.
2. Remove Left rear wheel.
3. Remove the left quarter panel splash shield.
4. On new fuel filler tube verify and write down existing torque (Fig. 1).

NOTE: It may be necessary to loosen the worm gear hose clamp and rotate to allow the fuel filler neck to fit between the body and frame. If clamp is loosened then once installed re-torque to noted value.
