Michael A. Berardi
Director
Service Engineering Operations
Ford Customer Service Division

SUBJECT: **DEMONSTRATION / DELIVERY HOLD - Application Performance Upgrade 13A01 – Supplement #3**
Certain 2012-2013 Focus Electric, 2013 C-MAX Hybrid and C-MAX Energi, and 2013 Fusion Hybrid Vehicles Equipped with MyFord Touch® Application Performance Upgrade

DEMONSTRATION / DELIVERY HOLD**Application Performance Upgrade 13A01 – Supplement #3**

Certain 2012-2013 Focus Electric, 2013 C-MAX Hybrid and C-MAX Energi,
and 2013 Fusion Hybrid Vehicles Equipped with MyFord Touch[®]
Application Performance Upgrade

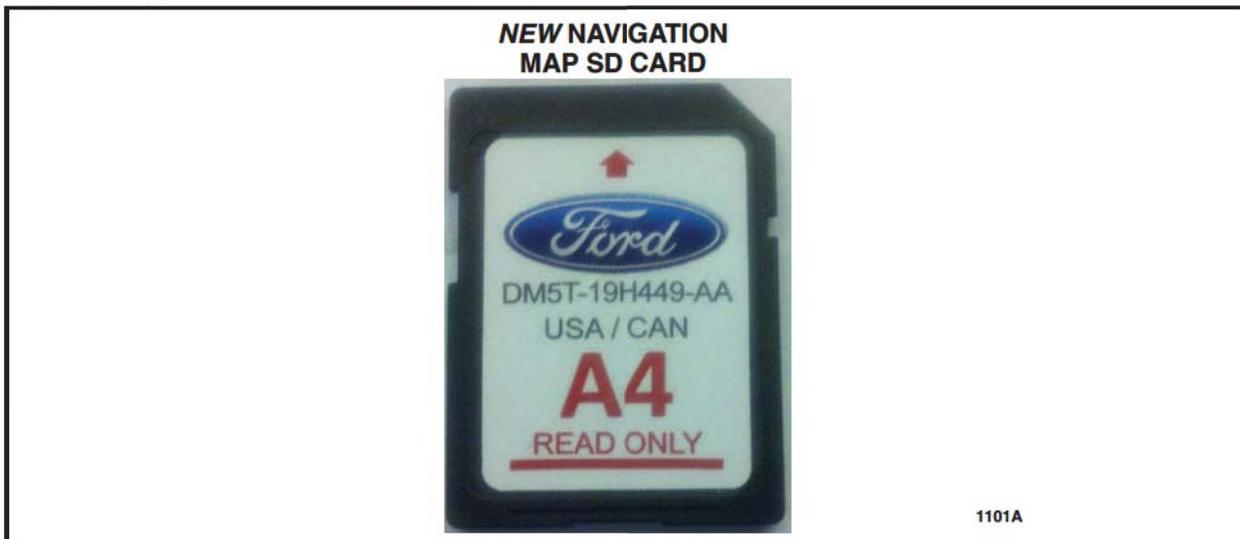
FIGURE 2

NOTE: After the reprogramming procedure completes, an SD card fault will appear on the screen. This is normal.

3. Remove the A3 level Navigation Map SD Card from the vehicle's map card slot.
4. Tap "SD Nav" on the touchscreen to clear the SD card fault.
5. Install the *new* A4 level Navigation Map SD Card into the vehicle's map card slot. See Figure 2. Wait for the *new* Navigation Map SD Card to be recognized and tap "OK" when the "SD Card Detected" screen appears on the touchscreen.

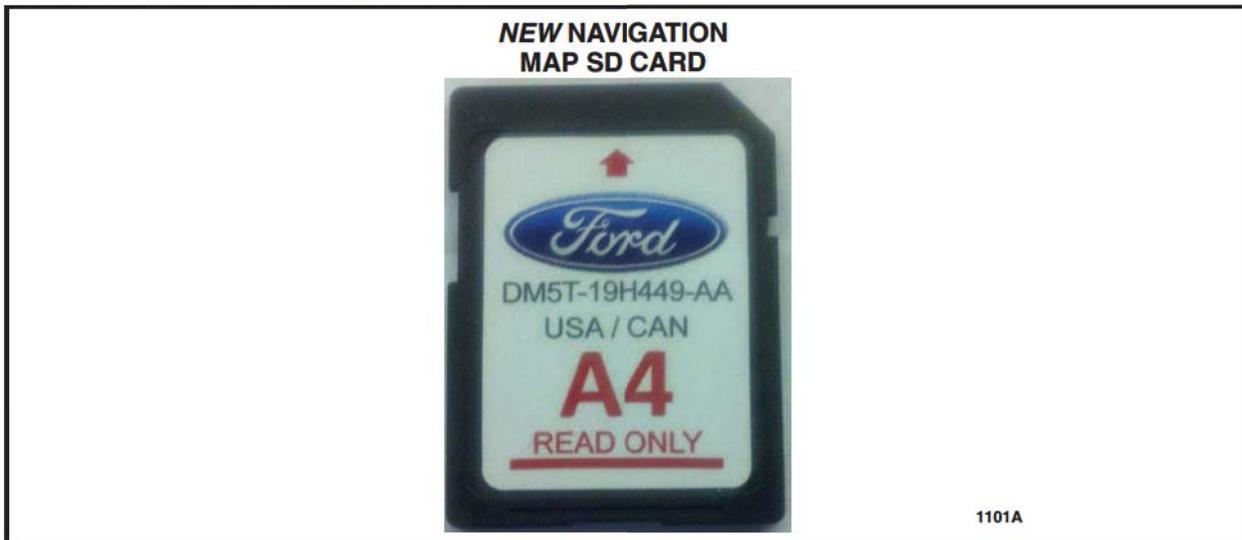
FIGURE 2

NOTE: After the reprogramming procedure completes, an SD card fault will appear on the screen. This is normal.

5. Remove the A3 level Navigation Map SD Card from the vehicle's map card slot.
6. Tap "SD Nav" on the touchscreen to clear the SD card fault.
7. Install the *new* A4 level Navigation Map SD Card into the vehicle's map card slot. See Figure 2. Wait for the *new* Navigation Map SD Card to be recognized and tap "OK" when the "SD Card Detected" screen appears on the touchscreen.

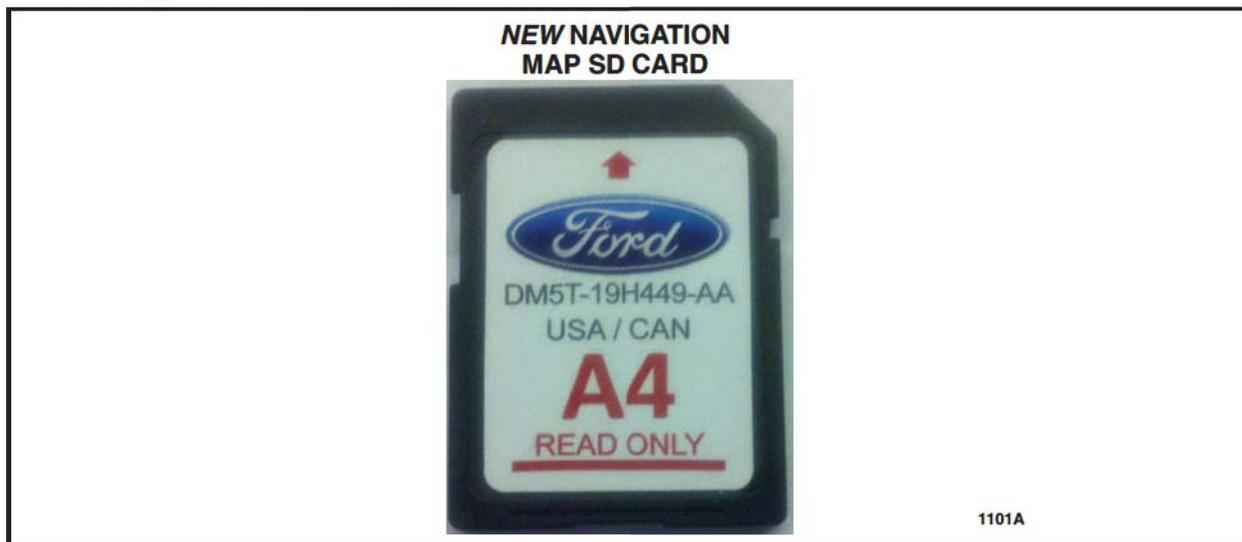
FIGURE 3

NOTE: After the reprogramming procedure completes, an SD card fault will appear on the screen. This is normal.

6. Remove the A3 level Navigation Map SD Card from the vehicle's map card slot.
7. Tap "SD Nav" on the touchscreen to clear the SD card fault.
8. Install the *new* A4 level Navigation Map SD Card into the vehicle's map card slot. See Figure 3. Wait for the *new* Navigation Map SD Card to be recognized and tap "OK" when the "SD Card Detected" screen appears on the touchscreen.
