BANG NOISE HEARD AND/OR BUMP FELT FROM FRONT OF VEHICLE DURING A QUICK 1-2 AND/OR 2-3 SHIFT—UNDER MODERATE TO AGGRESSIVE ACCELERATION

TSB 13-6-10

FORD:
2013 Focus

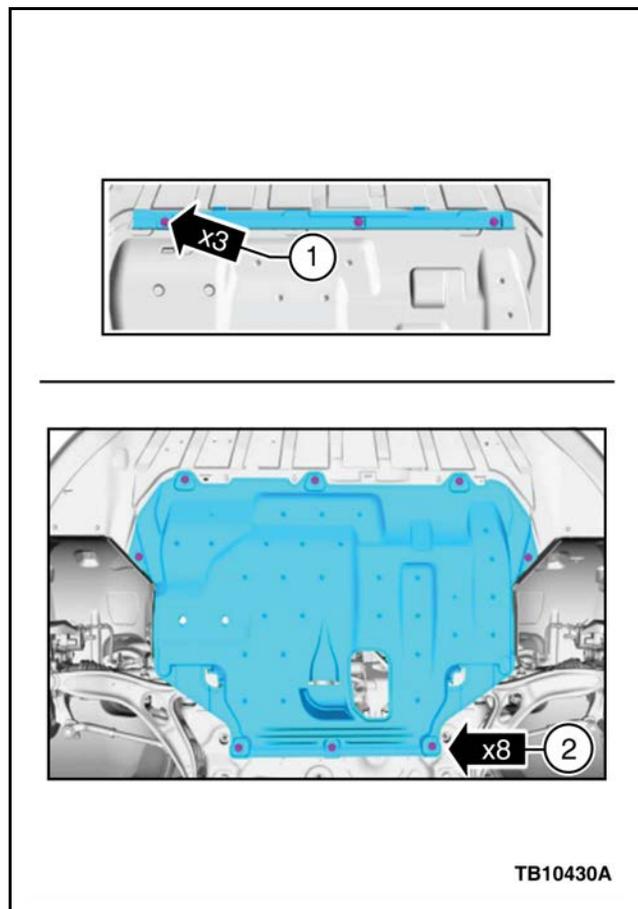
Figure 1 - Article 13-6-10

Some 2013 Focus ST vehicles may exhibit a bang noise and/or bump felt from front of vehicle during a quick 1-2 and/or 2-3 shift under moderate to aggressive acceleration.

1. Raise the vehicle on a hoist. Refer to Workshop Manual (WSM), Section 100-02.
2. Remove the lower air deflector by removing the three (3) fasteners. (Figure 1)
3. Remove the engine compartment splash shield by removing the eight (8) fasteners. (Figure 1)
4. Lower the vehicle.
5. Remove battery and battery tray. Refer to WSM, Section 414-01.
6. Position hydraulic floor jack with a wood block under transmission and raise only enough to support weight of transmission.
 - a. Do not attempt to lift the transmission or damage will occur.
