**3.5L GTDI—INTERMITTENT MIL ILLUMINATED WITH ONE OR MORE OF THE FOLLOWING DTCS P0236, P0238, P025E AND/OR P007D—BUILT ON OR BEFORE 2/15/2013**

TSB 13-6-12

2013 F-150

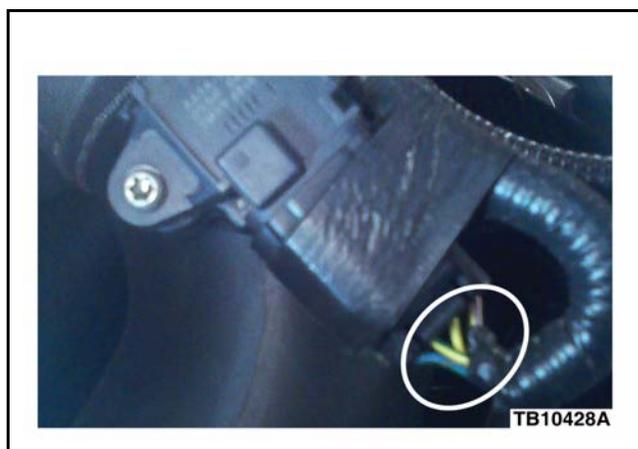
Figure 1 - Article 13-6-12

Some 2013 F-150 vehicles built on or before 2/15/2013 and equipped with a 3.5L Gasoline Turbocharged Direct Injection (GTDI) engine may exhibit an intermittent malfunction indicator light (MIL) illuminated with one or more of the following diagnostic trouble codes (DTCs); P0236, P0238, P025E and/or P007D.

1. Using Integrated Diagnostic System (IDS), retrieve DTCs.
2. Are one or more of the following DTCs stored in the Powertrain Control Module (PCM); P0236, P0238, P025E and/or P007D?
  - a. Yes - proceed to Step 3.
  - b. No - this article does not apply. Refer to Powertrain Control/Emissions Diagnosis (PC/ED) manual for normal diagnosis.
3. Inspect for damage the wiring harness at the Turbocharger Boost Sensor connector C1588 for crack to wiring insulation. (Figure 1)
4. Is the wiring insulation damaged?
  - a. Yes - proceed to Step 5.
  - b. No - this article does not apply. Refer to PC/ED manual for normal diagnosis.
5. Install connector pigtail. Refer to splicing methods in Wiring Diagram, Section 5-1.
6. Using electrical tape, retain the harness to the connector shell with enlarged loop. (Figure 2)
