**5.0L—MALFUNCTION INDICATOR LAMP (MIL)—DTCS
P0300-P0308 AND/OR P0316 NO DRIVABILITY
SYMPTOMS—BUILT ON OR BEFORE 5/1/2013**

TSB 13-6-15

FORD:
2011-2014 Mustang

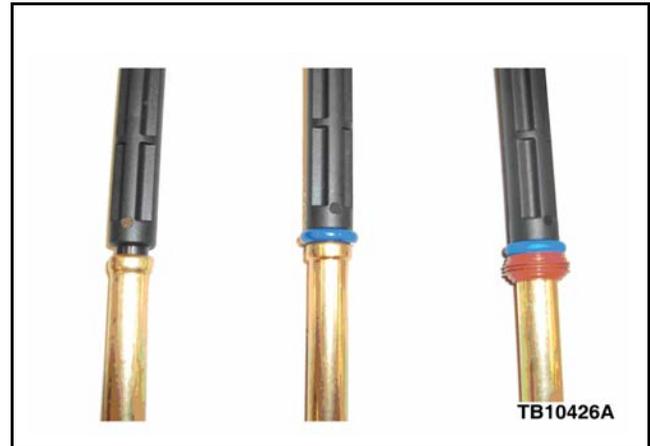
Figure 1 - Article 13-6-15

Some 2011-2014 Mustang vehicles equipped with a 5.0L engine and built on or before 5/1/2013 may exhibit a MIL illuminated with any combination of diagnostic trouble codes (DTCs) P0300, P0301, P0302, P0303, P0304, P0305, P0306, P0307, P0308 and/or P0316. There will be no other DTCs or drivability symptoms present.

1. Using Integrated Diagnostic System (IDS), perform self test on the powertrain control module (PCM) to check for both key-on engine off (KOEO) and key-on engine running (KOER) DTCs.
 - a. If any DTCs P0300-P0308 and/or P0316 are present in KOER and/or a drivability concern such as cylinder misfire are present, this article does not apply. Refer to Powertrain Control/Emissions Diagnosis (PC/ED) manual for normal diagnostics.
 - b. If any DTCs P0300-P0308 and/or P0316 are present in KOEO and no drivability concerns are present, remove the crankshaft position (CKP) sensor and install an o-ring on the CKP sensor. Refer to Workshop Manual, Section 303-14. (Figure 1)
