**SB-10054704-3330****FORD:**

2013 F-150

**ISSUE**

Some 2013 F-150 vehicles equipped with a 3.5L Gasoline Turbocharged Direct Injection (GTDI) engine and with an engine build date of 4/1/2013 and through 9/15/2013, may exhibit a shudder/runs rough concern at hot idle during stop-and-go driving and/or diagnostic trouble code (DTC) P0015 stored. The malfunction indicator lamp (MIL) may or may not be illuminated.

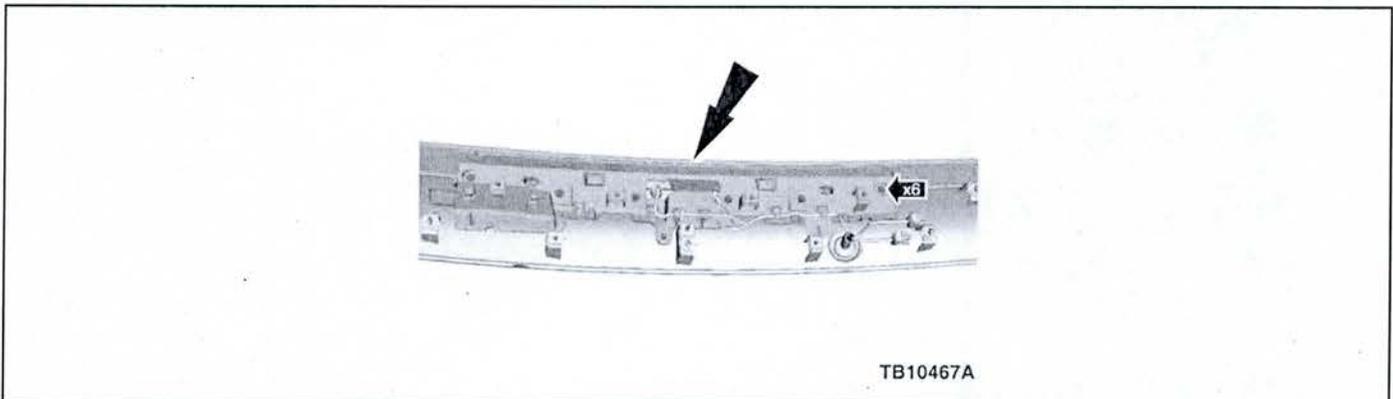
Figure 1 - Article 13-12-19

Some 2013 Lincoln MKZ vehicles may exhibit a concern of the luggage compartment lid lower moulding warping upward at the center. This condition may only be present after the vehicle is exposed to direct sunlight.

7. Apply 152 mm (6") of 3M™ Automotive Acrylic Plus Premium Attachment Tape or equivalent to the moulding and leave adhesive backer installed. (Figure 1)

- a. Firmly press tape into position.

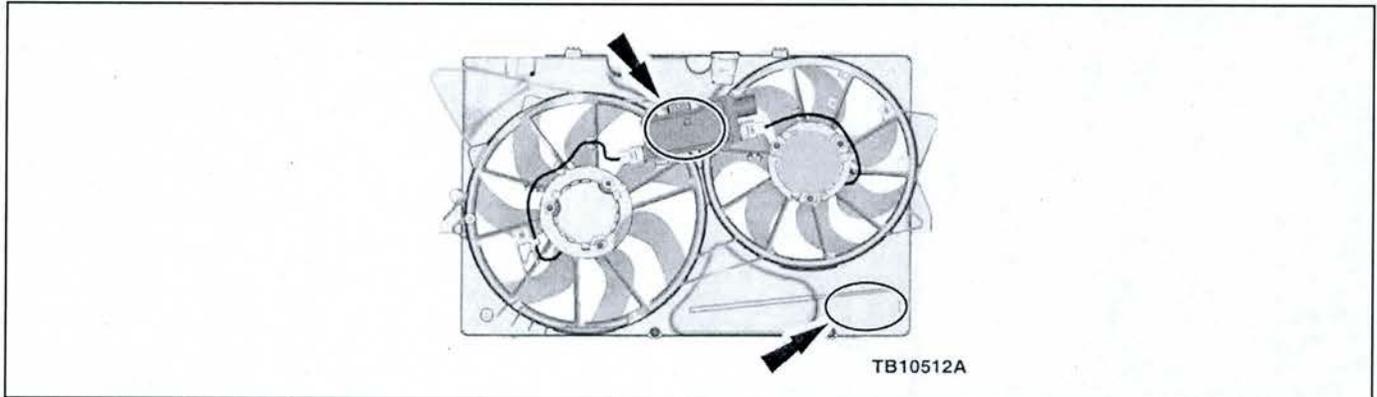
Figure 1 - Article 13-12-21

- a. No - please be sure to check the fan assembly for being original equipment manufacturer (OEM). (Figure 1)

- (1) For Taurus and MKS vehicles, replace the cooling fan motor and control module assembly. Refer to Workshop Manual (WSM), Section 303-03 and then proceed to Step 5.
- (2) For Explorer, Flex and MKT vehicles, proceed to Step 3.
