Michael A. Berardi
 Director
 Service Engineering Operations
 Ford Customer Service Division

September 16, 2014

SUBJECT: **Regional Program 13R01 – Supplement #3**
 Certain 2005 through 2011 Model Year Crown Victoria, Grand Marquis, and Town Car
 Vehicles Not Covered Under Safety Recall 13S08
 Steering Column Shaft

REF: **Regional Program 13R01 – Supplement #2**
 Steering Column Shaft dated February 21, 2014

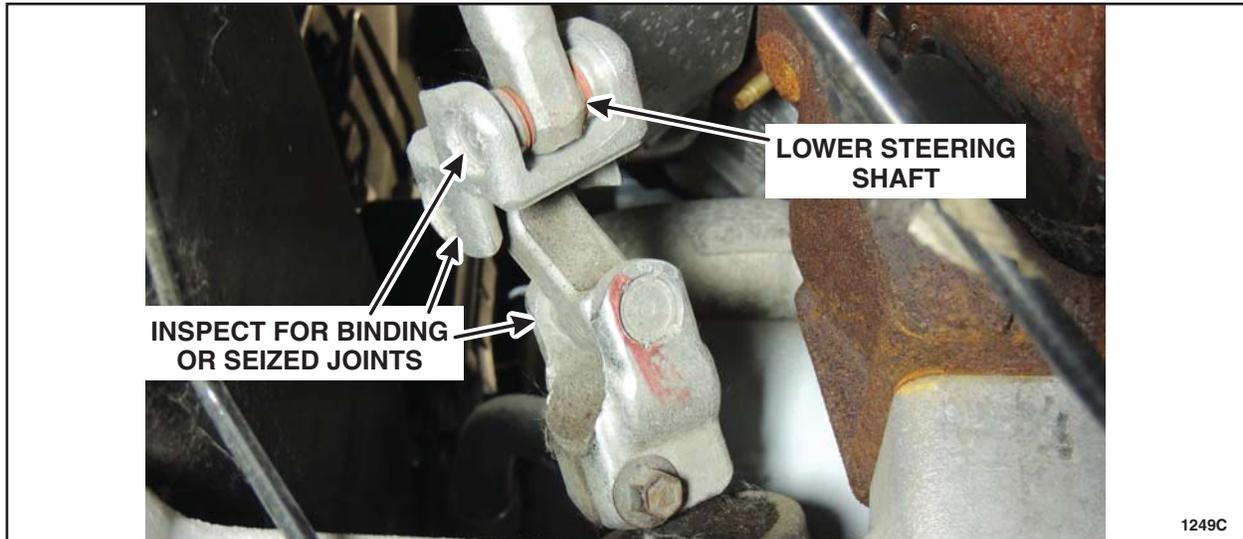
FIGURE 2

- c. Exercise the upper portion of the lower steering shaft throughout its range of motion. See Figure 2, on Page 2.
- d. If the lower steering shaft does not move freely and without binding, **it fails inspection.**

Lower I-Shaft Replacement (Failed Inspection Only, Refer to Flowchart within Attachment III)

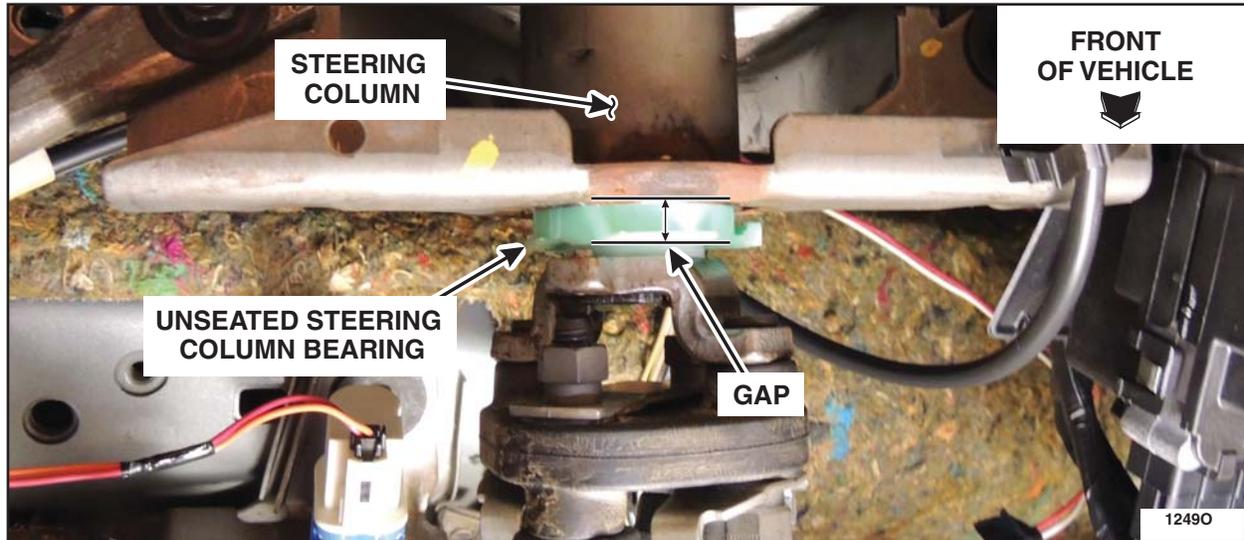
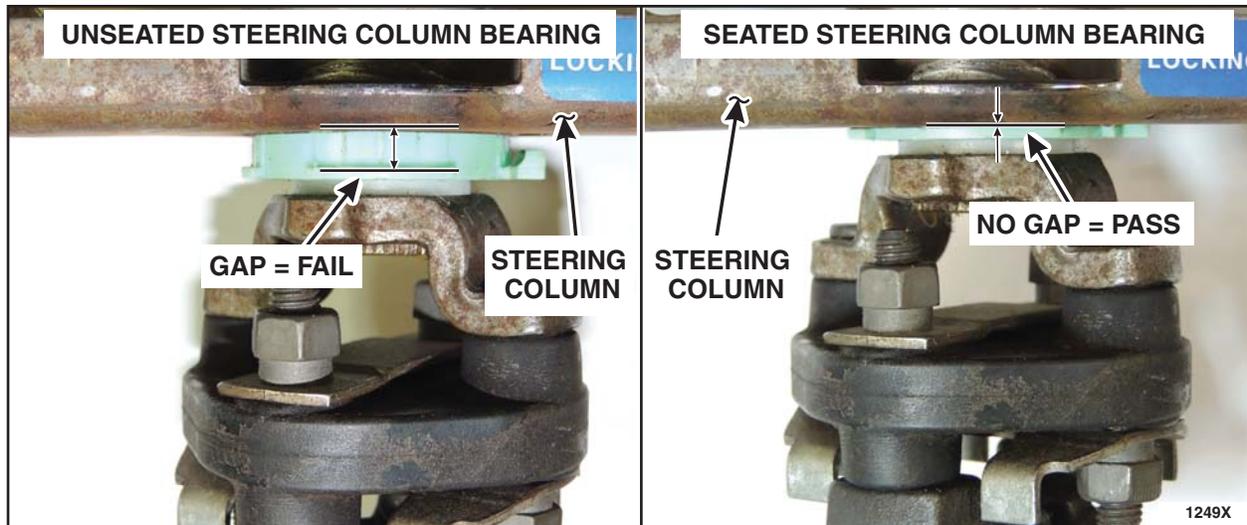
FIGURE 3

1. Inspect the steering column for an unseated steering column bearing. See Figures 3 and 4.

- If the steering column bearing is unseated, **it fails inspection.**

Steering Column Bearing Orientation and Retainer Installation (Failed Inspection Only, Refer to Flowchart within Attachment III)

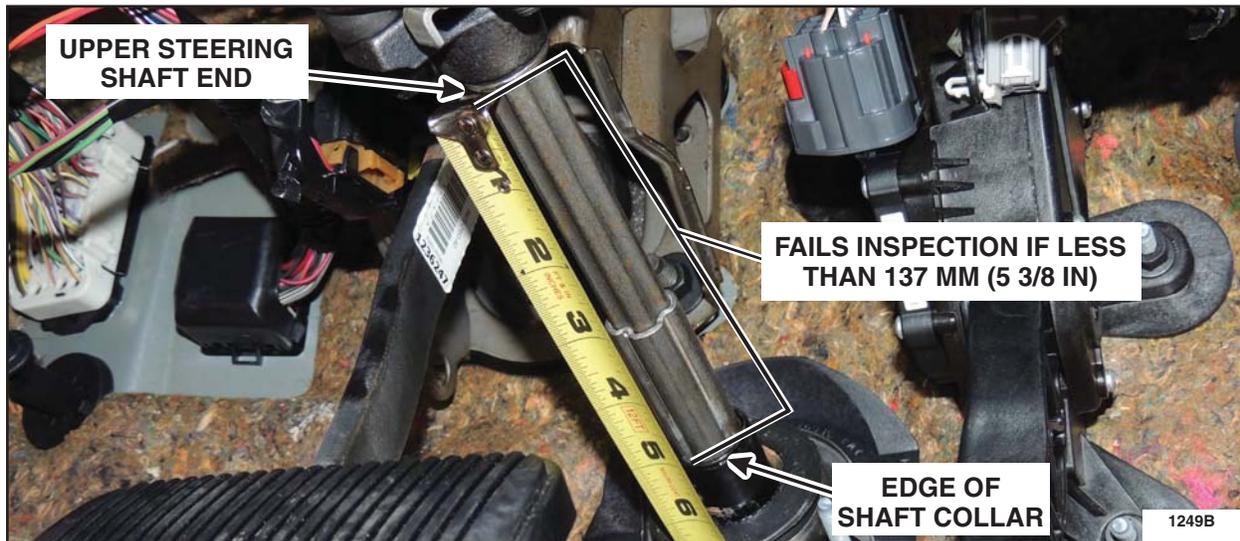
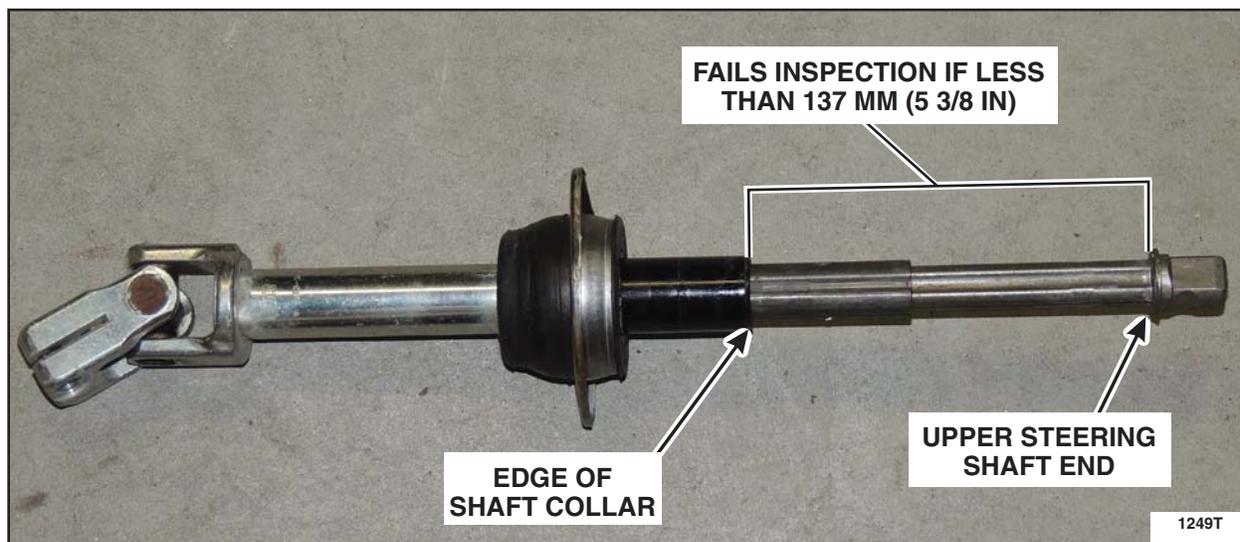
FIGURE 5

1. Measure the distance between upper steering shaft end and the edge of the shaft collar.
See Figures 1 and 2.

- If the upper steering shaft measurement is less than 137 mm (5 3/8 in), it fails inspection.

NEW! *Upper I-Shaft Replacement (Failed Inspection Only, Refer to Flowchart within Attachment III)*
