**Regional Program 13R01 – Supplement #2**

Certain 2005 Through 2011 Model Year Crown Victoria, Grand Marquis, and Town Car Vehicles  
Not Covered by Safety Recall 13S08  
Steering Column Shaft

## CERTAIN 2005 THROUGH 2011 MODEL CAR CROWN VICTORIA, GRAND MARQUIS, AND TOWN CAR VEHICLES NOT COVERED UNDER SAFETY RECALL 13S08 — STEERING COLUMN SHAFT

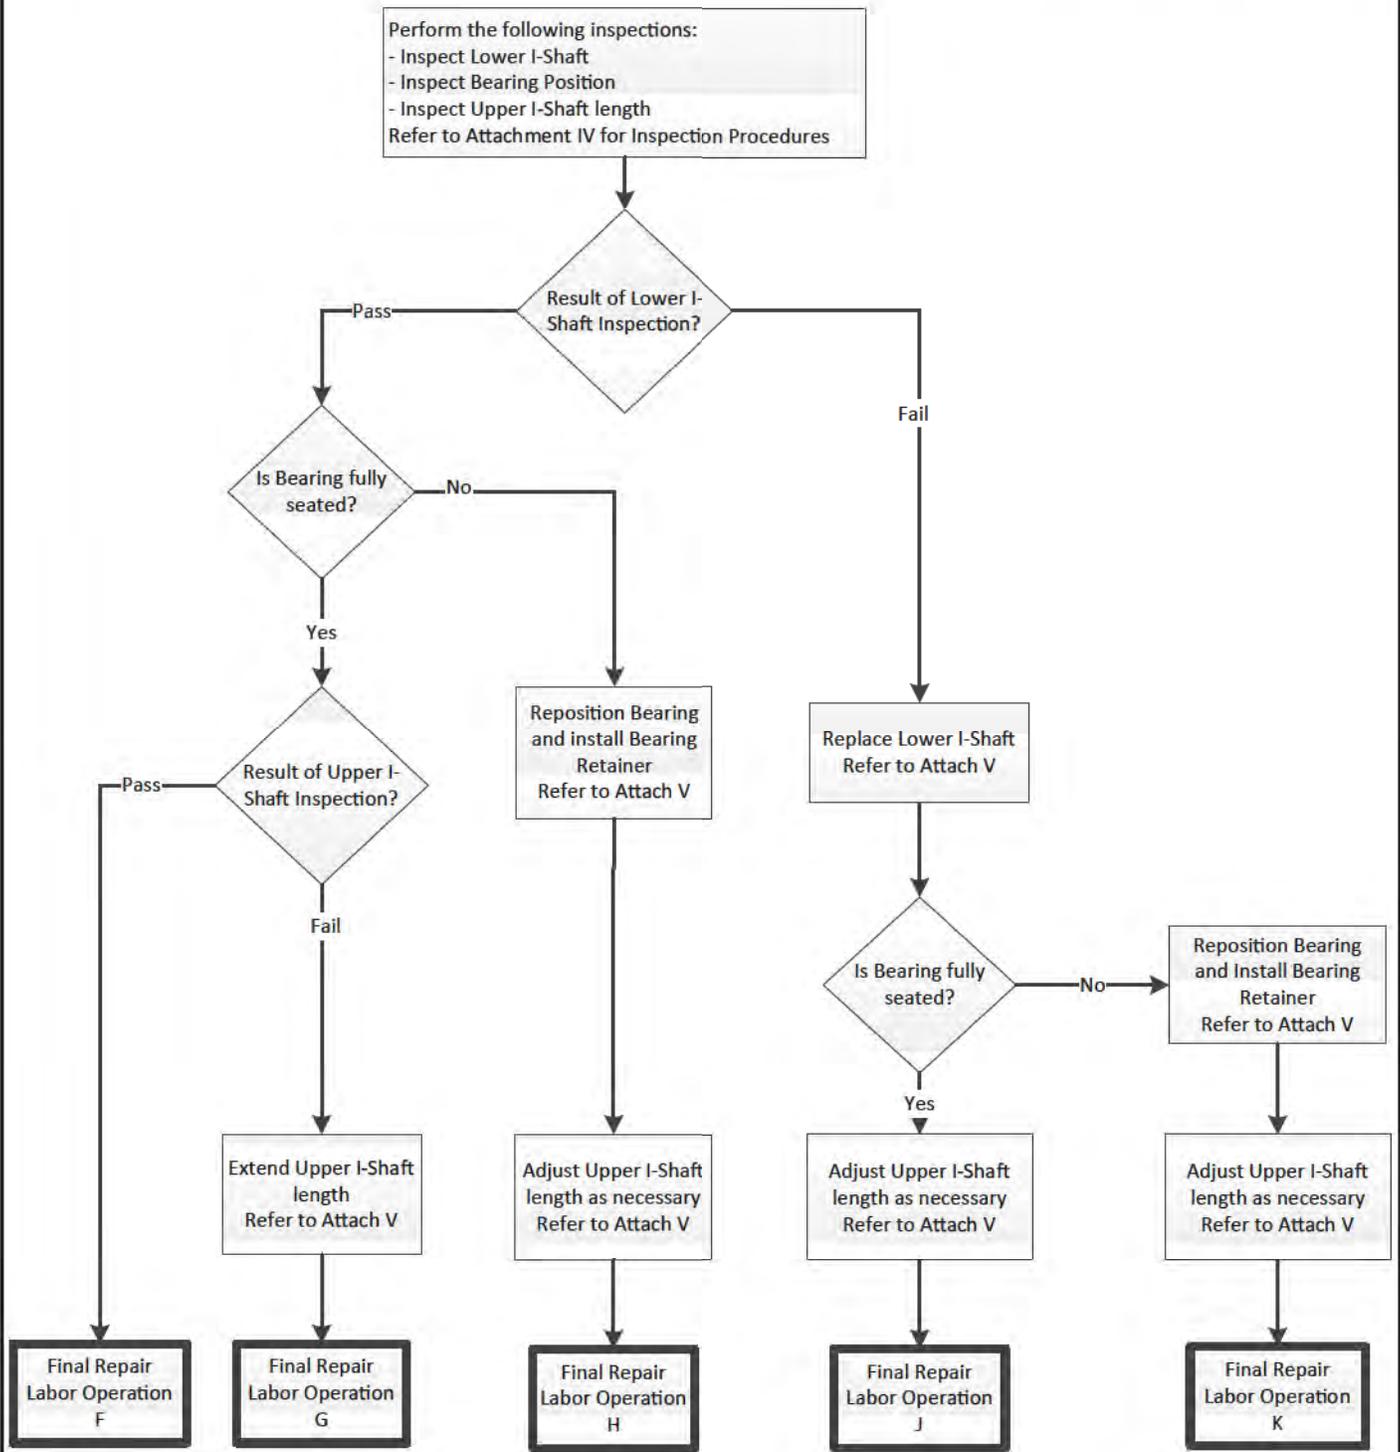
All three inspections must be performed to determine the appropriate repair action. Technicians should familiarize themselves with all aspects of the flowcharts prior to initiating repairs to avoid unnecessary disassembly/reassembly steps.

Refer to the flow chart on Page 2, for inspection and repair criteria.

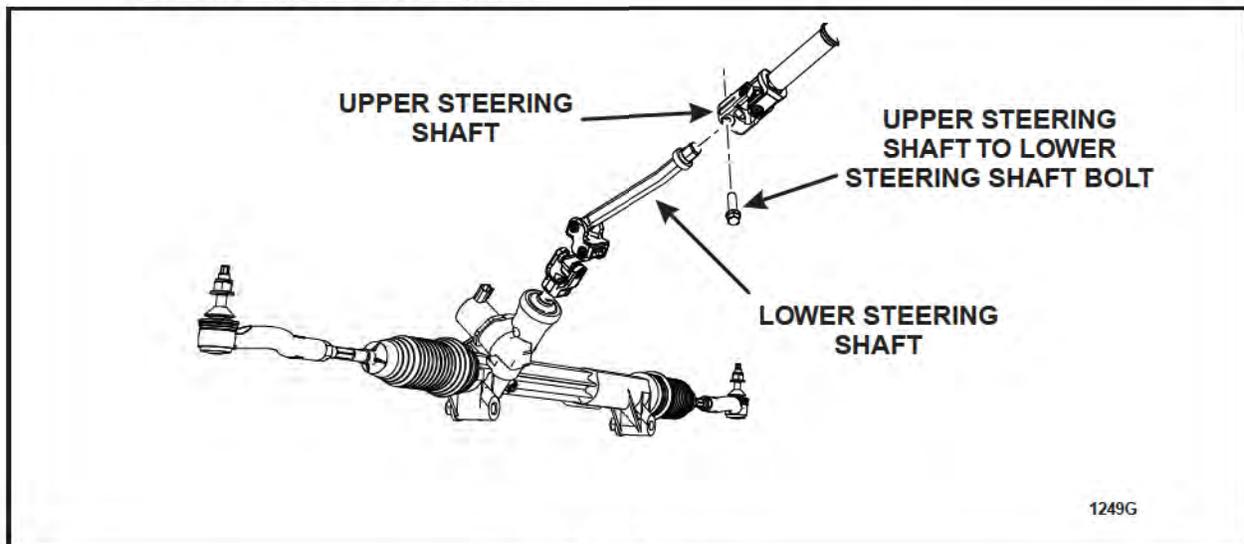
**FIGURE 1**

1. Inspect the lower steering shaft joints for binding or seizure, as follows:
  - a. Use a steering wheel holding device (such as Hunter® 28-75-1 or equivalent) to hold the steering wheel in the straight-ahead position.
  - b. Remove and discard the upper steering shaft to lower steering shaft bolt and disconnect the lower steering shaft. See Figure 1.

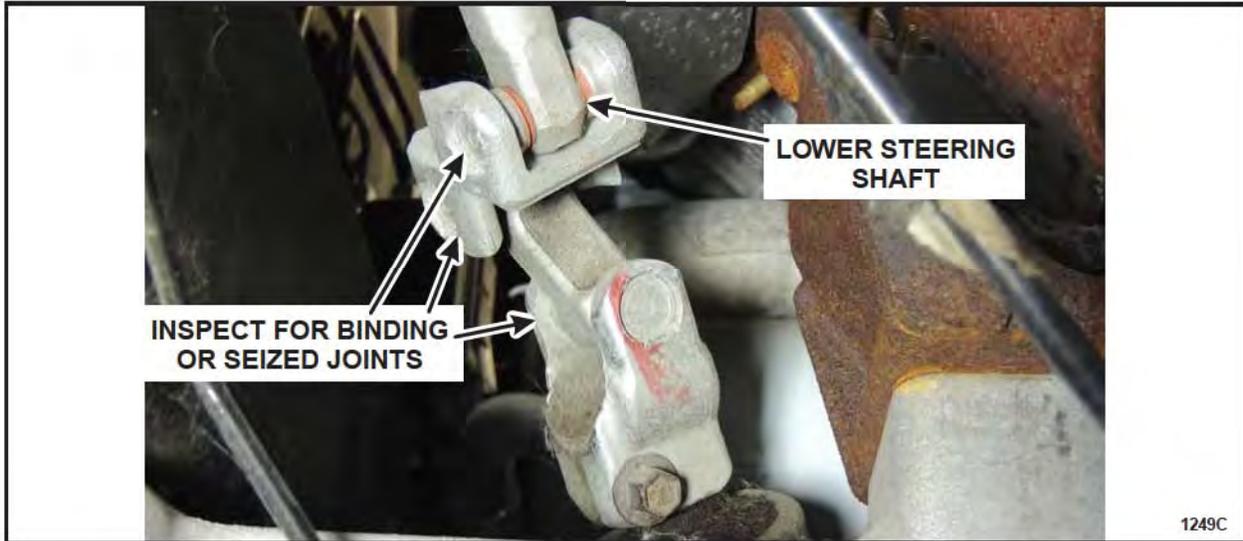
FIGURE 2

- c. Exercise the upper portion of the lower steering shaft throughout its range of motion. See Figure 2, on Page 2.
- d. If the lower steering shaft does not move freely and without binding, **it fails inspection.**

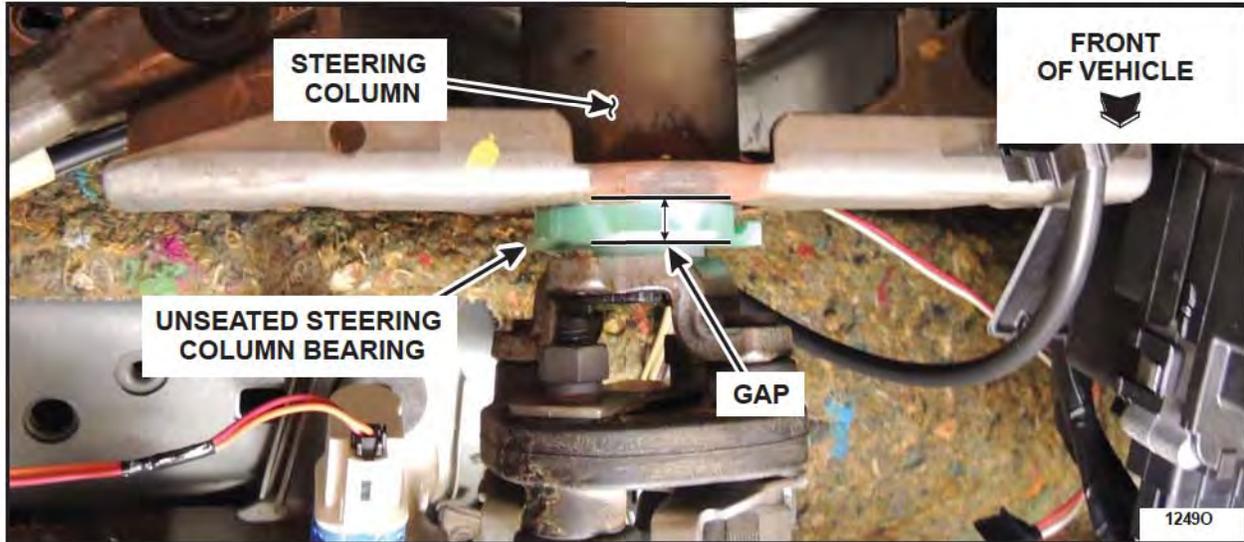
FIGURE 3

1. Inspect the steering column for an unseated steering column bearing. See Figures 3 and 4.

- If the steering column bearing is unseated, **it fails inspection.**

2. Align the bearing alignment tab with the slot in the column flange. See Figure 8.

3. Use a suitable dead blow hammer to lightly tap the steering column to upper steering shaft coupling to seat the steering column bearing. See Figure 9.

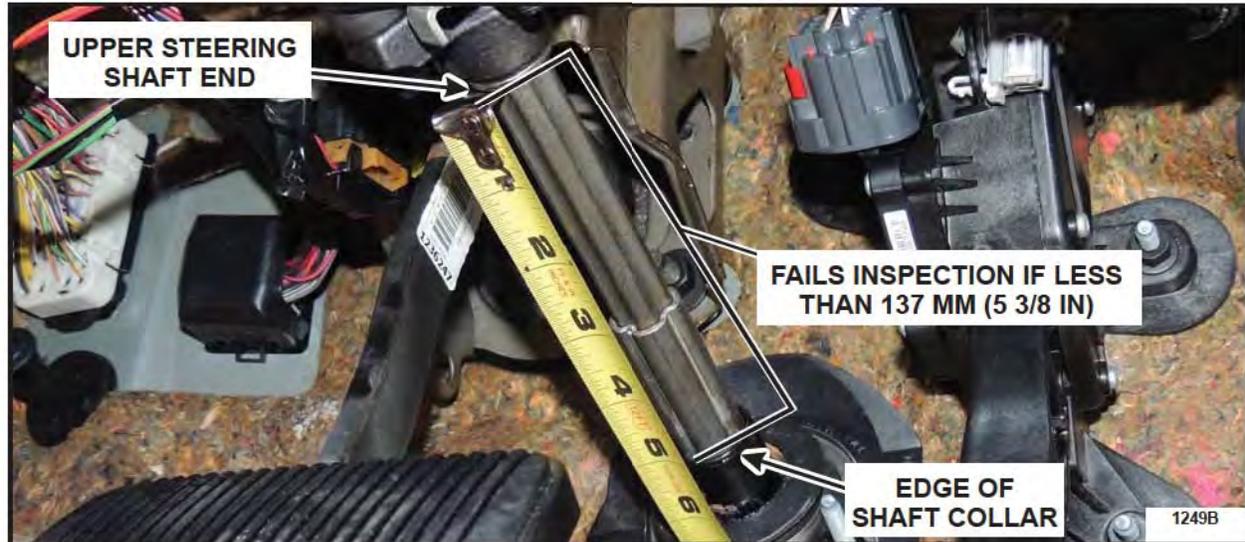
FIGURE 5

1. Measure the distance between upper steering shaft end and the edge of the shaft collar, to check for a collapsed upper steering shaft. See Figures 5 and 6.

- If the upper steering shaft measurement is less than 137 mm (5 3/8 in), **it fails inspection.**

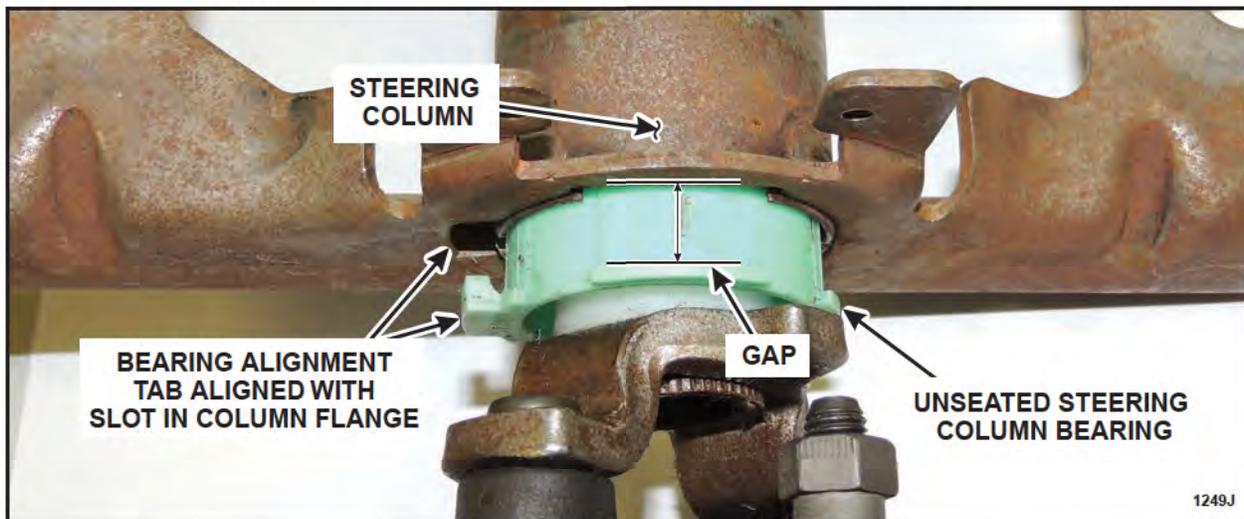
FIGURE 8

**NOTE:** In some instances the steering column bearing orientation tab may have broken off. If the tab has broken off, the bearing is still usable and can be seated within the steering column in any orientation.
