**3.5L GTDI - INTERMITTENT STUMBLE/MISFIRE ON ACCELERATION  
FROM HIGHWAY CRUISE IN HUMID OR DAMP CONDITIONS - BUILT ON  
OR BEFORE 12/16/2013**

**TSB 14-0017**

**FORD:**

2013-2014 F-150

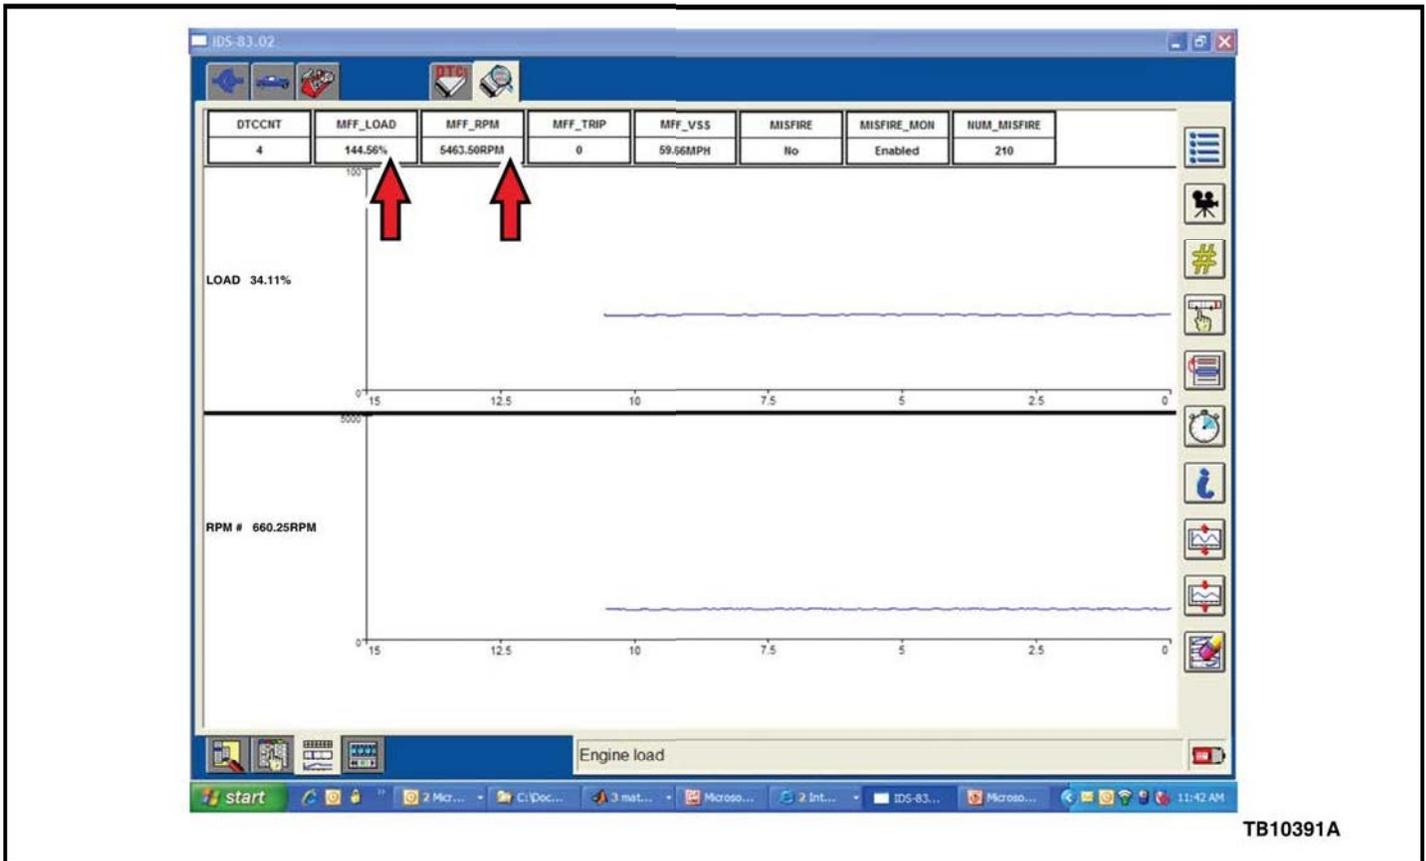
Figure 1 - Article 14-0017

1. Acquire Misfire Freeze Frame Data and DTC's with the Integrated Diagnostic System (IDS). Use the following steps with IDS to obtain Misfire Freeze Frame Data.
  - a. Select Toolbox
  - b. Data Logger
  - c. Modules
  - d. PCM
  - e. Select the following PIDs:
    - (1) MFF\_LOAD
    - (2) MFF\_RPM
2. Does the misfire concern only occur in humid or damp conditions?
  - a. Yes - proceed to Step 3.
  - b. No - this article does not apply. Refer to Powertrain Control/Emission Diagnosis (PC/ED) manual Section 3: Powertrain Symptom Index to inspect such areas as Ignition, Compression, and Injection.
3. Does the Misfire Freeze Frame Data indicate engine speed above 2500 rpm and load 100% or above? (Figure 1)

- a. Yes - proceed to Step 4.
  - b. No - this article does not apply. Refer to PC/ED manual Section 3: Powertrain Symptom Index to inspect such areas as Ignition, Compression, and Injection.
4. Is DTC P0430 present?
- a. Yes - replace the left hand catalytic converter. Refer to Workshop Manual (WSM), Section 309-00. Proceed to Step 5.
  - b. No - Proceed to Step 5.
5. Is the charge air cooler equipped with a top or bottom air deflector? (Figure 2 and Figure 3)
