Program Bulletin

SB-10057640-6326

SUBJECT: Front Seat Manual Recliner Cable Adjustment

MODELS: 2014 Chevrolet Caprice

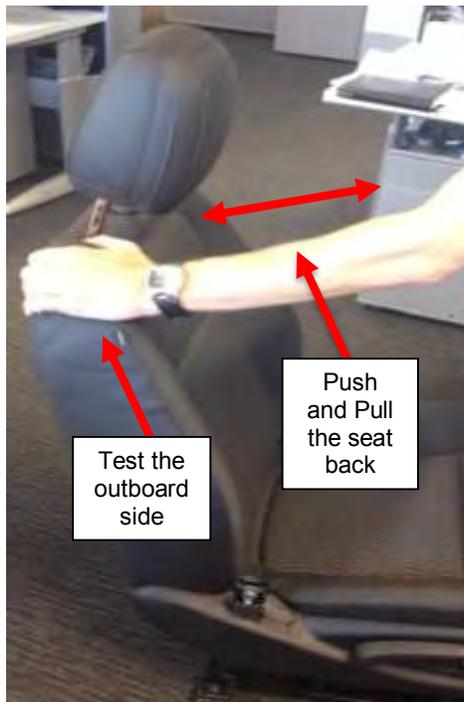
Figure 1

OUTBOARD RECLINER MECHANISM

1. Technicians must inspect the fore and aft movement of both front seat back recliner mechanisms following the inspection steps below. If there is not enough free play in the recliner cable, the seat back may not be locked to the seat base, causing the seat back to have excessive fore and aft movement.
2. With the seat in place, push and pull on the top of the seat back on the outboard side of the seat with a similar force to that used when opening a door handle (5 KG), refer to figure 1.
3. Repeat the process with the inboard side of the driver's seat, pushing and pulling with a similar force to that used when opening a door handle (5KG), refer to figure 2.

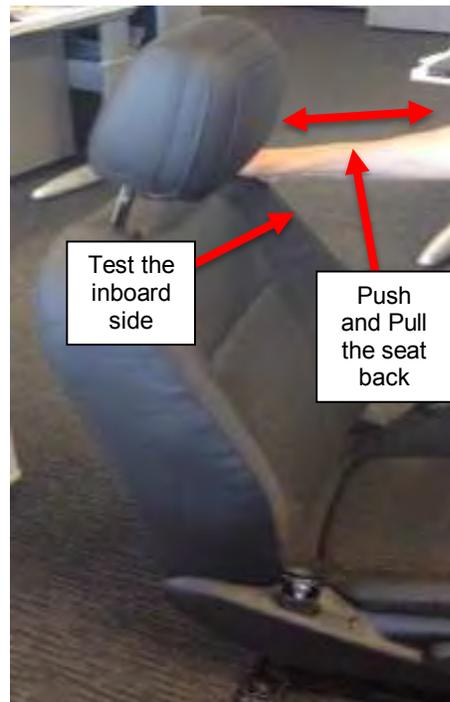
Figure 2

INBOARD RECLINER MECHANISM
