Service Bulletin

SB-10057644-3583

SUBJECT: Special Coverage Adjustment – Driver Airbag Light On

MODELS: 2008-2009 Chevrolet HHR SS
2009 Chevrolet Cobalt
2009 Pontiac G5, Solstice
2009 Saturn Sky

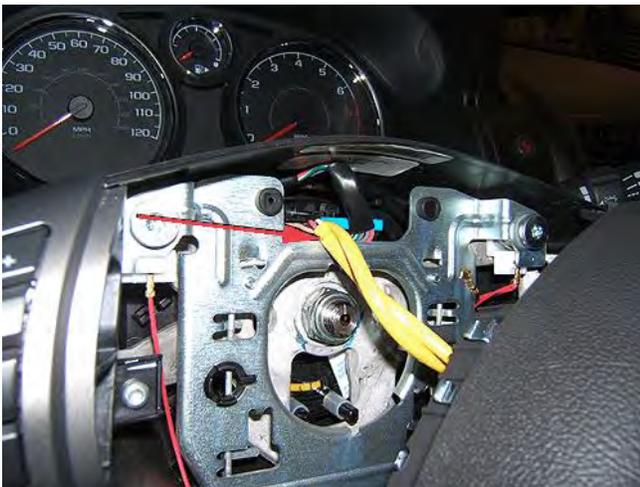
2291094

1. Remove the steering wheel inflatable restraint module. Refer to *Steering Wheel Inflatable Restraint Module Replacement* in SI.
