# Service Bulletin

**SB-10057651-9064**

**SUBJECT:** Service Update for Inventory and Customer Vehicles  
Incorrect Console Wiring  
Expires with Base Warranty

**MODELS:** 2015 Chevrolet Suburban, Tahoe  
2015 GMC Yukon, Yukon XL  
Equipped with Custom Front Floor Console without Cooler

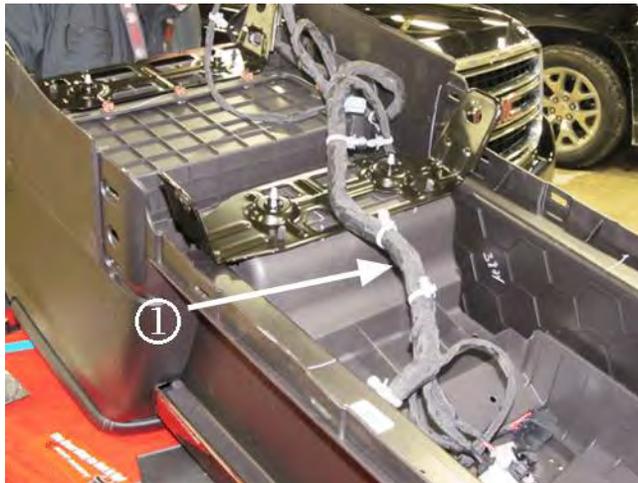
4065612

This bulletin provides a service procedure to replace the console-wiring harness on **certain** 2015 model year Chevrolet Suburban, Chevrolet Tahoe, GMC Yukon and GMC Yukon XL vehicles equipped with a custom front-floor console without cooler. These vehicles may have been built with an incorrect console-wiring harness which may cause the transfer case, child-door lock, window lock, heated-steering wheel, park assist and lane-departure switch indicators to not function. The heated seats function as intended, but because of the incorrect console harness, the battery-feed circuit to the heated-seat switches is protected by the wrong fuse and will not be properly protected if a short-circuit failure ever occurs.

**NOTE:** To help eliminate/minimize damage to the console molded tabs, use care when removing the original harness push fasteners.

1. Remove the front floor console wiring harness (1). Refer to *Front Floor Console Wiring Harness Replacement (Chevrolet / GMC)* in SI.
2. Install the new front floor console wiring harness. Refer to *Front Floor Console Wiring Harness Replacement (Chevrolet / GMC)* in SI.
