Service Bulletin

SB-10057653-4981

SUBJECT: Service Update for Inventory and Customer Vehicles
Accessory Drive Idler Pulley Failure
Expires with Base Warranty

MODELS: 2015 Chevrolet Camaro
Equipped with V8 Engine (L99/LS3/LSA/LS7)
2015 Chevrolet Silverado
2015 GMC Sierra
Equipped with V6 Engine (LV3)

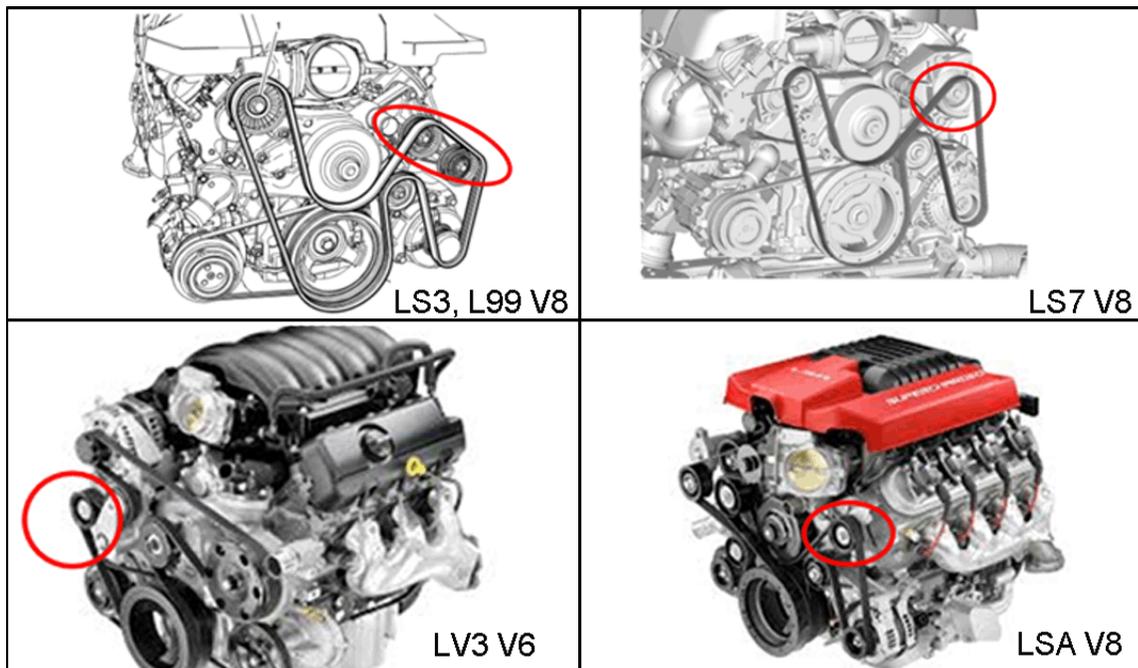
4063612

This bulletin provides a service procedure to replace the accessory drive idler pulley on certain 2015 model year Chevrolet Camaro vehicles equipped with a V8 engine (L99/LS3/LSA/LS7) and certain 2015 model year Chevrolet Silverado and GMC Sierra vehicles equipped with a V6 engine (LV3). A supplier manufacturing defect may exist in the idler pulley on these vehicles. If the defect exists, the customer may experience noise from the bearing. If the vehicle is not repaired and the vehicle continues to be driven, the pulley bearing may fail and the alternator and water pump may stop working, resulting in a malfunction indicator lamp (MIL) light for loss of charging and a possible MIL light for overheating.

Note: Remove and replace both drive belt idler pulleys on engines with RPOs LS3 and L99. Refer to the photograph above to determine the location of the drive belt idler pulley(s).

1. Remove the drive belt idler pulley. Refer to *Drive Belt Idler Pulley Replacement* in SI.
2. Install a new drive belt idler pulley. Refer to *Drive Belt Idler Pulley Replacement* in SI.
