Service Bulletin

SPECIAL COVERAGE

SUBJECT: Special Coverage Adjustment – Transmission Clutch Wave Plate

MODELS: 2007-2009 Buick Enclave
2008-2009 Chevrolet Equinox, Malibu
2009 Chevrolet Traverse
2007-2009 GMC Acadia
2007-2009 Pontiac G6
2008-2009 Pontiac Torrent
2007-2009 Saturn AURA, OUTLOOK

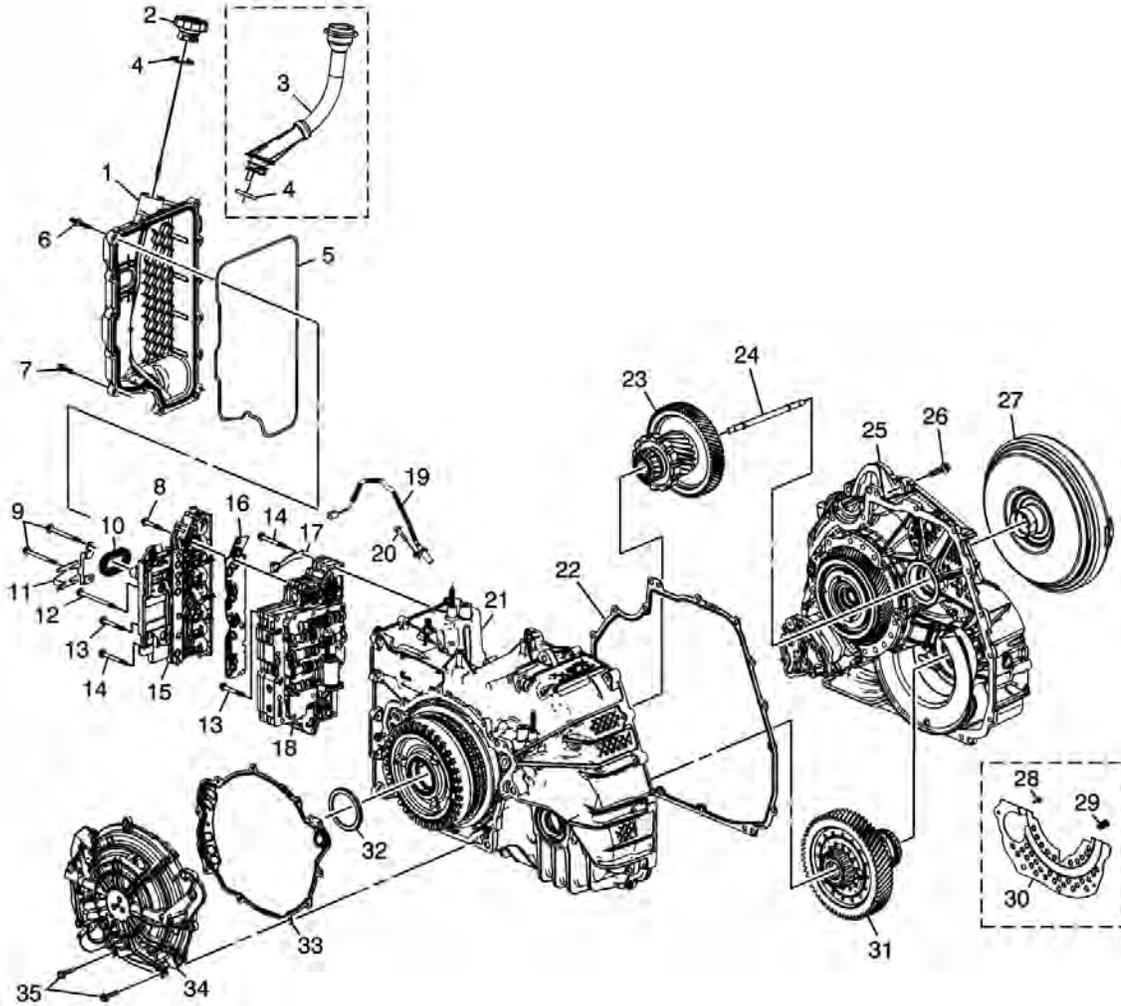
1725874

Note: The control solenoid (w/body and TCM) valve assembly should not be washed in a parts cleaner. The control solenoid (w/body and TCM) valve assembly should not be replaced for any DTC unless SI diagnostics for the DTC have been completed and instruct to replace the part.

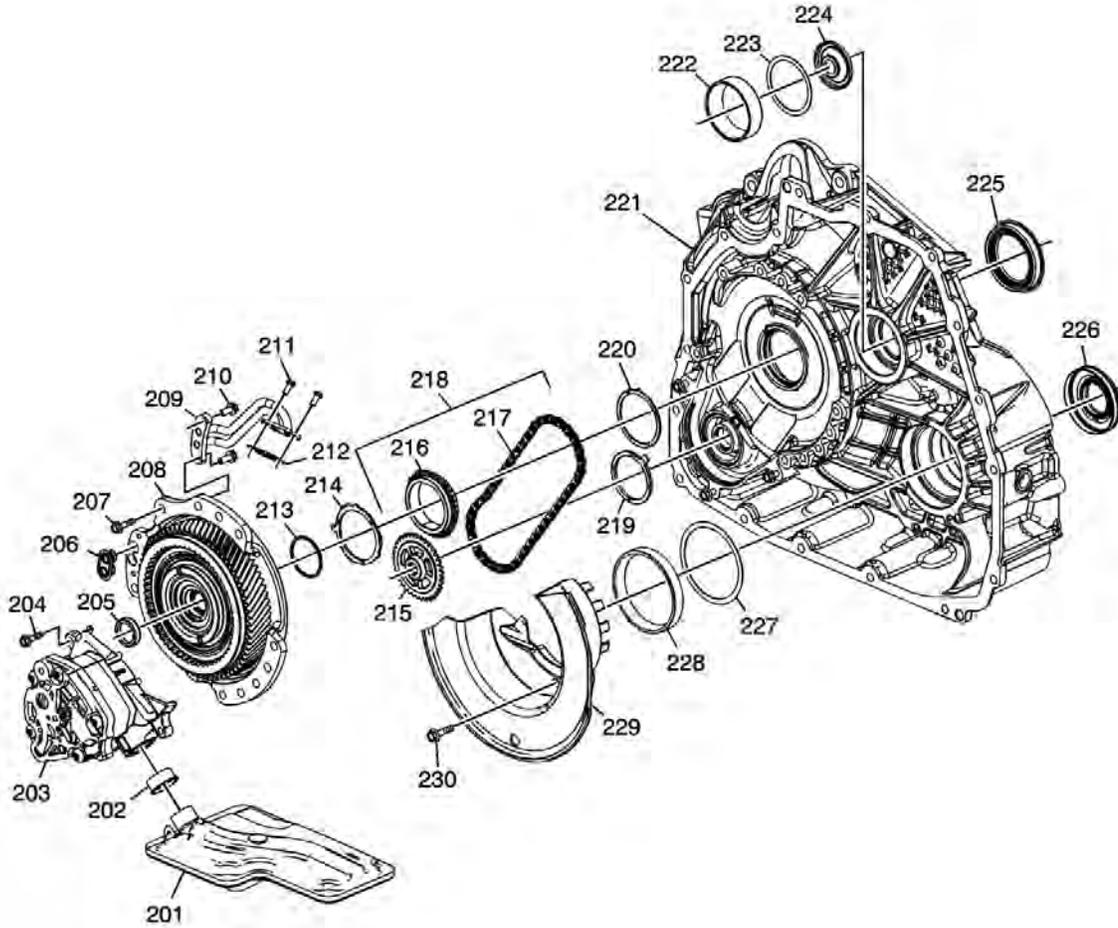
1725882

Note: Debris generated by the condition must be cleaned from the entire transmission and the pump fluid filter (201) and the control solenoid filter plate (16) must be replaced. Failure to separate the case halves, disassemble the transmission, clean the debris and replace the pump fluid filter (201) and the control solenoid filter plate (16) could lead to repeat transmission damage and repairs.

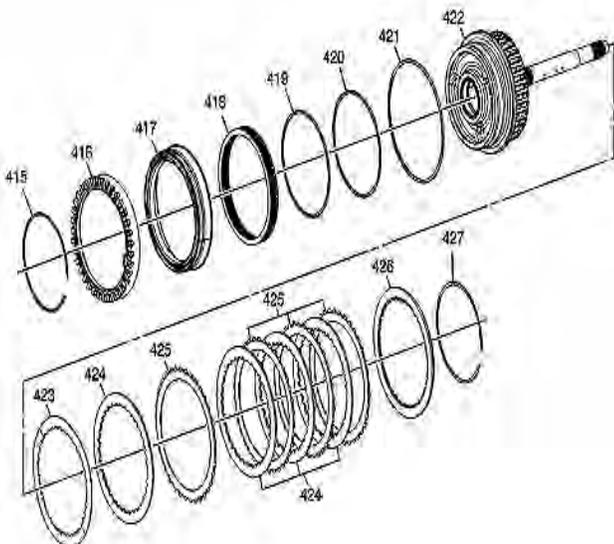
2584818

A broken 35R wave plate can generate varying amounts of debris inside the transmission. In most cases this debris has not passed through the pump fluid filter (201) potentially damaging the pump, valve bodies or torque converter. This debris can be cleaned and the transmission successfully repaired.

1. After removing the transmission from the vehicle, remove the case cover assembly (35). Inspect the case cover for damage. This part is serviced and can be replaced if it is damaged.
2. Remove the 35R/456 clutch housing assembly (422) and inspect it for a broken 35R wave plate (423).
3. Inspect the case (21) for damage caused by a broken wave plate as shown below.

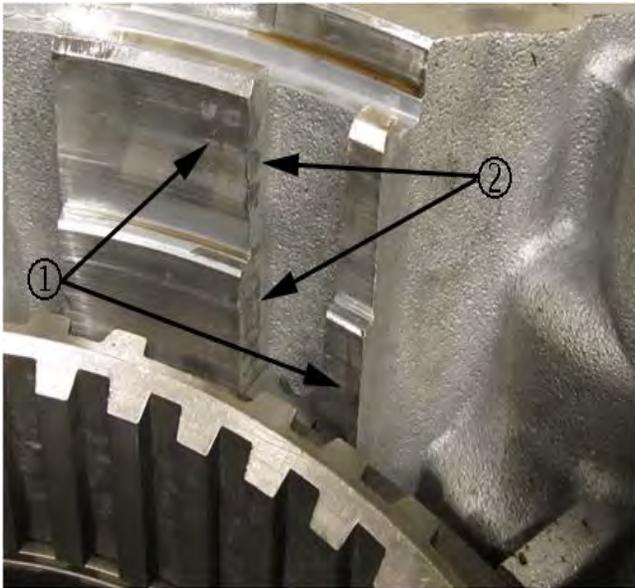
2753503

- The snap ring groove, which is well below the 3-5-R wave plate area, is unlikely to be damaged. It should still be checked to verify the snap ring is fully seated and to be securely retained.

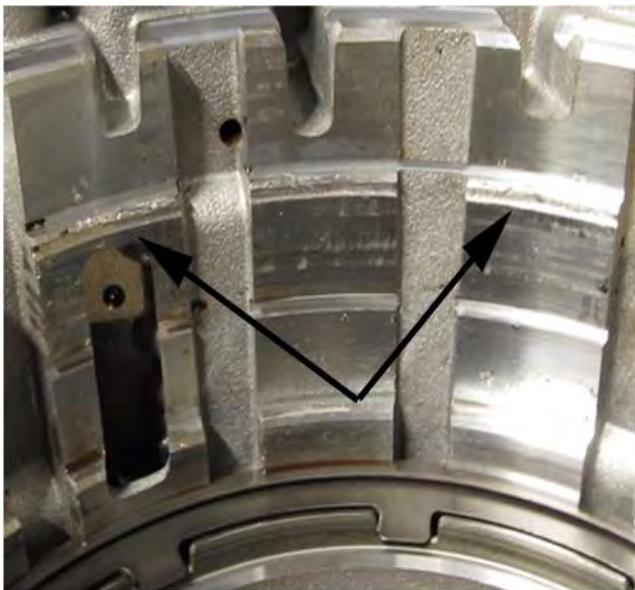
2753506

- Peening or wear of the face or edge of the case lugs that engage the steel clutch plates is normal and not cause for transmission replacement.

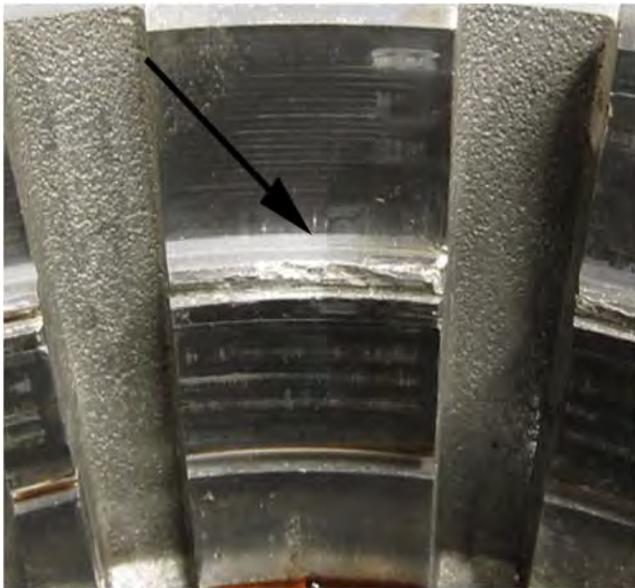
2753509

- Some degradation of the shelf for the 2-6 backing plate is acceptable as long as the plate can lie flat. A raised burr that prevents this can be removed using a de-burring tool, file or some other abrasive.

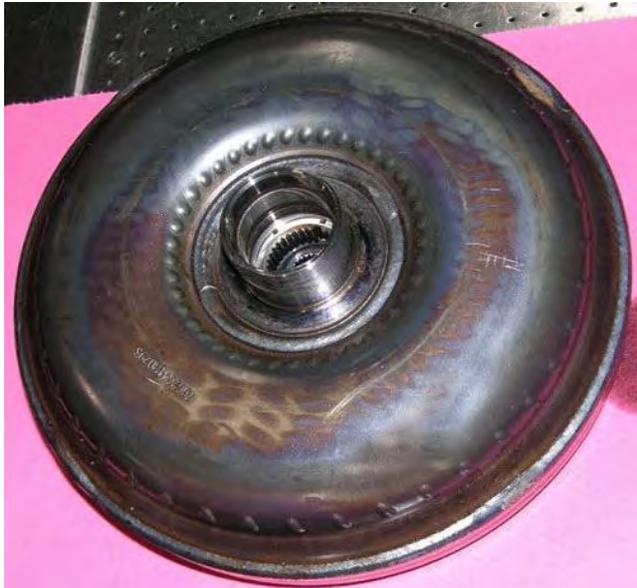
2739303

- Fine metal particles that you cannot feel (traces of metal flakes/gray color to the fluid) are not reasons to replace the torque converter.
 - Metal chips/debris that you can feel or that are found in the converter, or when flushing the cooler and cooler lines, indicate the torque converter should be replaced.

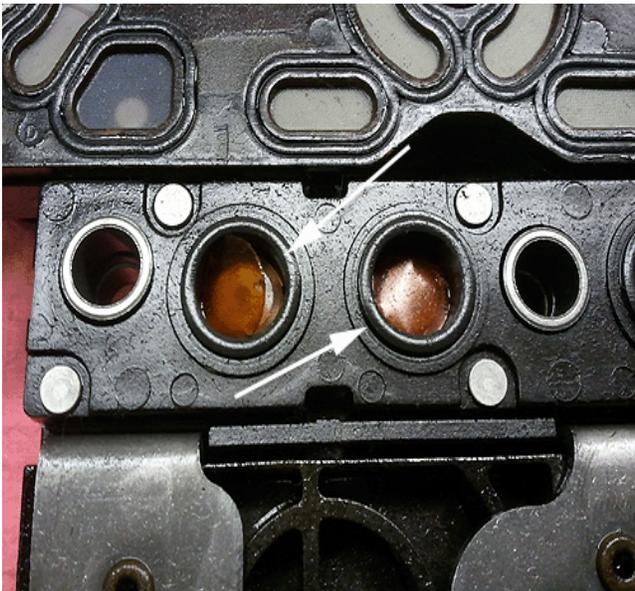
2630114

6. Inspect the control solenoid (w/body and TCM) valve assembly (TEHCM) (15) pressure switches. The O-ring seals may be deformed but if they are attached, as shown above, the TEHCM should not be replaced; it should be reused. Deformed seals do not affect switch performance.

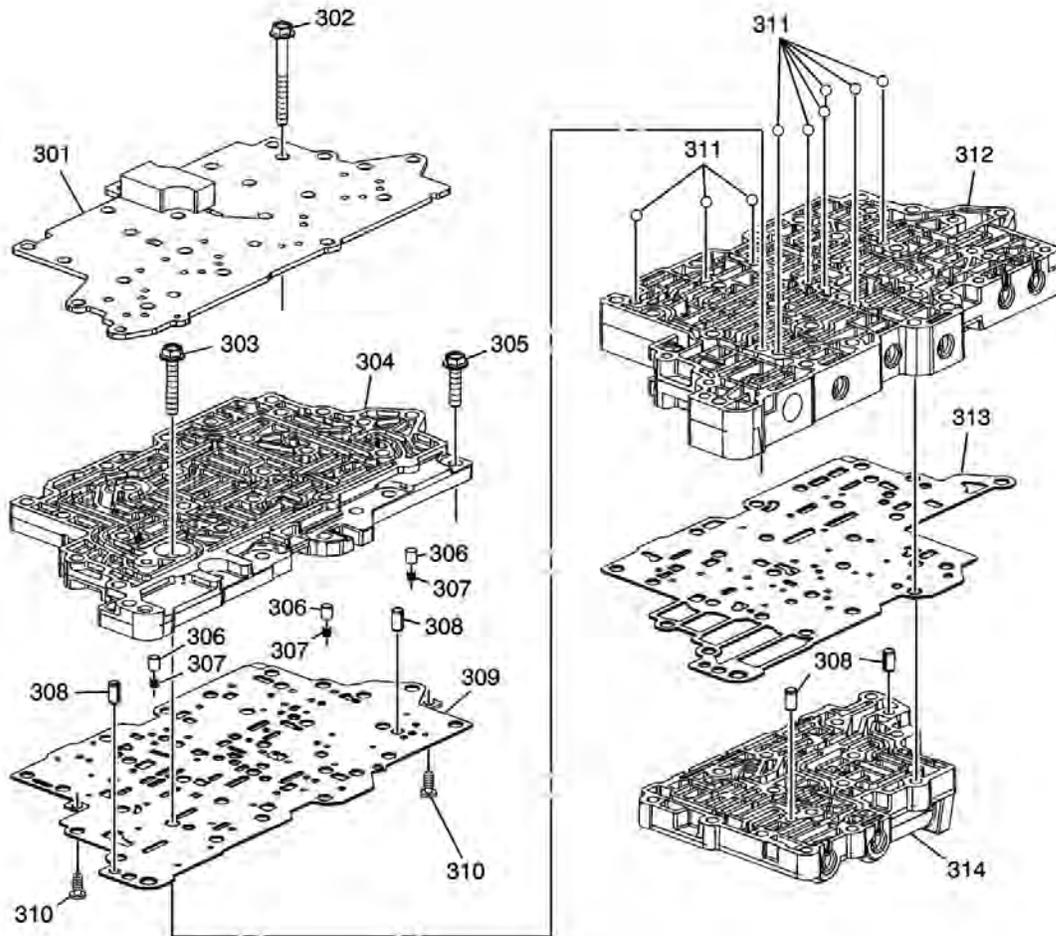
1725885

Note: 2007-2008 applications – when assembling these transmissions, inspect the control valve channel upper plate (301) to make sure that it contains the slot as indicated above. Plates installed that do not include this slot may result in DTCs.
