Service Bulletin

SUBJECT: Service Update for Inventory and Customer Vehicles - Front Lower Control Arm Rear Link Ball Joint Re-torque – Both Sides
Expires with Base Warranty

MODELS: 2014-2015 Chevrolet Caprice, Caprice PPV, SS

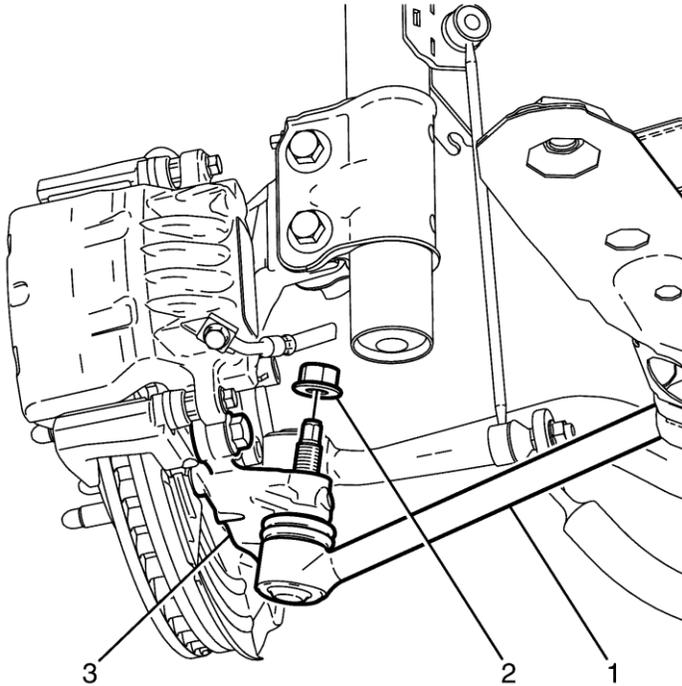
1949920

This bulletin provides a service procedure to re-torque the front lower control arm rear link ball joint nuts on **certain** 2014-2015 model year Chevrolet Caprice and SS vehicles. These vehicles may have under torqued front lower control rear link ball joint nuts. This condition may result in a clunk or rattle type noise in the front suspension.

1. Raise and support the vehicle. Refer to *Lifting and Jacking the Vehicle* in SI.
2. Torque the existing front lower control arm rear link (1) ball joint nut (2) to **150 Nm (111 lb-ft)** to fully seat the joint in the steering knuckle (3).
3. Loosen the ball joint nut (2) 180 degrees.
4. Re-torque the ball joint nut (2) to **55 Nm (41 lb-ft)**.
5. Tighten nut another 30 degrees.
