GM Bulletin No.: 15217
Date: April 2015

Service Bulletin

SUBJECT: Service Update for Inventory and Customer Vehicles
TCM Harness Routing
Expires with Base Warranty

MODELS: 2015 Chevrolet Silverado
2015 GMC Sierra
HD Vehicles Equipped with Dual Generators (KHB)

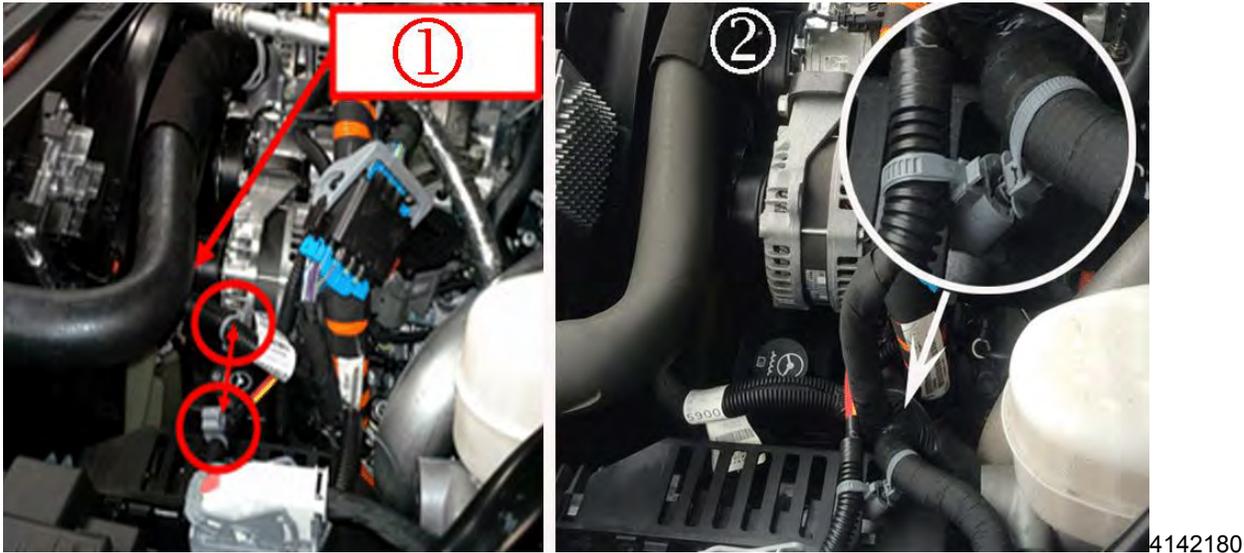
On these vehicles, the TCM branch of the engine-wiring harness may have been misrouted and not secured with an existing fir-tree clip on the auxiliary-positive battery cable, potentially allowing the harness to come in contact with either the auxiliary-generator pulley or belt.

Note: Item (1) shows the generator contact area of the TCM harness along with the disconnected two part clip. Item (2) shows the correctly fastened clip, retaining the TCM harness away from the generator.

2. Inspect the area to the left of the generator. Look for the gray two piece fir tree and buddy clip fastening the TCM harness to the auxiliary positive battery cable.
 - If the clip is fastened, no further action is needed.
 - If the clip is present but the two parts are not fastened, join the two parts of the clip.
 - If the clip is missing, or unable to be fastened, install a new fir tree fastener with tie straps on the harness to connect to the buddy clip.
 - If the TCM harness conduit is worn through at the serpentine belt, tape and secure the conduit in the affected area.
