# Program Bulletin

## SB-10058721-3804

### CUSTOMER SATISFACTION PROGRAM

**SUBJECT:** Brake and Fuel Pipe Bracket Contacting Fuel Feed Pipe  
**MODELS:** 2014 Chevrolet Caprice Police Patrol Vehicle (PPV)  
Equipped with 3.6L Engine (RPO LFX)

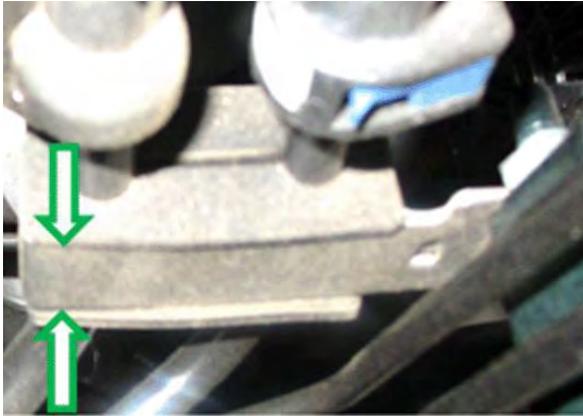
Bracket centered on rubber isolator.

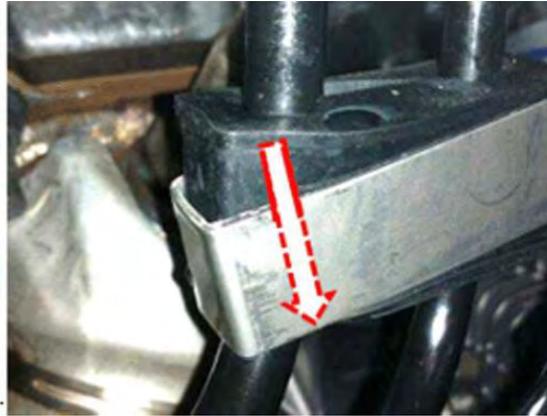
4225066

Bracket out of position.

- If the bracket is located in the **OK** position as shown on the left, no further action is required
- If the bracket alignment is found to be **NOT OK** as shown on the right, unfasten the bracket retaining nut and rotate the bracket to the **correct** position as shown on the left. Retorque the retaining nut to **22 N•m (16 lb-ft)**, and proceed to *Inspecting the Fuel Feed Line for Damage*, in this bulletin.

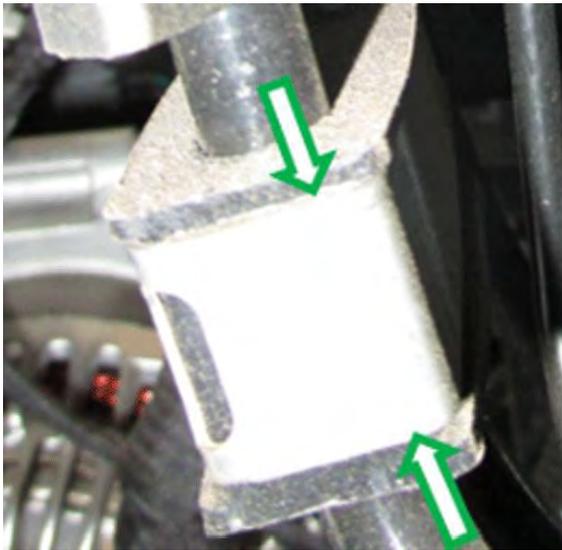
Bracket centered on rubber isolator.

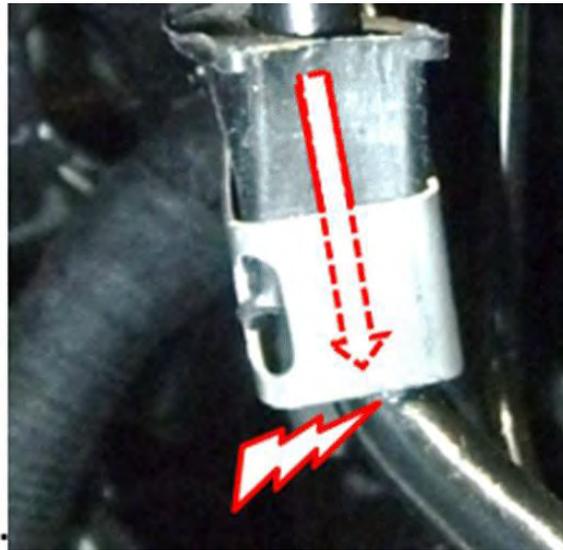
4225072

Bracket out of position.

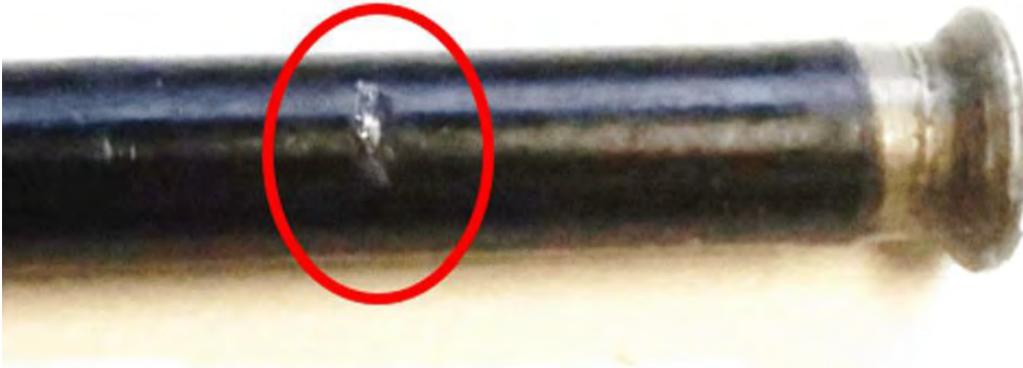
4225075

The fuel feed line consists of a mild steel inner line that is protected with a PVC coating. This coating may be damaged due to contact with the retainer bracket.

- Inspect the steel inner fuel line for any wear marks in the PVC coating where the bracket has contacted the line. There **MUST NOT BE ANY RUB THROUGH CONDITION** exposing the steel line as shown. **If the inner steel line is exposed, the fuel feed line MUST BE REPLACED.**
- If the PVC coating is still intact, and the inner steel line is not visible at the contact area, no further action is required.
