Service Bulletin

SB-10056459-3388

SUBJECT: Special Coverage Adjustment – Loss of Power Steering Assist

**MODELS: 2008-2011 Buick Enclave
2009-2011 Chevrolet Traverse
2007-2011 GMC Acadia
2007-2010 Saturn OUTLOOK**

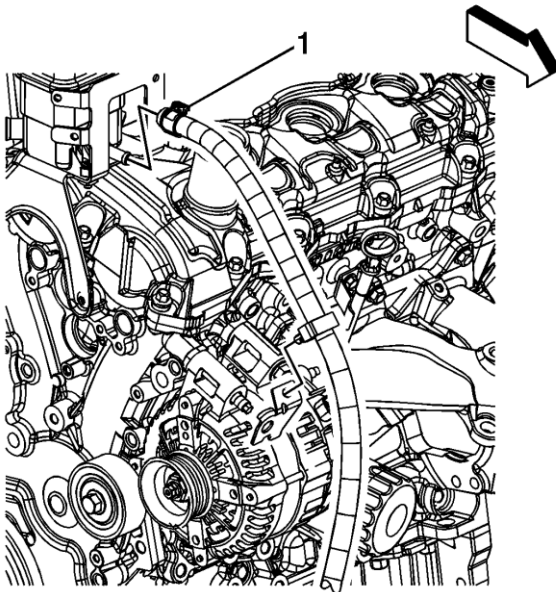
1856010

4. Loosen the hose clamp (1) and disconnect the power steering fluid reservoir inlet hose from the power steering fluid reservoir.
5. Plug the power steering fluid reservoir inlet port.

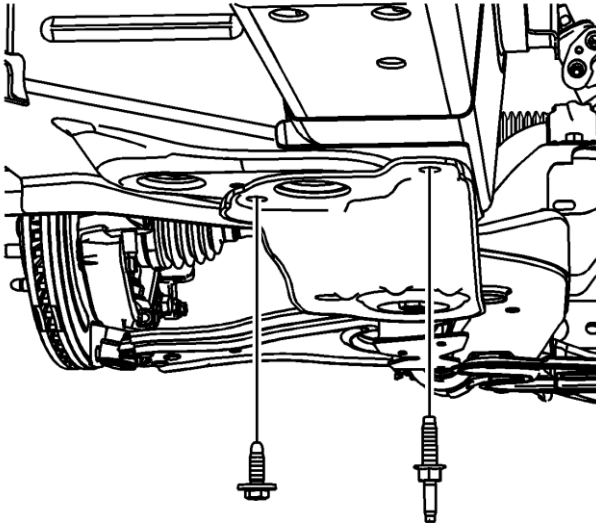
1856440

12. Remove the left and right front frame reinforcement mounting bolts. The left side is shown. The right side is similar.

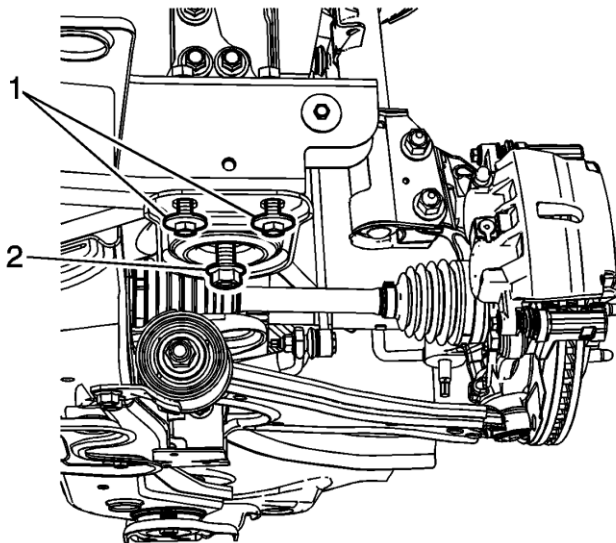
1856458

13. Loosen the front frame reinforcement mounting bolts (1). The left side is shown. The right side is similar.
14. Loosen the front frame mounting bolts (2). The left side is shown. The right side is similar.

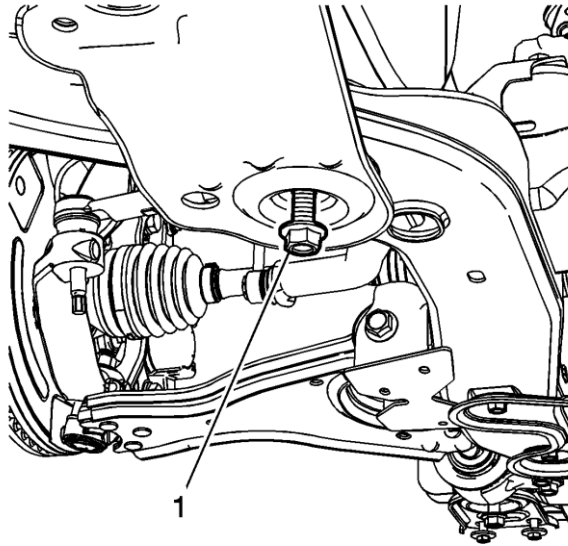
1856464

15. Loosen the front frame rear mounting bolts (1).
16. Lower the frame from the frame rail until enough clearance is gained to remove the steering gear housing.
17. Remove the steering gear heat shield.

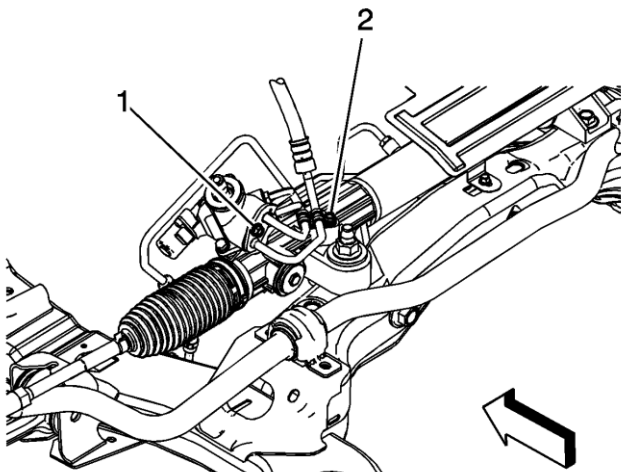
1861303

19. Remove the power steering gear inlet hose retaining plate bolt (1).
20. Disconnect the power steering gear inlet and outlet hoses from the steering gear.
21. Remove the power steering gear inlet and outlet pipe clip bolt (2).

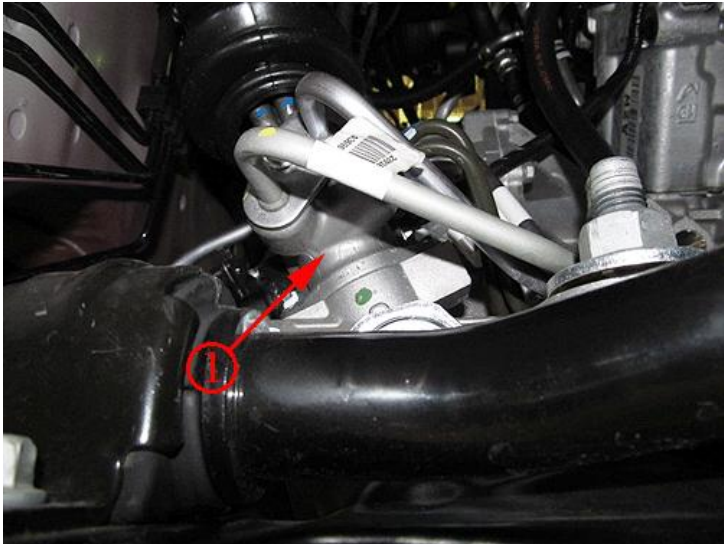
2691990

25. Remove the steering gear housing bolts and housing (1) from the steering gear.
26. Transfer the steering gear valve solenoid to the new housing, if equipped with Variable Effort Steering (RPO NV7).
27. Remove the steering gear solenoid valve bolts and valve.
28. Remove and discard the three O-ring seals.
29. Install the new O-ring seals provided in the kit.
30. Install the steering gear valve and secure with bolts.

Tighten the steering gear solenoid valve bolts to 8 N.m (71 lb in).

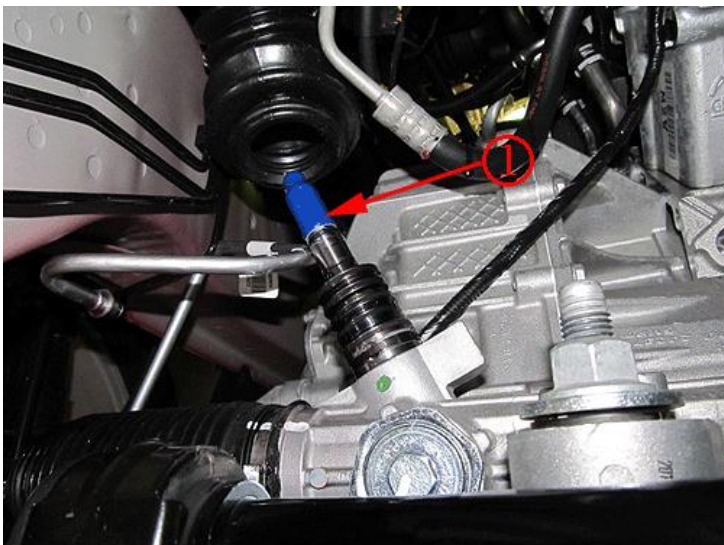
2691992

31. Install the blue seal protector (1) provided in kit onto the steering gear pinion shaft to prevent damage to the seal when installing the housing.
32. Install the new steering gear housing and bolts to the steering gear. Remove the seal protector.

Tighten the housing bolts to 21 N.m (16 lb ft).

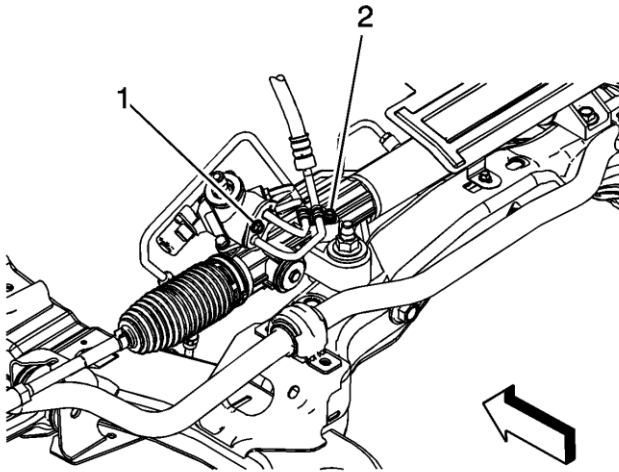
1861303

35. Install the power steering gear inlet hose retaining plate bolt (1).

Tighten the bolts to 21 N.m (16 lb ft).

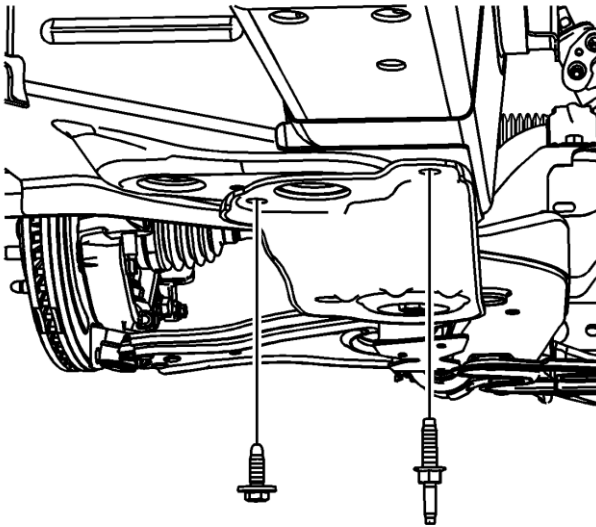
1856440

41. Install the left and right front frame reinforcement mounting bolts. The left side is shown. The right side is similar.

Tighten the bolts to 50 N.m (37 lb ft).

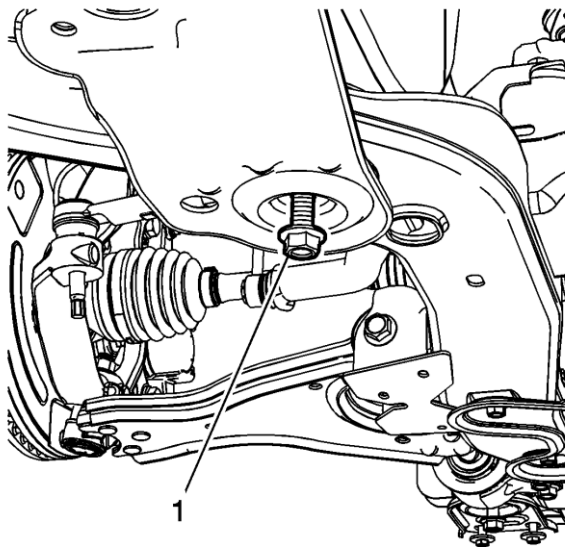
1856464

42. Install the NEW front frame rear mounting bolts (1).

Tighten the bolts to 100 N.m (74 lb ft). Tighten the bolts an additional 90 degrees.

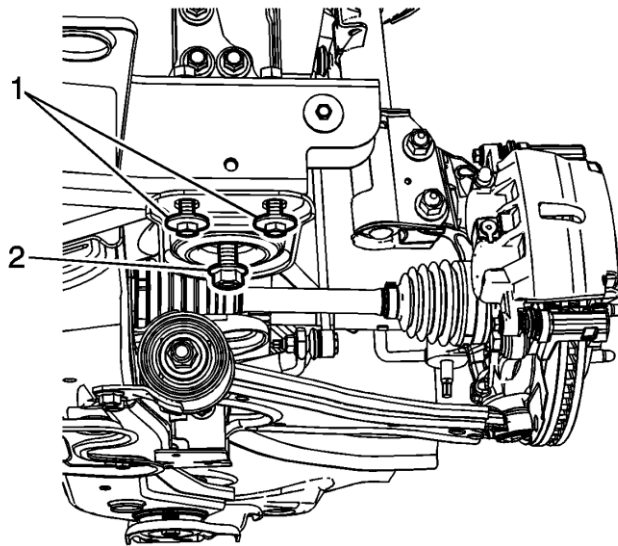
1856458

43. Install the NEW front frame mounting bolts (2). The left side is shown. The right side is similar.

- a. Tighten the bolts to 100 N.m (74 lb ft).
 - b. Tighten the bolts an additional 90 degrees.
44. Remove the adjustable jack stands from underneath the vehicle.
45. Install the intermediate steering shaft to the steering gear and install the intermediate steering shaft bolt.
46. Fill and bleed the power steering system. Refill with DEXRON®-VI Automatic Transmission Fluid, Refer to the *Power Steering System Bleeding* procedure in SI.
47. Ensure there are no power steering fluid leaks.
48. Lower the vehicle.
