Bulletin No.: P11294

Date: August, 2014

Service Bulletin

Subject: Intermittent Service Power Steering Message Displayed on DIC, DTC C056D, C0475 or U0131 May Be Set

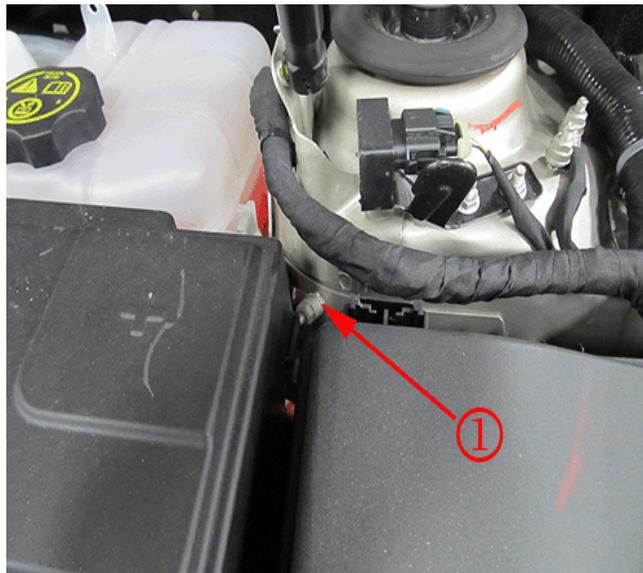
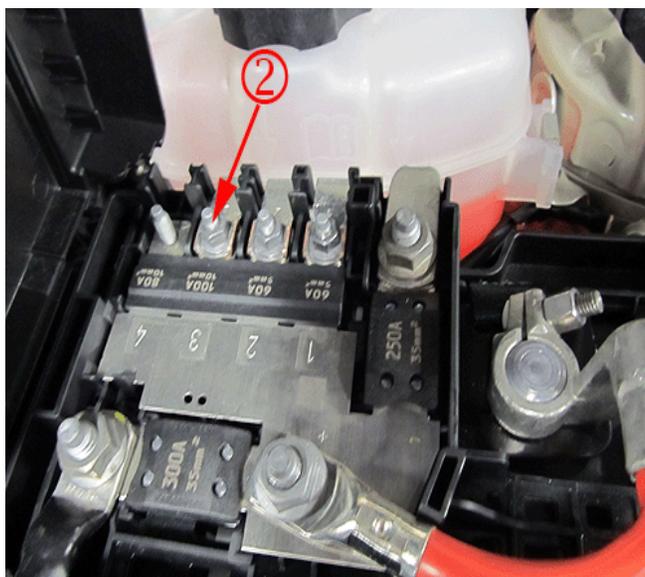
3775857

1. Inspect the G111 ground (1) and the 100A F3UB fuse (2) for proper connection. Ensure the ground is free of paint and both connections are tight.

- Tighten the G111 ground to 9 N•m (80 lb in).
 - Tighten the F3UB fuse to 4.7 N•m (42 lb in).
2. Fully charge the battery using the GR-8 Tool (EL-50313).
 3. Reprogram the power steering control module using the Service Programming System (SPS) with the latest calibrations available on TIS2WEB. Refer to the Power Steering Control Module Programming and Setup (NJ2) procedure in SI.
