Service Bulletin

Bulletin No.: PIT5307

Subject: SES MIL And/Or No Crank (Inspect Engine Harness Chaffing At Vacuum Pump Pulley)

Models: 2014 Chevrolet Silverado 1500
2014 GMC Sierra 1500
With Engine 5.3L (RPO L83) or 6.2L (RPO L86)

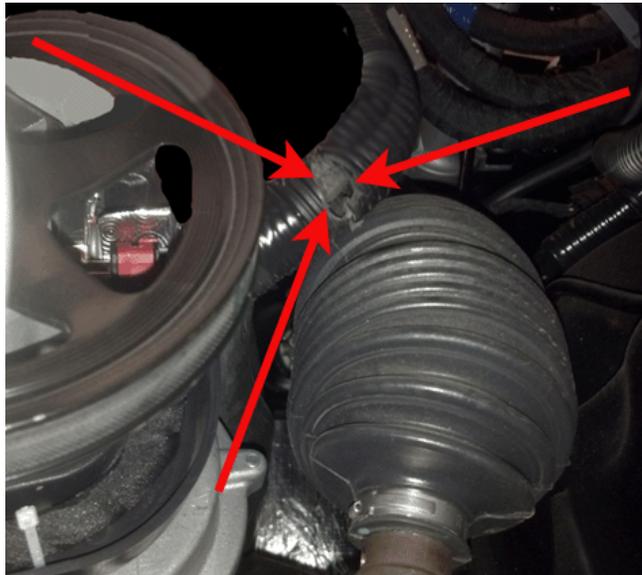
3958681

Some owners may comment on a SES MIL with any of the DTC's listed below and/or a no crank issue caused by the "STRTR" fuse 11 (F11UA) in the UBEC for being open. These issues could be caused by the engine harness rubbing on the engine vacuum pump pulley, as shown below.

Repair any damaged circuits, and resecure the harness away from the pulley to prevent the issue from reoccurring.
