GROUP Electrical	MODEL 2014MY Sorento (XMa) w/IMS Seats
	NUMBER ELE 069	DATE September 2014
<b>TECHNICAL SERVICE BULLETIN</b>		
SUBJECT: DRIVER'S SIDE POWER WINDOW SWITCH REPLACEMENT

**SUBJECT: DRIVER'S SIDE POWER WINDOW SWITCH REPLACEMENT**

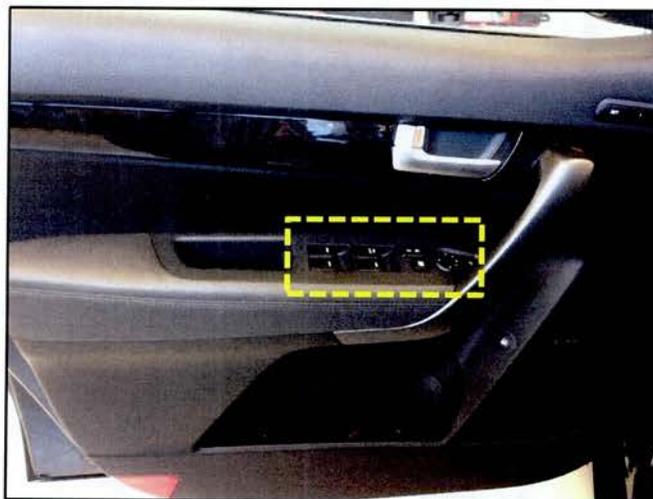
Master Power Window Switch

This bulletin provides the procedure to replace the window motor switch of some 2014MY Sorento (XMa) vehicles, produced from December 17, 2012 through December 13, 2013, which may exhibit an intermittent parasitic draw concern. Before conducting this repair, verify that TSB ELE057/SA163 - IPM Logic Improvement - has been performed on the vehicle. **This procedure applies ONLY to vehicles equipped with Integrated Memory System (IMS) Seats.**
