**SB-10056901-7043****FORD:**

2011-2015 Explorer

This article supersedes TSB 12-12-4 to update the vehicle model years and Service Procedure.

**ISSUE**

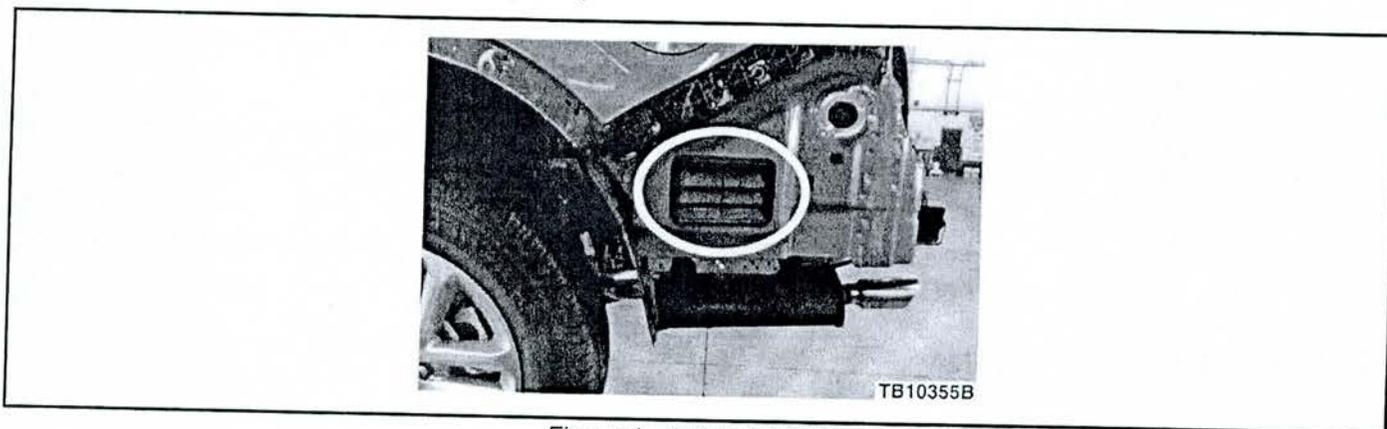
Figure 1 - Article 14-0130

Some 2011-2015 Explorer vehicles may exhibit an exhaust odor in the vehicle with the auxiliary climate control system on. Customers may indicate the odor smells like sulfur.

1. Reprogram the Heating Ventilation Air Conditioning (HVAC) module to the latest calibration using IDS release 91.02 or higher. Calibration files may also be obtained at [www.motorcraftservice.com](http://www.motorcraftservice.com).
  - a. When reprogramming the HVAC, IDS will have additional questions that require a yes response to reprogram the module.
2. Remove the rear bumper cover. Refer to Workshop Manual (WSM), Section 501-19.
3. Replace the left side rear air extractor. (Figure 1)

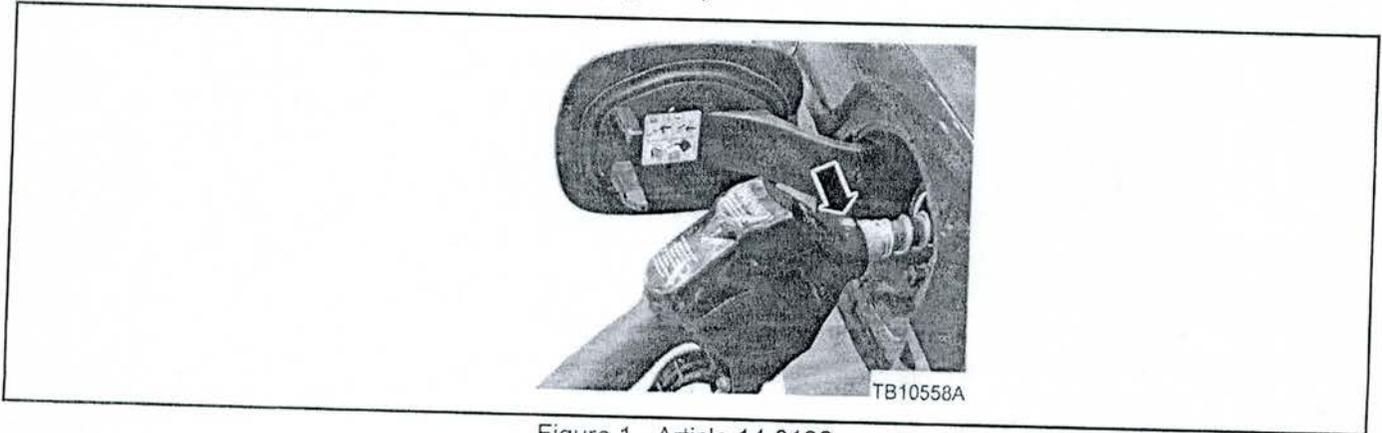
Figure 1 - Article 14-0132

Some vehicles equipped with the Easy Fuel™ Capless Fuel System may exhibit a concern where a fuel nozzle cannot be inserted and/or removed. This concern may be caused by a problem with the fuel station nozzle. The sleeve at the tip of the spout may be missing, not allowing the nozzle to be inserted, or could be loose/gapped not allowing the nozzle to be removed once inserted.

- a. Yes - Remove the single hex head set screw at the base of spout near the handle cover. Twist and pull the nozzle handle to separate from the spout. Once the fuel nozzle handle is separated from the spout, the fuel tank filler pipe can be replaced. Refer to WSM, Section 310-01. (Figure 1)

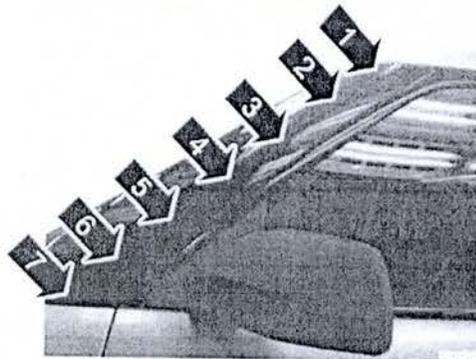
Figure 1 - Article 14-0133

Some 2013-2014 Flex vehicles may exhibit a wind or whistle-type noise from the left and/or right A-pillar area at highway speeds in crosswind conditions. This may be due to the A-pillar window moulding not being fully seated.

1. Push on the left and right A-pillar window mouldings. (Figure 1)

2. Was a click or snap-type noise heard when pushing on the A-pillar window mouldings?
  - a. Yes - repair is complete.
  - b. No - this article does not apply. Refer to the Workshop Manual (WSM), Section 501-00 for normal diagnosis.

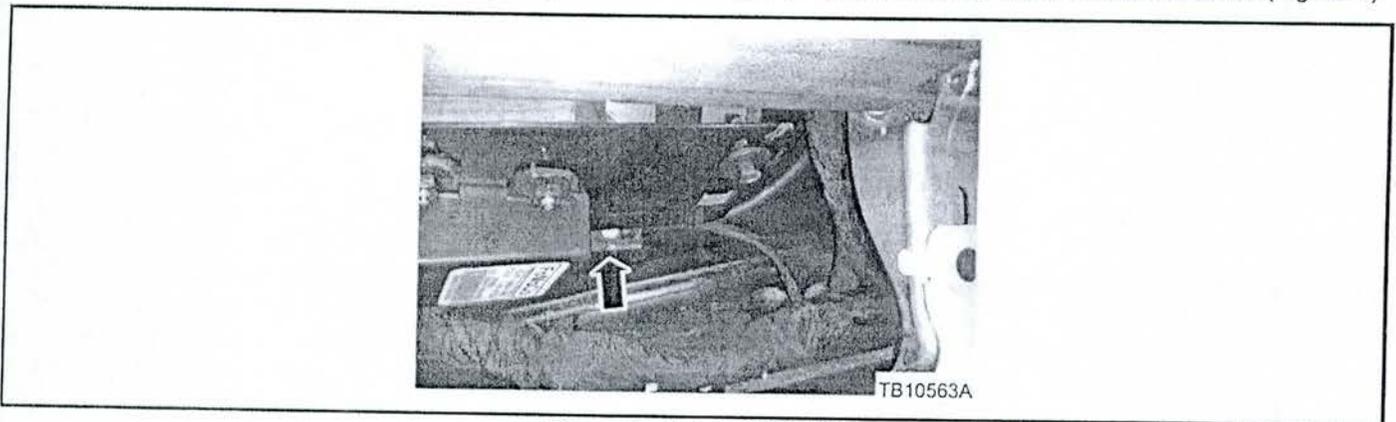
Figure 1 - Article 14-0136

Some 2013-2014 MKT vehicles may exhibit a wind noise originating from the passenger side glove box area while driving at 50 Km/h (30 MPH) or higher. In extreme cases, such as when agitated by high speed driving or gusting winds, this noise may escalate into a high pitched whistle. This may be caused by an incorrectly installed or missing dash body plug behind the instrument panel.

1. Lower the glove box and place a 10 mm (3/8") vacuum hose by the heated steering wheel module bracket. (Figure 1)

2. Drive the vehicle above 50 Km/h (30 MPH) in an effort to duplicate noise.
3. Is the noise loudest by the heated steering wheel module bracket or the two white push pins?
  - a. Yes – proceed to Step 4.
  - b. No – this article does not apply. Refer to Workshop Manual (WSM), Section 501-00 for normal diagnosis.
4. Remove the instrument panel and replace the dash body plug behind the instrument panel. Refer to WSM, Section 501-12.
