| 2.0L GDI - VARIOUS DRIVEABILITY CONCERNS OR ENGINE MALFUNCTION INDICATOR LAMP ILLUMINATED | TSB 14-0215 |

2012-2014 Focus

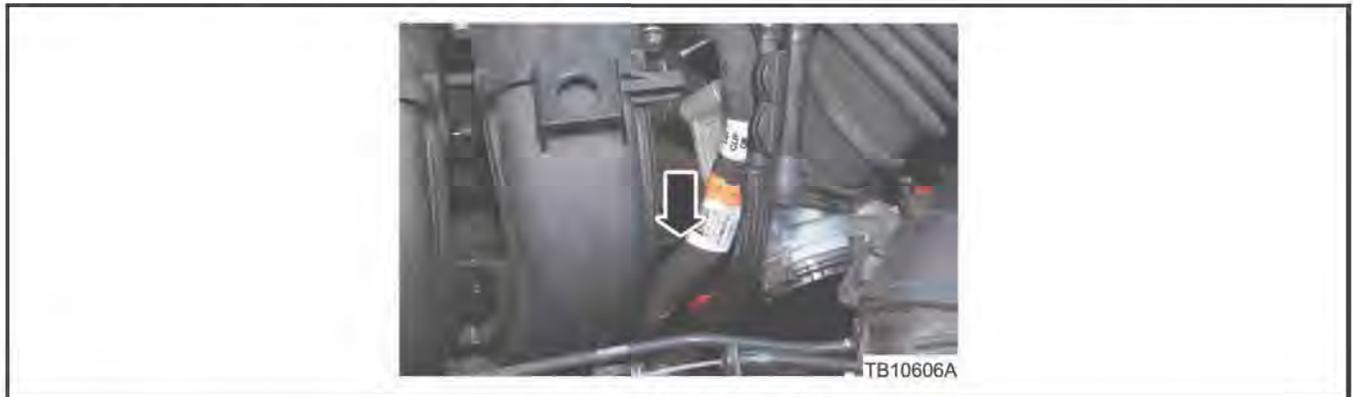
Figure 1 - Article 14-0215

Some 2012-2014 Focus vehicles equipped with a 2.0L Gas Direct Injection (GDI) engine may exhibit a concern of a malfunction indicator lamp (MIL) illuminated, engine runs rough, crank no-start, loss of power, or loss of engine RPM, with diagnostic trouble codes (DTCs) P0122, P0222, P0320, P0322, P0327, P0332, P0344, P0369, P06A7, P060D, P061C, P1336, P1674, P2111, P2112, P2127 and/or P2135.

1. Check the vehicle build date. Was the vehicle built on or before 2/4/2014 with an automatic transmission or built on or before 2/19/2014 with a manual transmission?
 - a. Yes - inspect the engine harness for chafing against the intake manifold, near the throttle body. (Figure 1)

- (1) It may be necessary to use a small mirror to inspect the back side of the harness where the harness may contact the intake manifold. Proceed to Step 2.
 - b. No - proceed to Step 5.
2. Does the wiring harness protection show damage, abrasion or chafing against the intake manifold?

- a. Yes - remove the harness protection to inspect for damaged circuits. Repair any damaged circuits.
 - (1) When repairing damaged circuits, it is necessary to first disconnect the electrical connectors for the HPP, MAF/IAT, EVAP purge valve, ECT, HO2S11, HO2S12, FRP, CMP11, CMP12, VCT11, VCT12 and all 4 coil on plugs (COPs). Refer to the Wiring Diagram for component locations.
 - (2) Remove the air cleaner assembly. Refer to Workshop (WSM), Section 303-12.
 - (3) Remove the bolt from ground G103.
 - (4) With the engine harness retainers disconnected from the top of the engine, the engine harness can be lifted and moved forward enough to gain access to circuits in the chafing location.
 - (5) Additional wire must be added to the repaired circuits to maintain proper circuit length. Refer to the Wiring Diagram Section 5 and use the solder method. Proceed to Step 3.
