Michael A. Berardi
 Director
 Service Engineering Operations
 Ford Customer Service Division

April 5, 2016

SUBJECT: **Safety Recall 15S34 – Supplement #2**
 Certain 2010-2011 Model Year Fusion and Milan Vehicles Equipped with 2.5L or 3.0L Engines
 Fuel Tank and Canister Purge Valve Inspection and Repair

NEW ! CERTAIN 2010-2011 MODEL YEAR FUSION AND MILAN VEHICLES EQUIPPED WITH 2.5L OR 3.0L ENGINES — FUEL TANK INSPECTION AND REPAIR

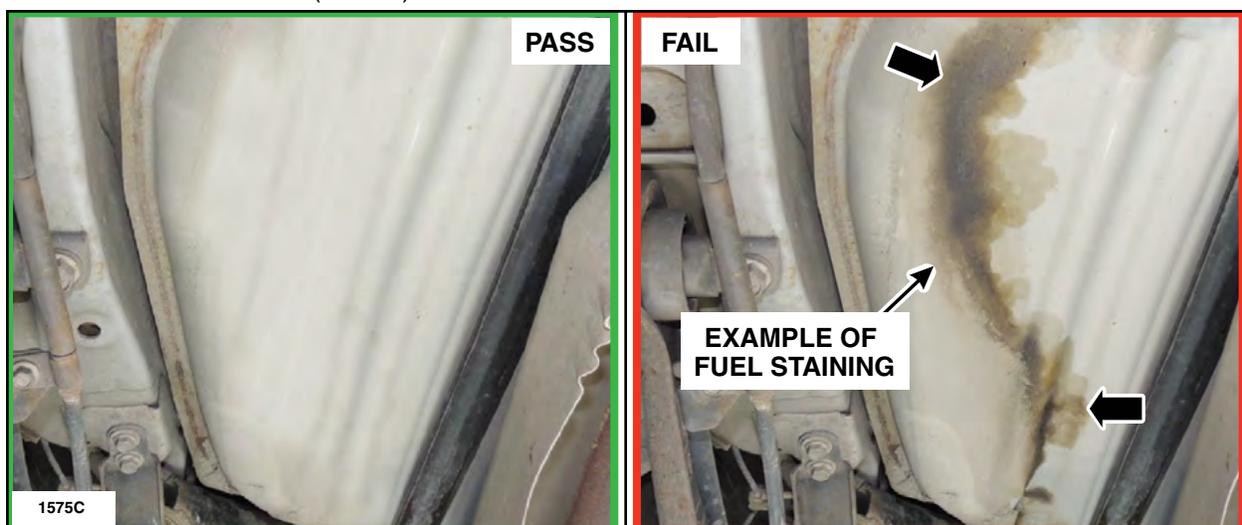
FIGURE 1

1. Inspect the fuel tank for any signs of fuel staining on the bottom of the fuel tank. See Figure 1.

2. Is there fuel staining on the bottom of the fuel tank?

YES - The fuel tank must be replaced. Replacement fuel tanks are not available at this time. Contact the Special Service Support Center (SSSC) using a Parts Order contact to place an order for a fuel tank and to request a rental vehicle, if needed. Photos of the fuel staining will be needed when submitting the request.

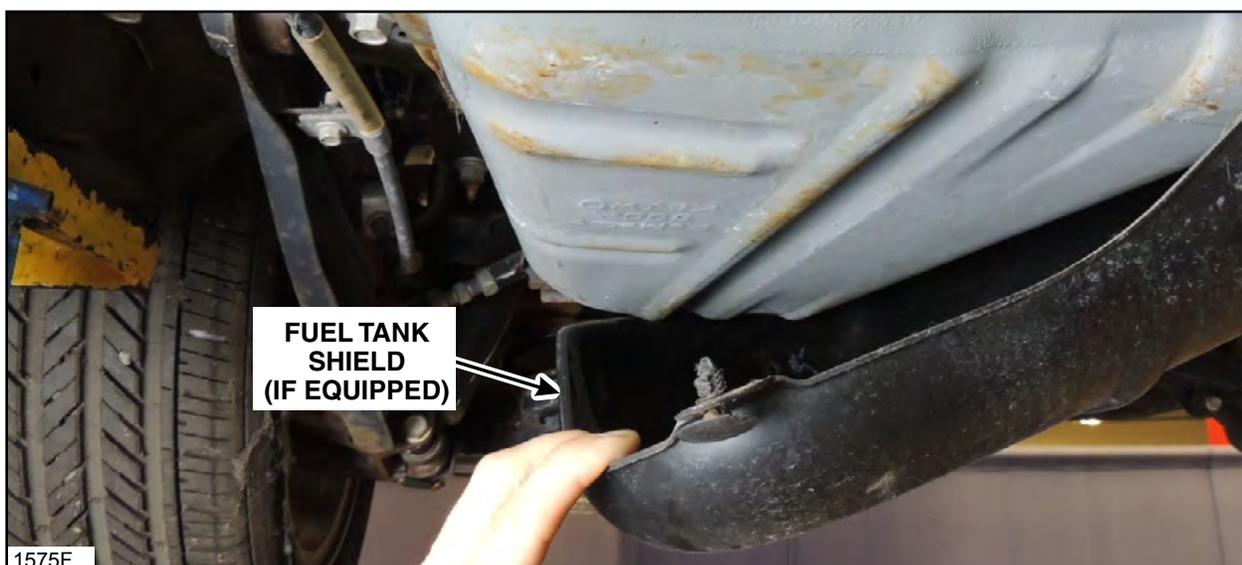
FIGURE 2

NOTE: AWD Vehicles Only - Fuel tanks come equipped with a plastic shield covering the tank. See Figure 2.

- a. Remove the fuel tank strap bolts and strap from the RH side of the fuel tank.
- b. Remove the two push pins and bend the plastic shield downward to inspect the RH side of the fuel tank.
- c. Reinstall the fuel tank strap, bolts and shield push pins. Perform the same inspection steps for the LH side of the fuel tank (Steps a-c).
- d. If fuel tank replacement is not required, tighten the fuel tank strap bolts to 40 Nm (30 lb-ft).

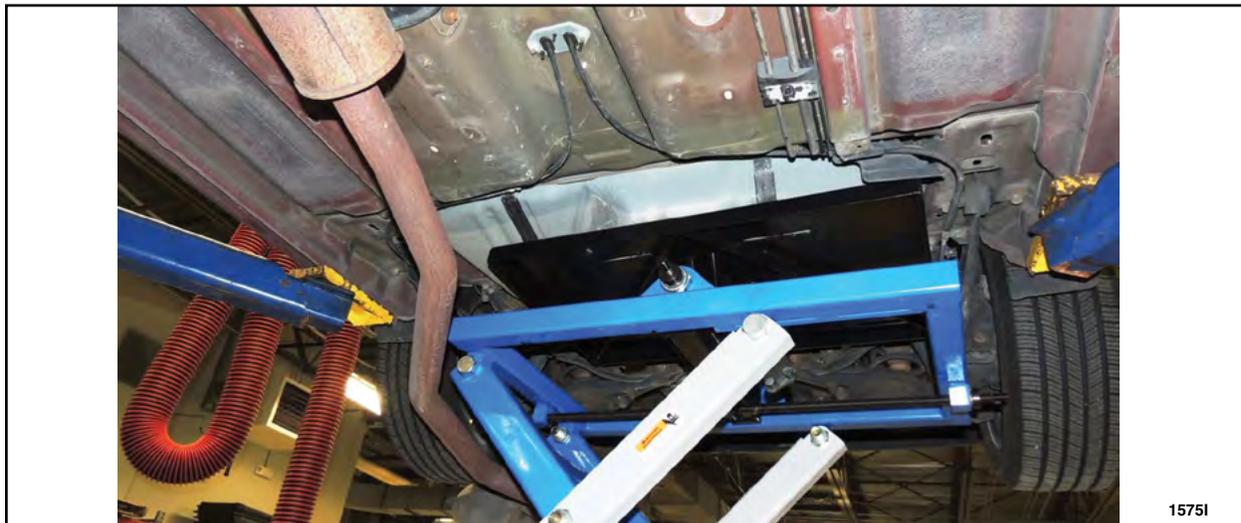
FIGURE 3

3. Partially lower the fuel tank to inspect the top of the fuel tank for any signs of fuel staining.
See Figures 3 and 4.

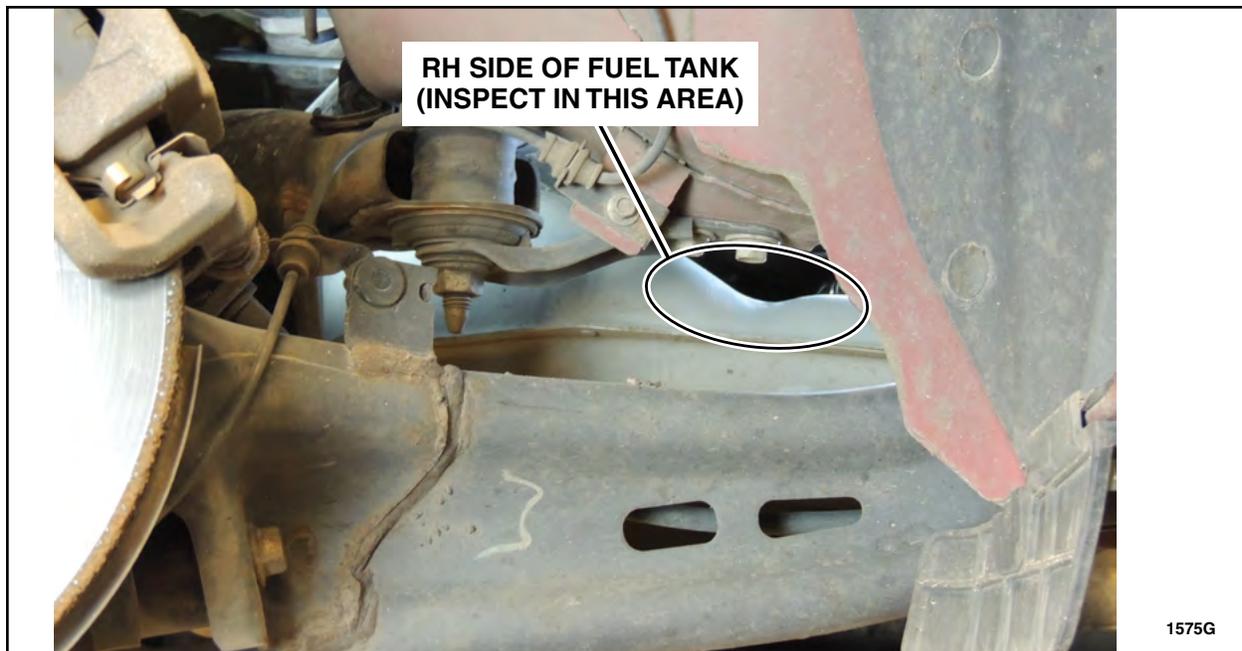
FIGURE 4

4. Check the top RH side of the fuel tank for signs of cracks. See Figures 4 and 5. Is cracking present?

YES - The fuel tank must be replaced. Because fuel tanks are not available, reinstall the fuel tank and contact the Special Service Support Center (SSSC) using a Parts Order contact to place an order for a fuel tank and to request a rental vehicle, if needed. Photos of the cracking will be needed when submitting the request.
