GROUP Accessories	MODEL 2014MY Sorento (XM)
	NUMBER 007	DATE March 2013
TECHNICAL SERVICE BULLETIN		
SUBJECT: SORENTO STAINLESS BUMPER PROTECTOR SEPARATING

SUBJECT: LIFTER BRACKET REPLACEMENT FOR SORENTO POWER
TAILGATE SYSTEM

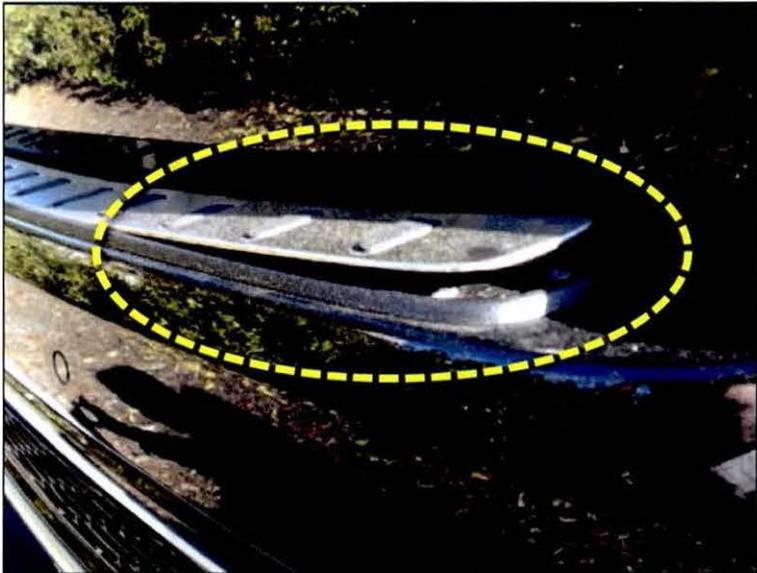
Some 2014MY Sorento vehicles, equipped with a Kia accessory Stainless Rear Bumper Protector, may exhibit a condition where the stainless insert is separating from the protector base, as shown below. To resolve this condition, a revised bumper protector should be installed. Follow the procedure outlined in this TSB to remove the original bumper protector and then follow the instruction sheet enclosed with the revised part to install the new bumper protector.
