MODEL
Sportage (SL)

NUMBER
PS329

SUBJECT: ADJUSTING REAR HATCH CLOSING EFFORT

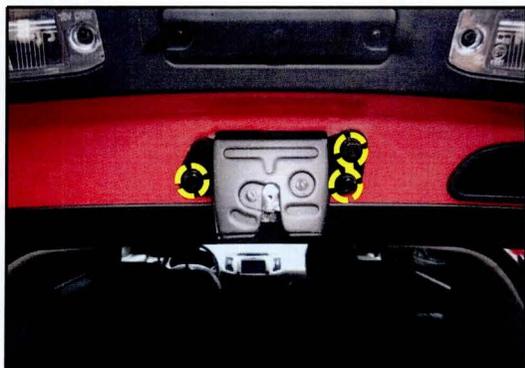
When encountering a customer concern related to excessive rear hatch closing effort on some 2011MY to 2014MY Sportage (SL) vehicles, first, verify the customer concern by comparing the closing effort on the affected vehicle to other like vehicles. Make sure all windows are rolled up and use minimal effort to try and close the hatch. If more effort is required to close the hatch than on like vehicles, perform the following procedure:

1. Loosen three bolts securing the latch to the tailgate.
